PUBLIC RIGHTS OF WAY AND GREENS COMMITTEE

3 APRIL 2006

PUBLIC RIGHT OF WAY 464, ST. MARTINS GARDENS TO IMPERIAL WALK

(Report of the Director of Planning, Transport and Sustainable Development)

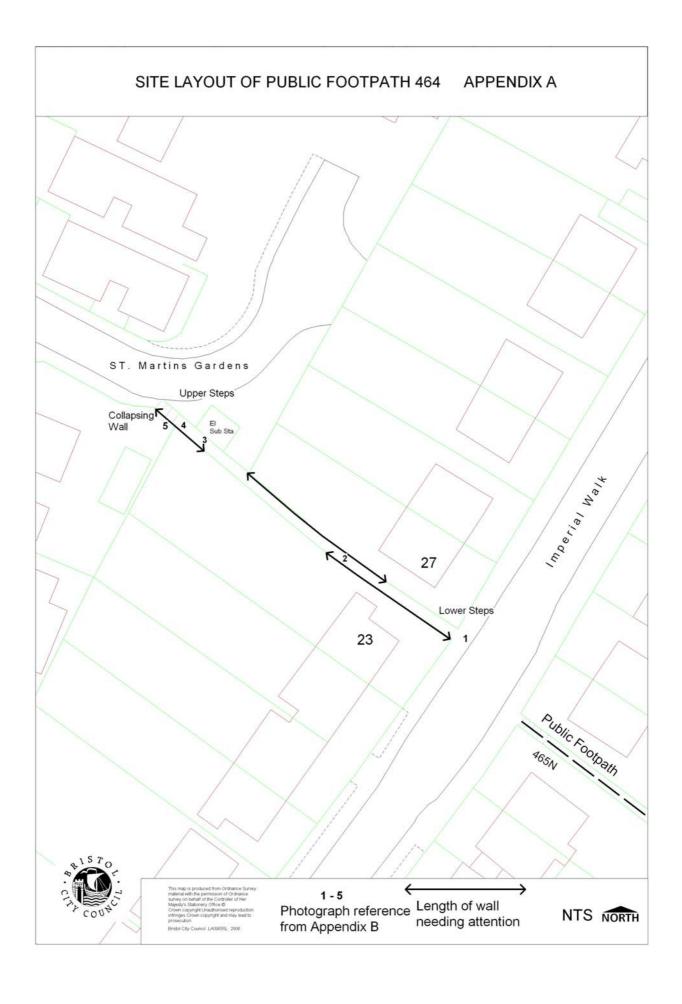
Figure 1 Lower Steps at Imperial Park

Figure 2 Mid-way looking towards St. Martins gardens

Figure 3 Looking towards Imperial Park

Figure 4 Upper Steps at St Martins gardens

Figure 5 Collapsing wall
