# Redcliffe Bridge Final Mechanical & Electrical Inspection Report

PREPARED FOR: Chris Dooley Bristol City Council  
COPY TO:  
PREPARED BY: Jim Walters  
DATE: June 2017  
PROJECT NUMBER: 203742  
REVISION NO.: Rev 2  
APPROVED BY: K Powell

The purpose of the report is to assess the condition of the mechanical and electrical items of the bridge installation and to determine what measures are required to extend the asset life for a further 20 years.

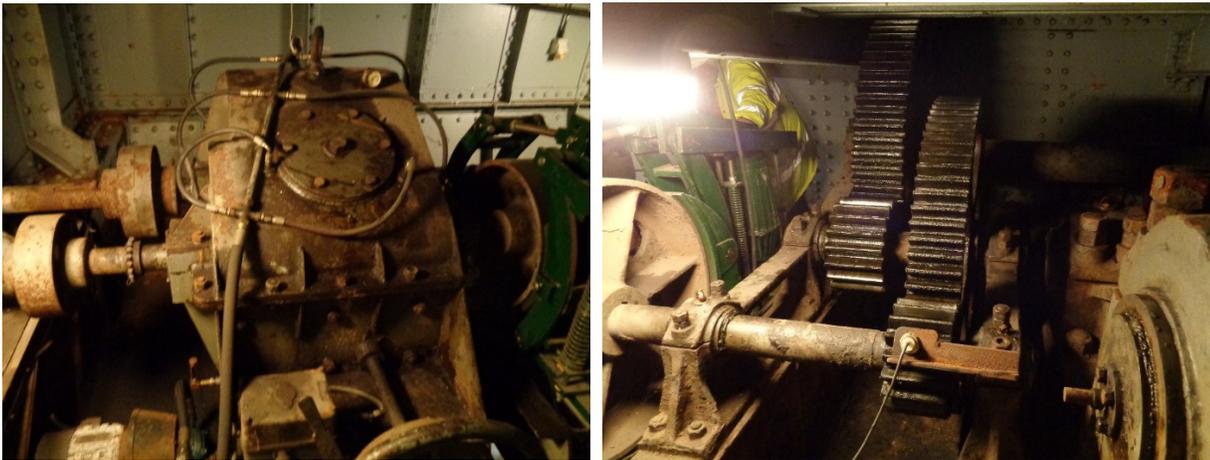
The main drive train is located in the machinery rooms below the main bridge deck but elevated from the machinery chamber, although there is some corrosion to the floor panels and surrounding steelwork structure the main drive train is generally in good condition.

The general condition of the main drive train is good with no concerns regarding a bridge movement, there are some minor recommendations in the Radicon report, typically replace the existing lubrication oil and correct any minor leaks in the distribution pipework, fit a gasket to the inspection cover and possibly replace the oil seals with split units. The open gearing arrangement on the drive shafts are in good condition and have been regularly greased as have the supporting plunger block bearings, continue with the maintenance regime.

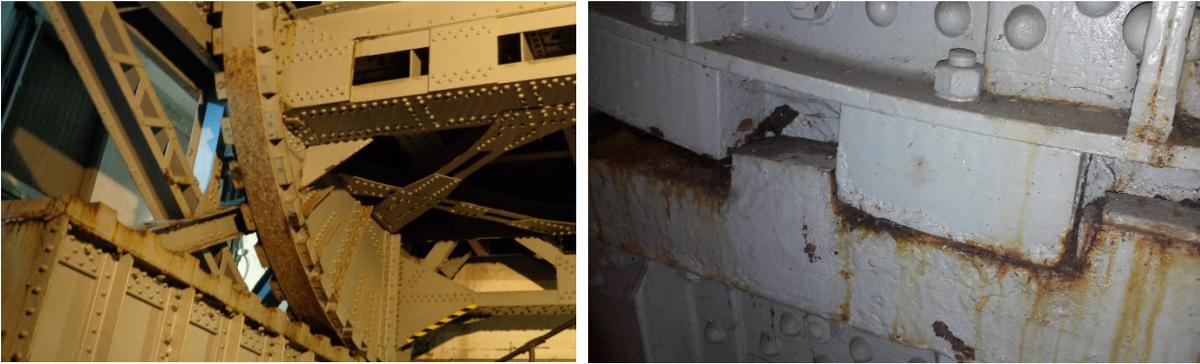
The toothed quadrants and associated toothed tracks are located in the machinery chamber which is at or partially below the water level in the floating harbour and subject to damp and humid conditions. There is also evidence of surface water run-off from the above road deck down the side of the bridge structure, this leads to corrosion which in turn, debris falls down onto the horizontal track which causes an issue with the bridge movement. There is significant corrosion to the interlocking blocks/teeth on the outer quadrants and track, there is also evidence of wear to the leading edges which could promote misalignment.

The main rolling quadrants require some major works to remove any corroded material from the interlocking teeth of the quadrant and track, this should include the removal of the quadrant teeth and making good and repainting. The majority of this work could be undertaken during normal shift working hours however there would be a night time bridge closure required to access the teeth that are currently engaged on the track.

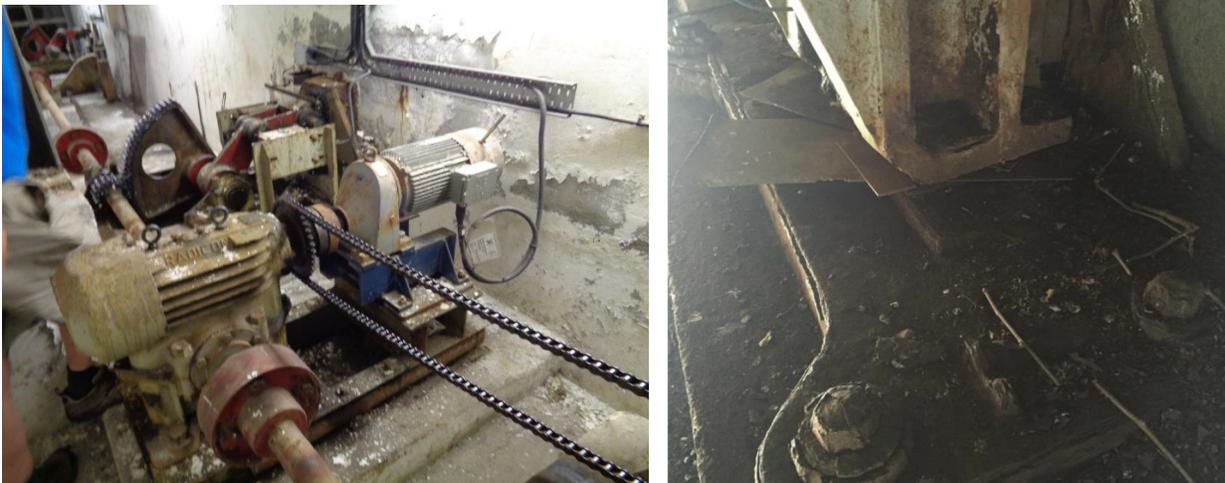
The nose bolt assemblies are in the gallery and relatively well protected from the elements, all three mechanisms appear to be in good condition. The nose bolts appear well greased, however the nose bearings are heavily corroded and have a significant amount of temporary packing fitted believed to be to limit the bounce of the bridge when subject to heavy traffic and reduce the resulting noise.

The nose bolts will need to be retracted and the grease removed from the bolt, housing and nose bearing to check for wear on these items.

The nose bolt drive assemblies are generally in good condition and do not require any remedial works. The nose bolts should be retracted and inspected for damage and wear in conjunction with the pockets on the respective bearing stools on the bridge structure.

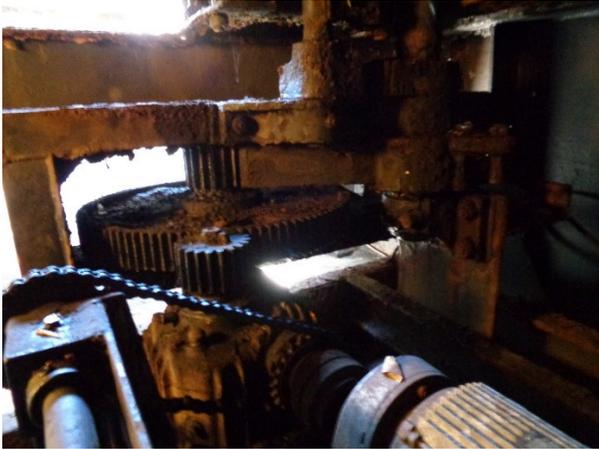
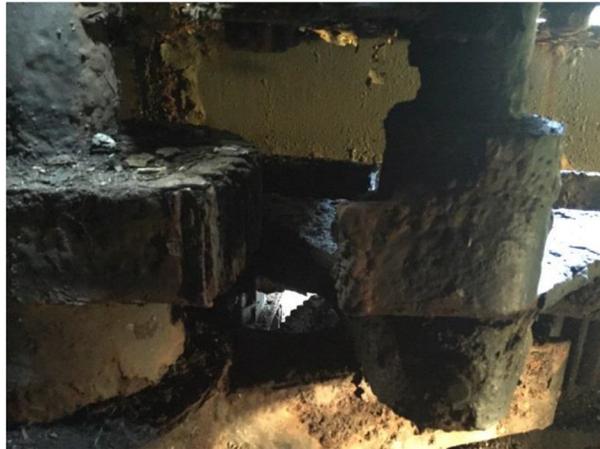
The barrier operating gear is located in a suspended pit below the road deck and is in very poor condition, surface water, grit and road debris passes through the opening in the deck for the barrier drive shafts and accumulates on the quadrant and spur gears unnoticed. The quadrant gear on the pedestrian barrier drive

shaft is so badly corroded that most of the gear teeth are missing, there is trapped water in the support structure and the manually operated chain drive is also seized solid. The limit switch brackets are so corroded it is unlikely that they operate correctly, it is highly unlikely that this particular barrier would operate correctly.

- A – Replace both the vehicle and pedestrian gates and the operating mechanism at all four locations with a new gate set tailored solution to suit the existing site layout and constraints. The new gates can be designed to match the style of the existing gates and will operate in the same manner as the existing with the drive mechanism installed above ground.

- B – Replace the existing vehicle and pedestrian gates and the operating mechanism at all four locations with a new vertical lift barrier arrangement to suit the existing site layout and constraints. The new drive mechanism to be installed above ground.

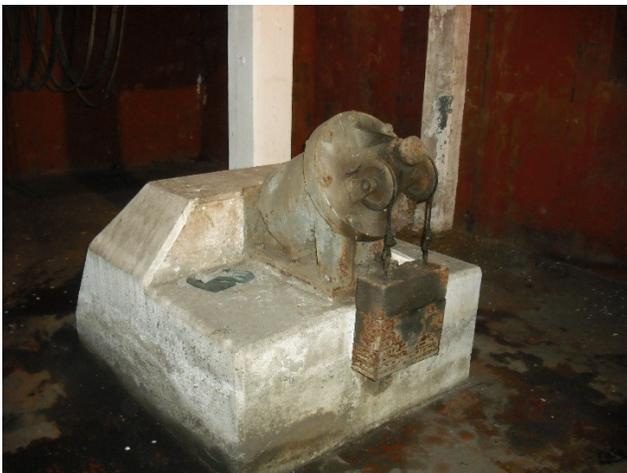
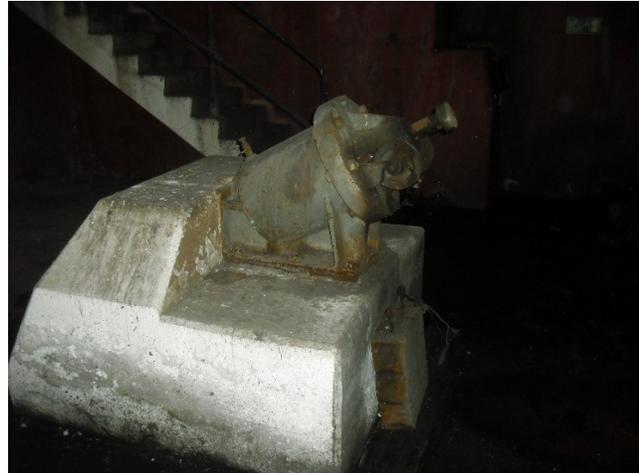
The two bridge tail buffers located in the machinery chamber are inoperable, one is stuck in the depressed position and the other stuck in the extended position with the counterweight disconnected.

The buffers/dampers at the tail in the machinery chamber should be replaced with new hydraulically operated industrial standard dampers.

Also the three wooden block end stops should be replaced, sized to suit the stroke of the new damper.

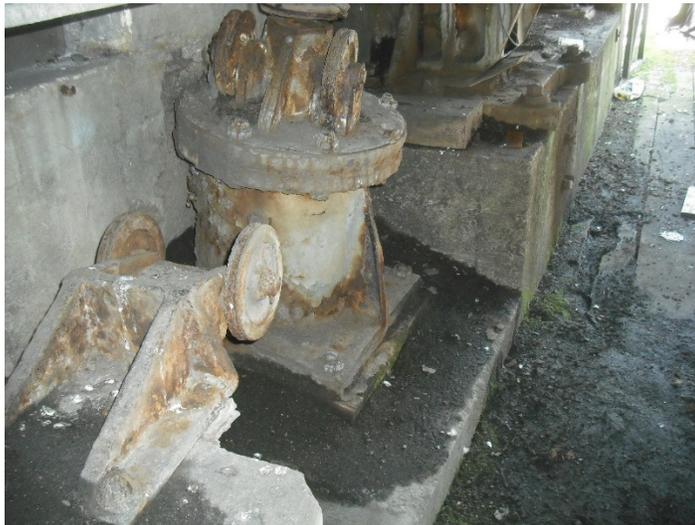
The two bridge nose buffers are beyond repair, both are severely corroded with their counterweights missing.

The buffers/dampers located at the nose pier of the bridge structure are beyond economic repair, it is unclear whether they would be a functional element of the structure even if they were in an operational condition.
