River Wall and Chocolate Path – Section B

BD79/13 Management Report

Document No. R002 | A

Client: Bristol City Council

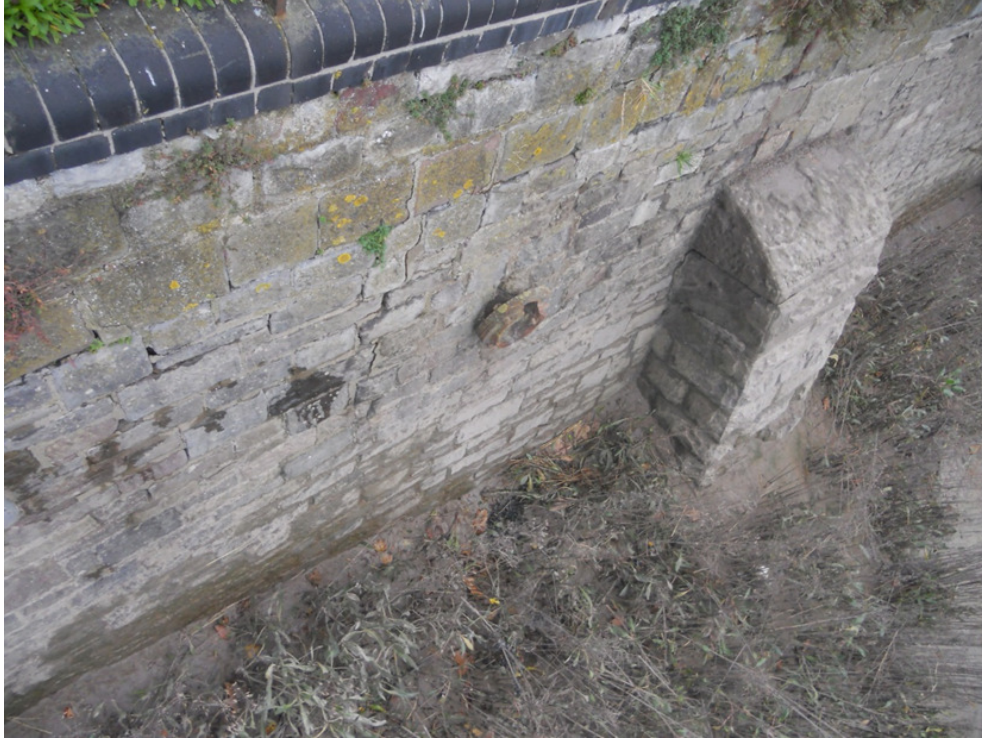
Retaining Wall: Wall was inspected remotely from the south bank using high resolution photographs. The retaining wall has undergone significant settlement and rotation between 140m – 210m due to assumed slip circle failure. There are significant areas of missing mortar (80m²), significant displacement of stonework in at least 4 areas, bulging to stonework (2 areas) and multiple cracks ranging from 1mm – 10mm wide.

Photo 05 - Cracks in Wall Near to Buttress B11 (Ch144m)

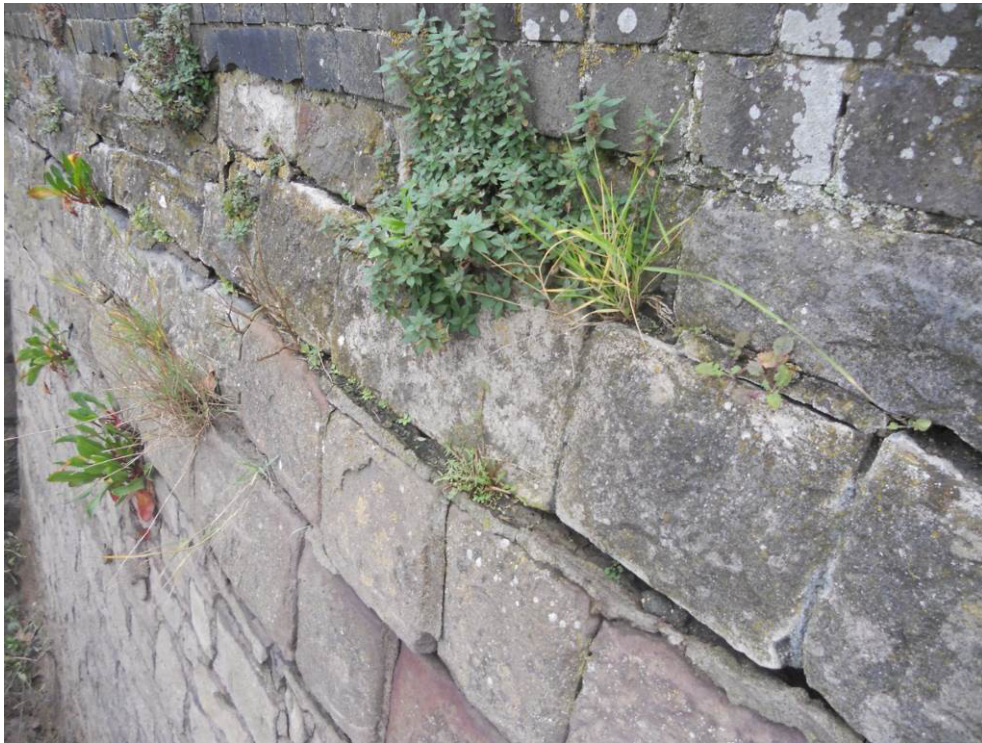
Photo 07 – Displaced Stonework Between Buttress B13 and B14 (Ch157m – 160m)

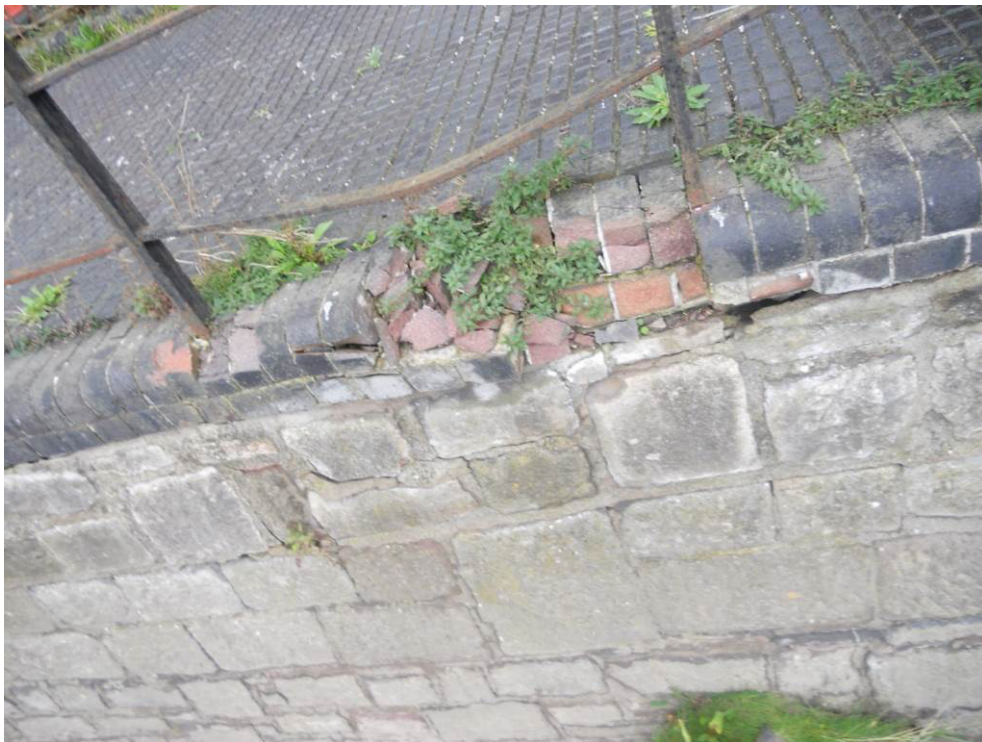
Photo 08 – Displaced Brickwork Above Buttress B15 (Ch168m)

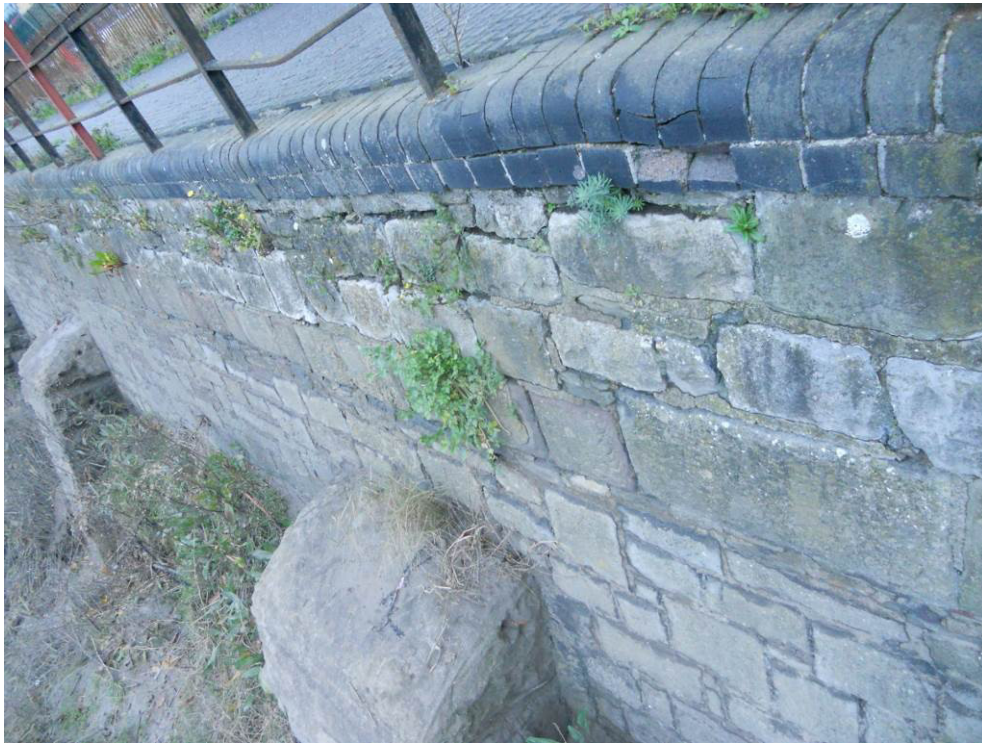
Photo 09 – Mortar Deterioration above Buttress B17 (Ch180m)

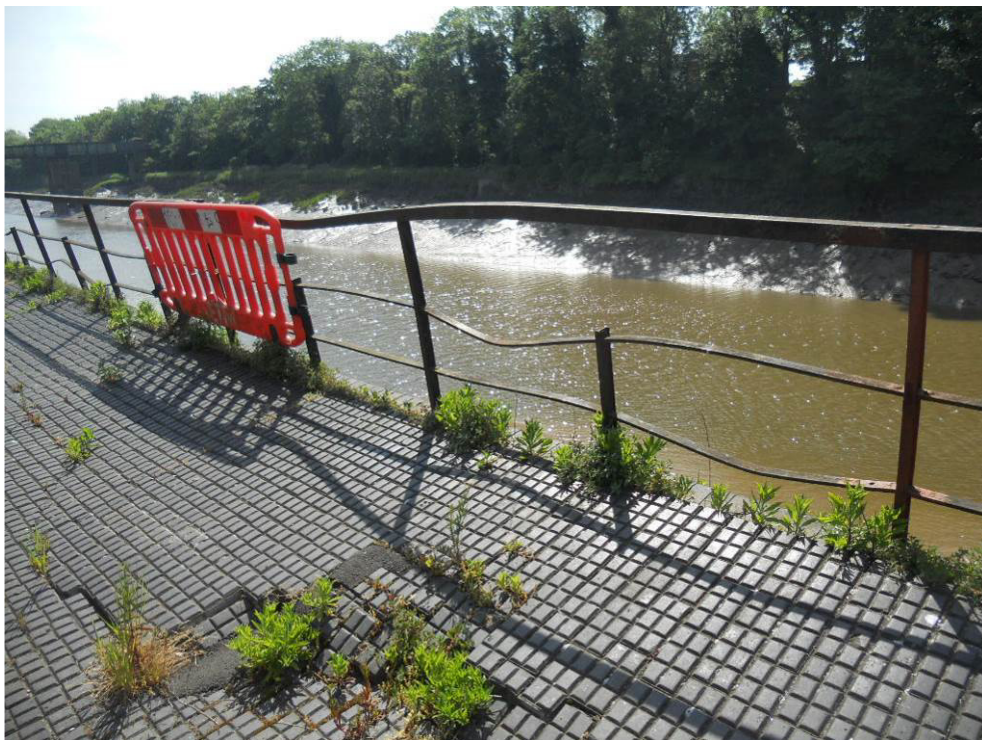
River Parapets: The paint coatings have failed resulting in surface corrosion throughout. The parapet comprises posts and 3 rails without any infill. The parapet is not compliant with current standards. A small number of intermediate rails are loose due to fixing corrosion. There is severe corrosion to the base of several posts. Major deformation of railings at the centre of the slip circle. Smaller deformation elsewhere. Posts lean towards the river by up to 180mm (11°).

Photo 10 – Major Distortion of Railings at Centre of Slip (Ch170m)

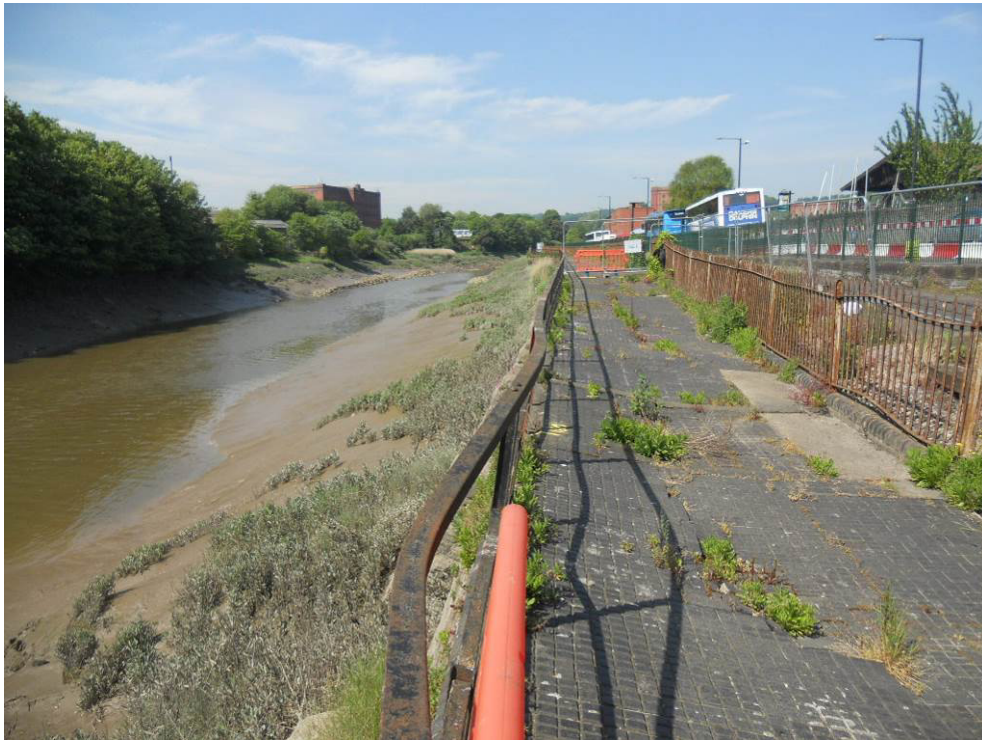
Photo 11 – Major Distortion of Railings at Centre of Slip (Ch170m)

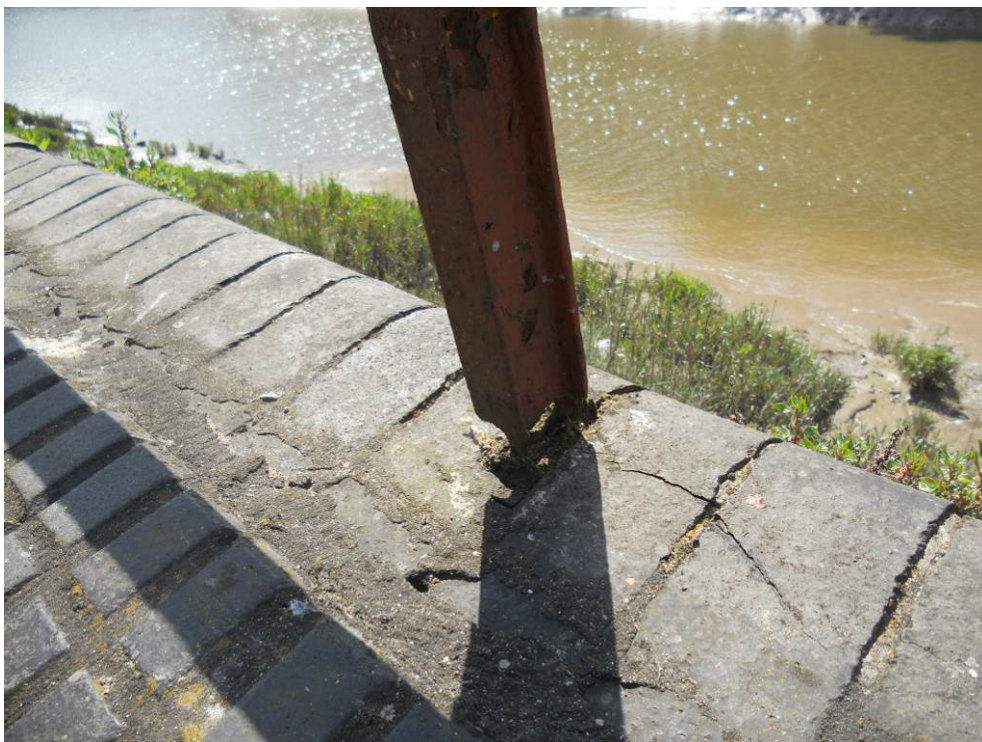
Photo 12 – Localised Severe Corrosion to Base of Parapet Post (Ch140m)

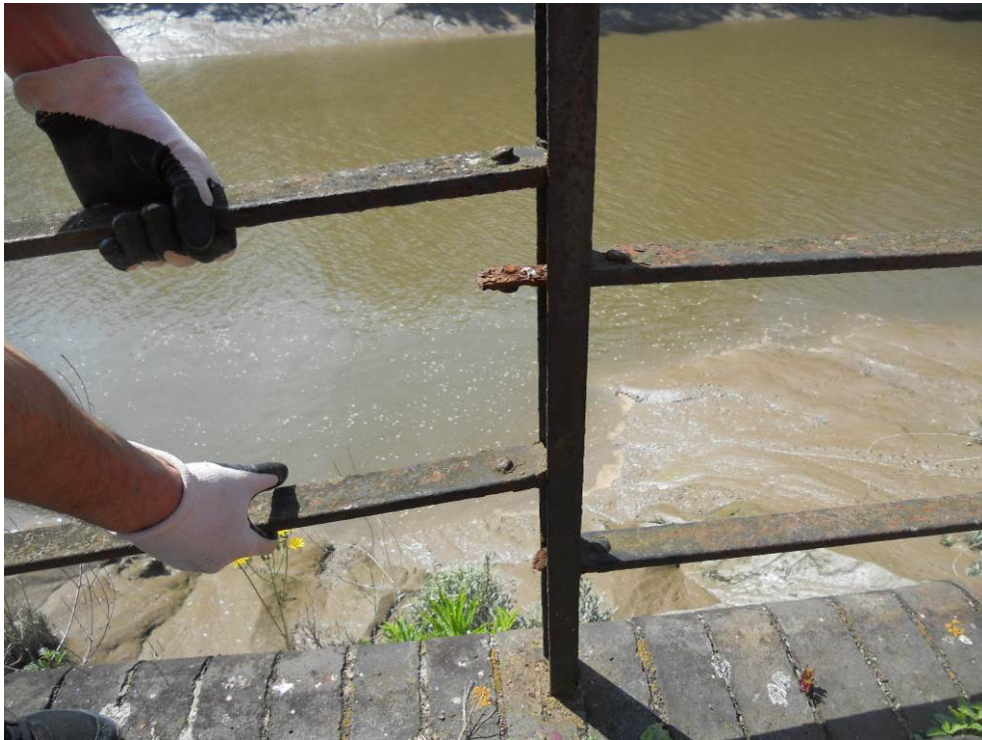
Photo 13 – Corroded Fixings to Intermediate Rails (Ch210m)

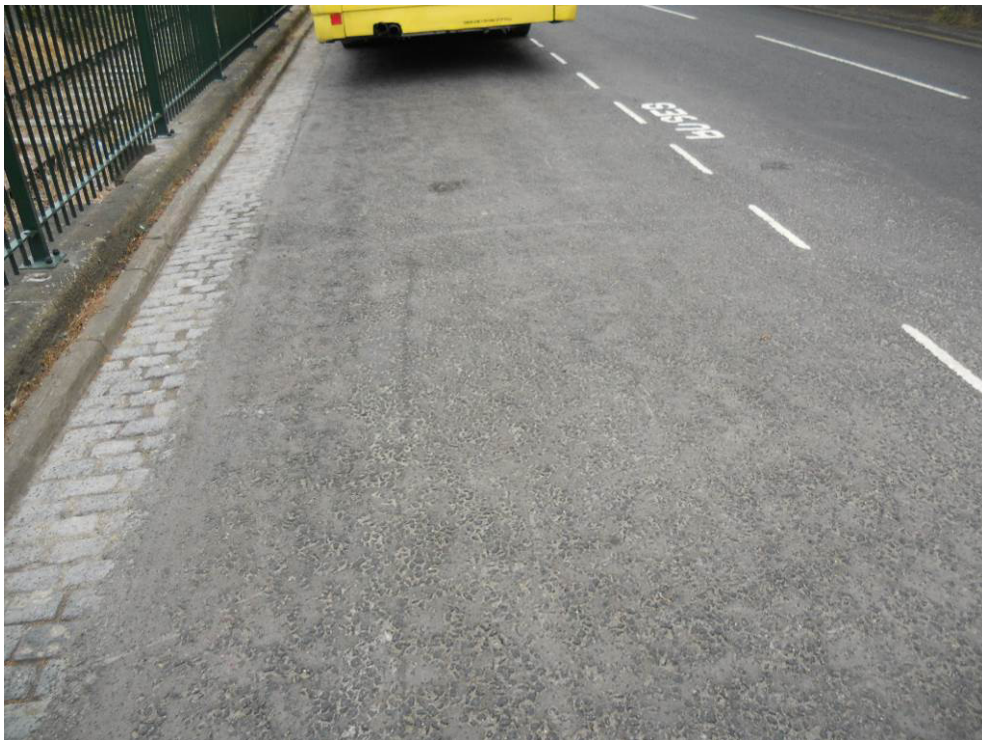
Photo 14 – Cumberland Road (Ch230m)

Cumberland Road: Recently resurfaced. Good condition with no apparent defects.

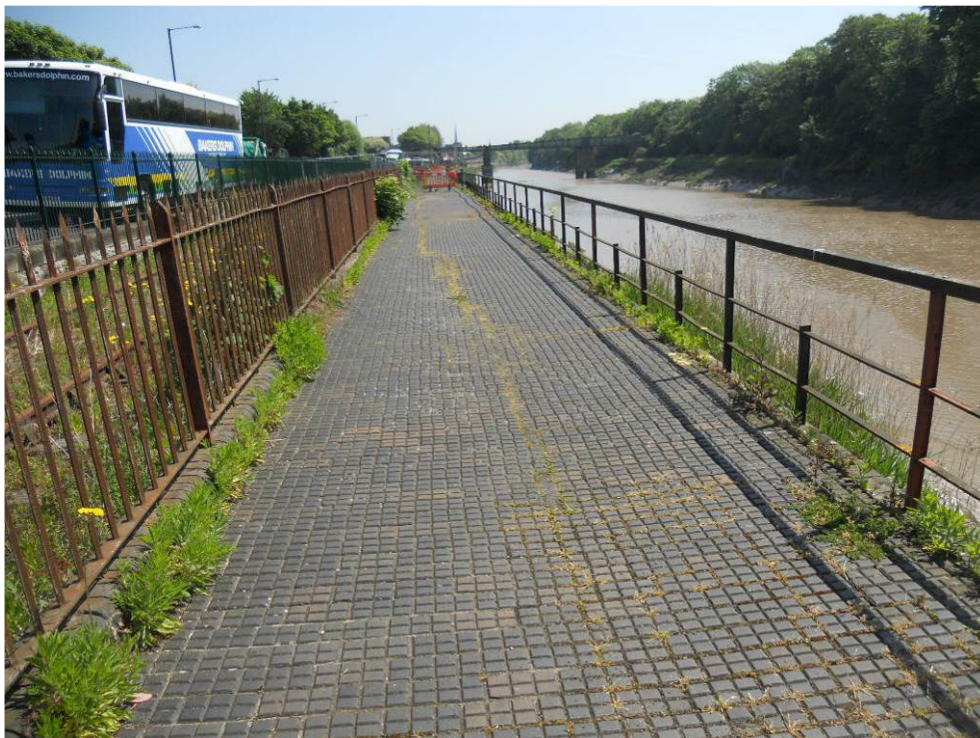
Photo 16 – General Condition of Chocolate Path (Ch81m to Ch130m)

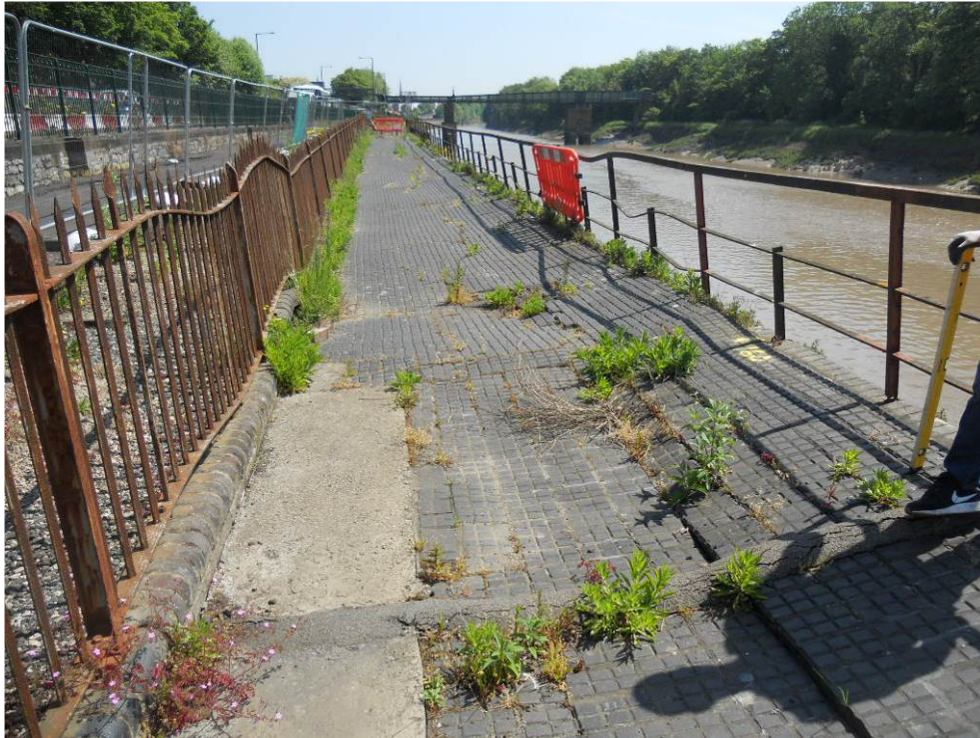
Photo 17 – Major Deformation of Chocolate Path (Ch160m)

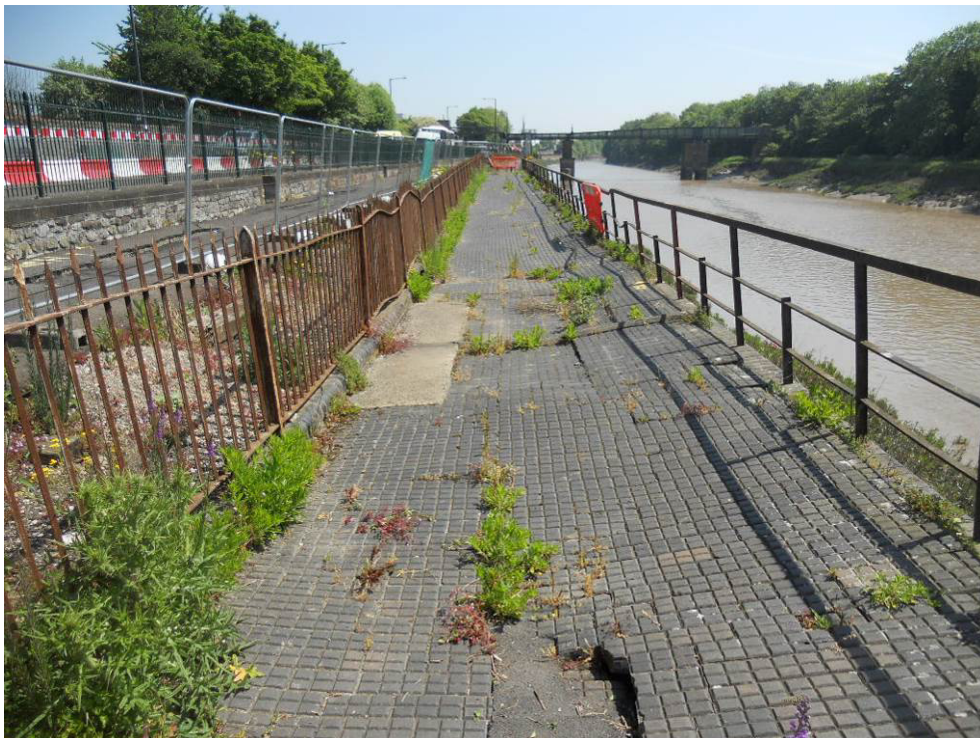
Photo 18 – Major Deformation of Chocolate Path (Ch150 - 160m)

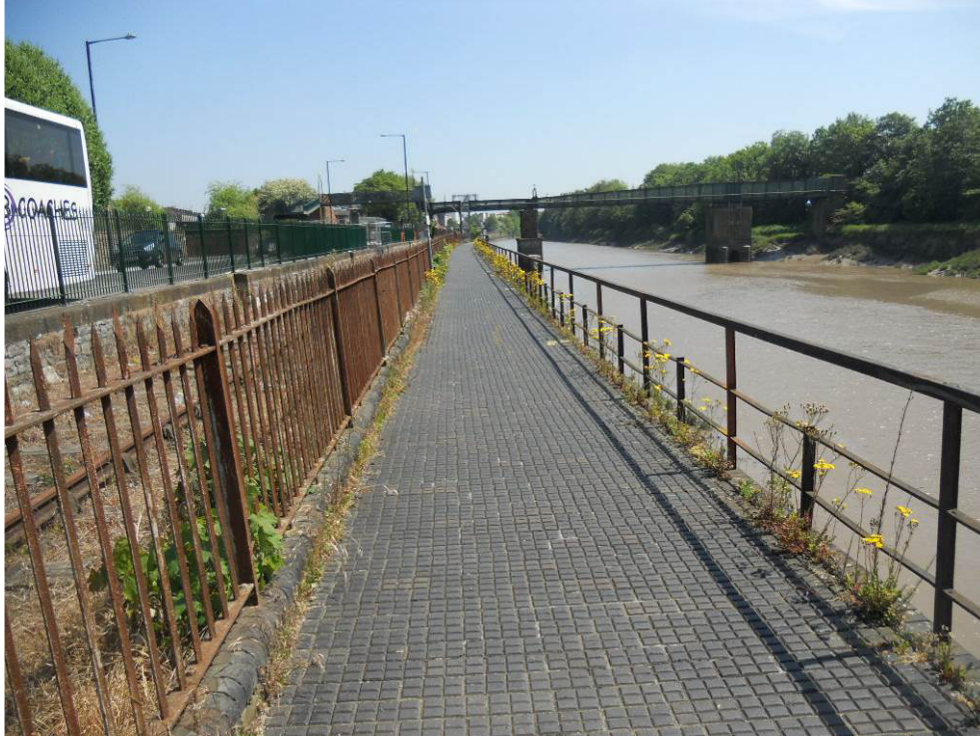
Photo 19 – General Condition of Chocolate Path (Ch215m to Ch306m)

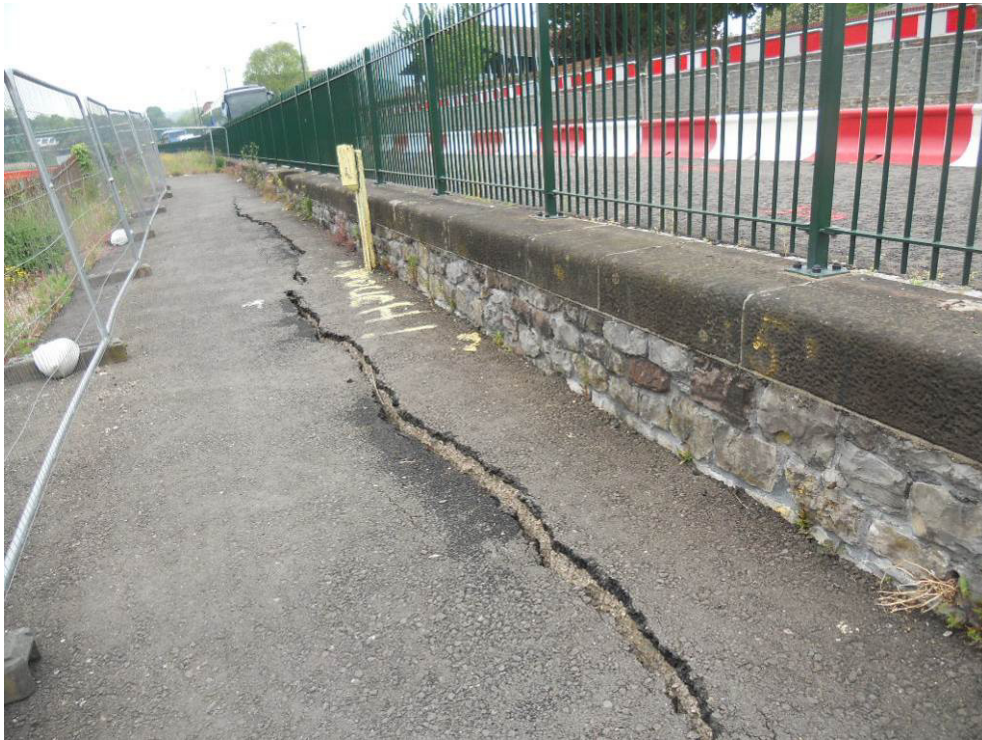
Railway: The railway has been tarmacked over between Ch147 – 195m due to significant settlement. The temporary footpath also has a 50mm wide tension crack with a 100mm vertical step due to ground movement (slip circle). The remainder of the railway appears sound.

Photo 21 – Tension Crack in Tarmac over Railway (Ch147m – 195m)

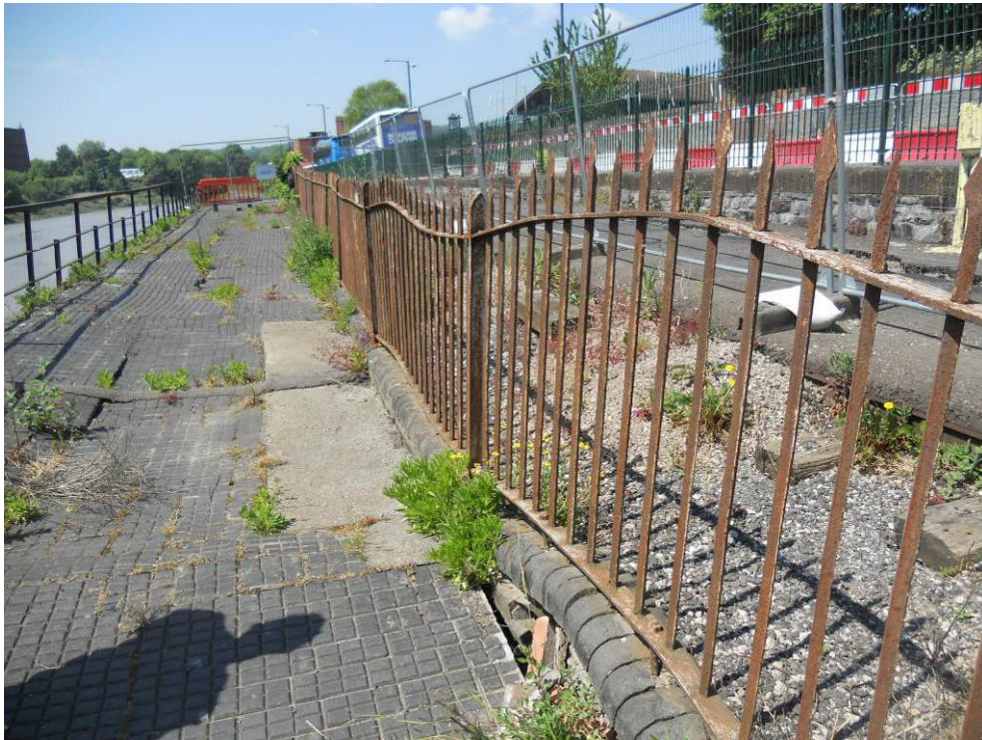
Railway Railings: The railings are 1.4m high with spiked tops creating a potential impalement risk to cyclists. The paint coatings have failed and there is surface corrosion throughout. There is corrosion and significant section loss at the base of some posts. The railings have been distorted at Ch165m due to ground movement (slip circle).

Photo 23 – Major Deformation of Railway Railings Due to Ground Movement (Ch165m)

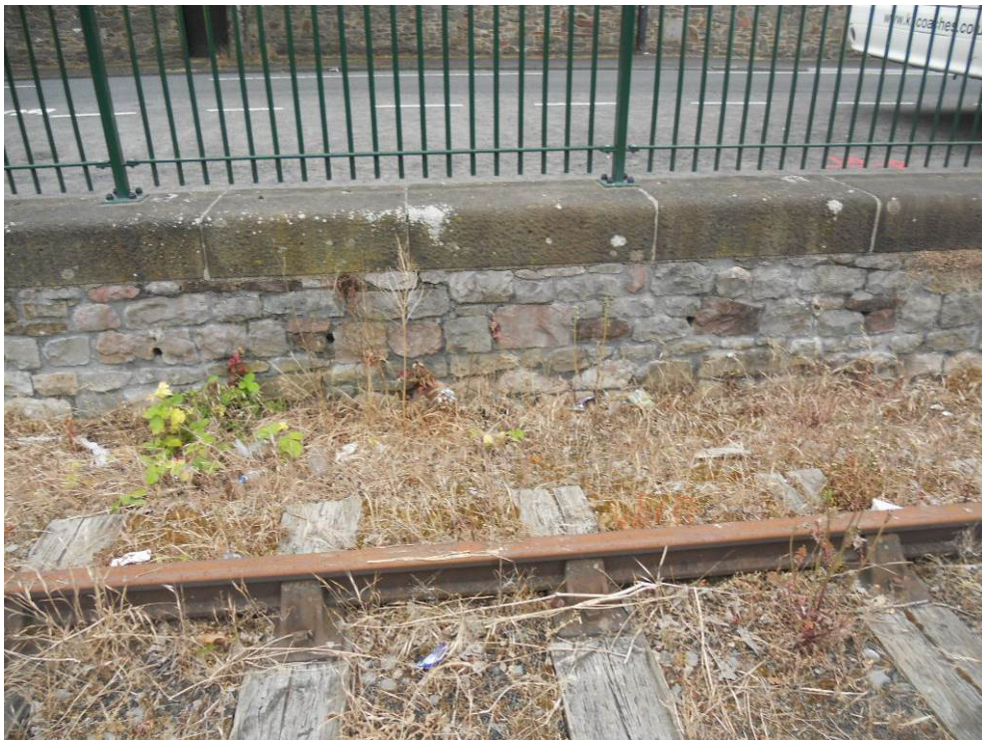
Photo 24 - Highway Retaining Wall

Highway Retaining Wall: Good condition with no signs of distress or settlement. Light vegetation growing on the wall (Ch130 – 200).

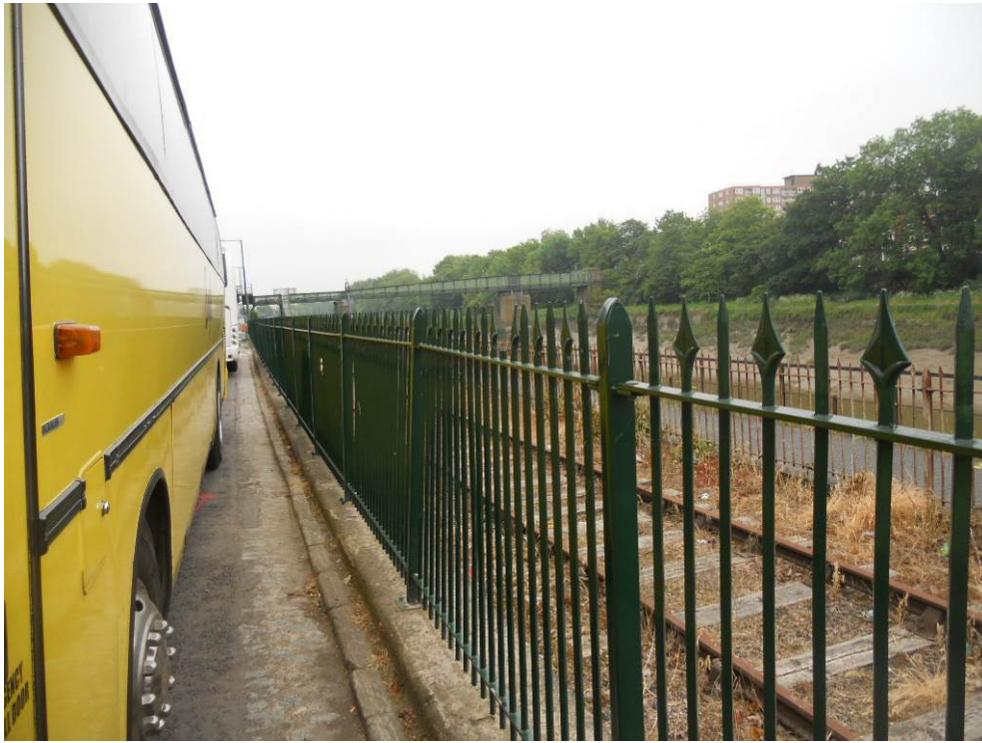
Cumberland Road Railings: New railings installed as part of the AVTM works. Generally in good condition apart from RTA damage to 3 panels.

Photo 25 - Cumberland Road Railings – Minor RTA Damage to 3 Panels (Ch220m)
