REPORT

Temple Gate MSCP Life Care Plan

Bristol City Council

April 2018

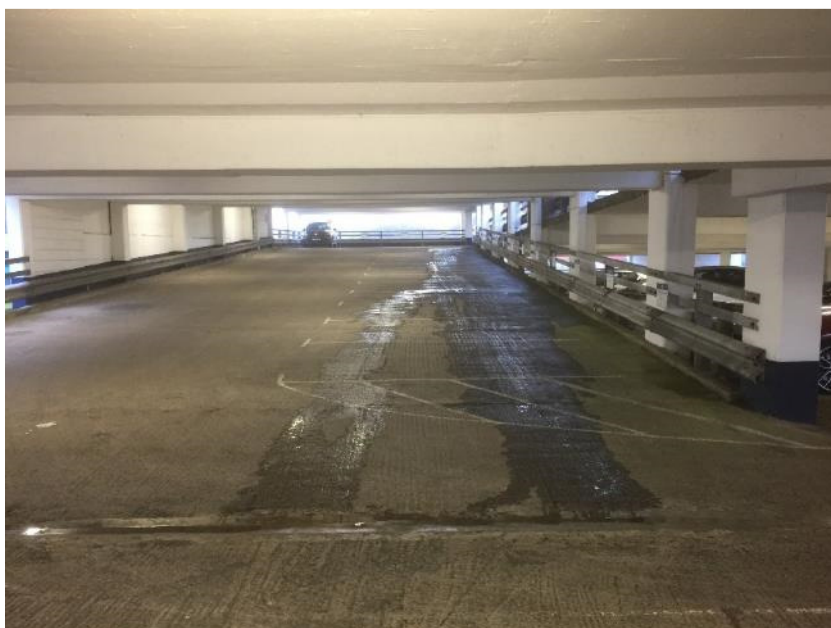
Figure 5-1. Structural arrangement

The columns and beams are painted white (see Figure 5-1). The coating is typically in good condition. There are a small number of defect in the beams and columns that relate to, or appear to relate to corrosion of embedded reinforcement. However, there is no evidence of distortion or significant structural damage.

Typical slab, column, beam, soffit and wall arrangement

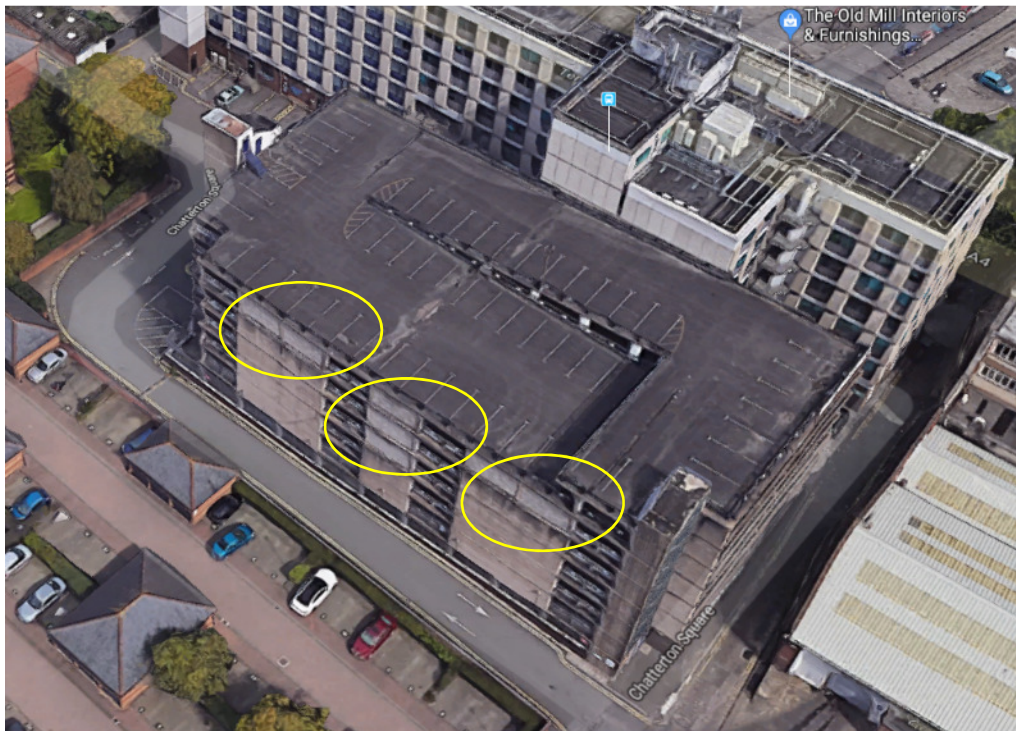
Figure 5-2 Infill walls
Southwest Elevation Infill Walls (Missing Outer Leafs Ringed)

To several sections of the infill wall at the upper levels, parts of the outer leafs are missing (see Figure 5-2) and the inner leafs are clearly damp stained. We suspect that corrosion of the cavity ties (where present) may be taking place, which if correct, would likely continue to the remainder of the elevations and hence a risk that requires further investigation.

There is also concern that falling masonry might occur at any time. In light of this, we recommend urgent inspection, using a scaffolding tower, to properly examine the walls for defect and stability. It will also aid the preparation of the specification for remedial works required.

If the walls are found to require replacement, this could present an opportunity to re-clad the elevation with a maintenance-free cladding system such as those shown in Figure 5-3. These would of course incorporate suitable framework to provide the shear resistance required, but with an improved and relatively maintenance-free external appearance.

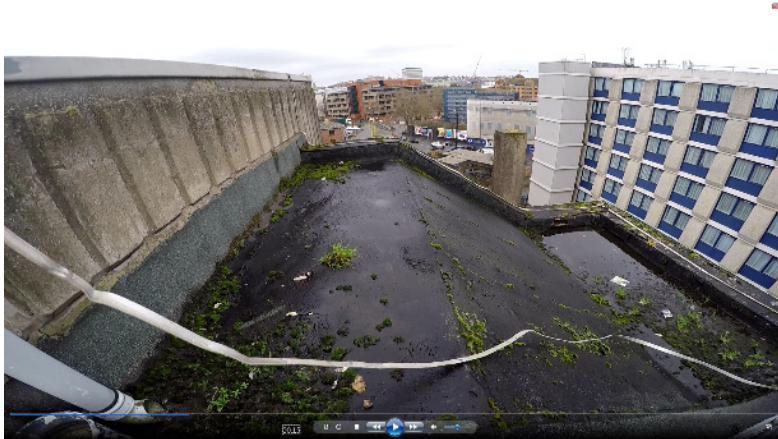
Figure 5-4 Main stairwell roof

The roof is partly obscured with silt, had standing water over 80% of the area, and the upstands were heavily coated with algae.

Deterioration of roofing material, standing water and detachment of lightning strip from file GOPR0427

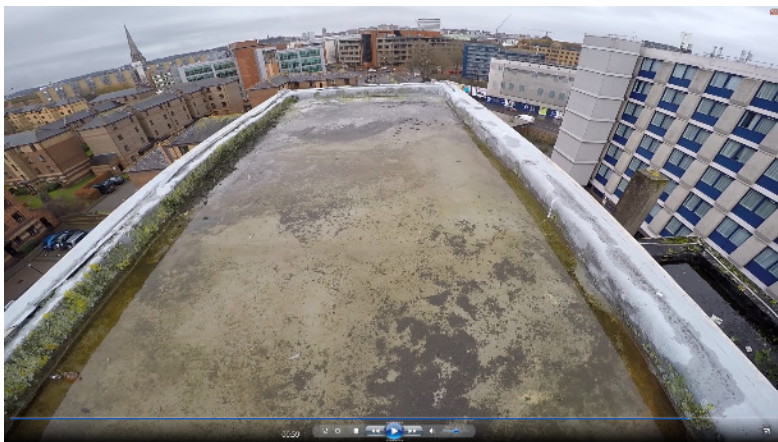
Figure 5-5 Lift motor room roof

Roofing material in good condition, standing water and lightning strip from file GOPR0428

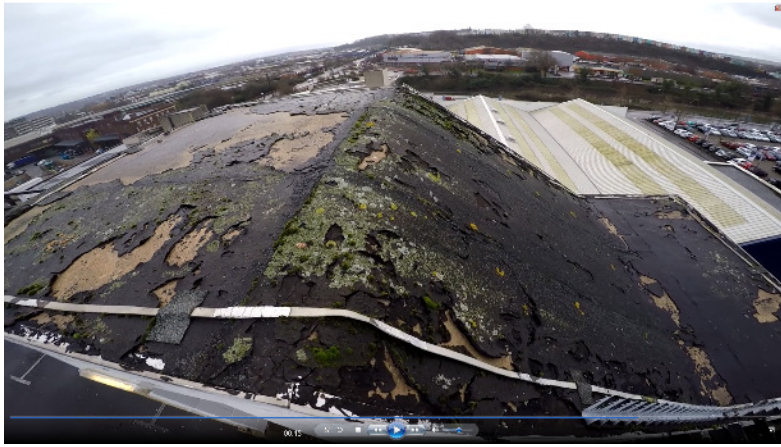
Figure 5-6 Southwest corner stairwell roof

The stairwell at the south corner of the car park comprises an upper and lower flat roof sections with an intermediate inclined roof section (Figure 5-6). There are no perimeter upstands. There is a lighting tape attached to the perimeter, and a galvanised steel anti-climb strip at the top of the lowest section of wall facing the car park.

The roof was formed of concrete which was coated with what appears to be a thin (<5mm thick) bituminous system, possibly some form of bituminous felt. This surfacing has degraded heavily, has disintegrated or been removed, or is otherwise extensively damaged on the horizontal roof sections, and to a lesser degree the inclined surface. The whole roof needs to be re-surfaced, which requires removal and re-attaching the lighting protection tape and anti-climb strip.

Roofing material in degraded condition, and lightning strip from file GOPR0429

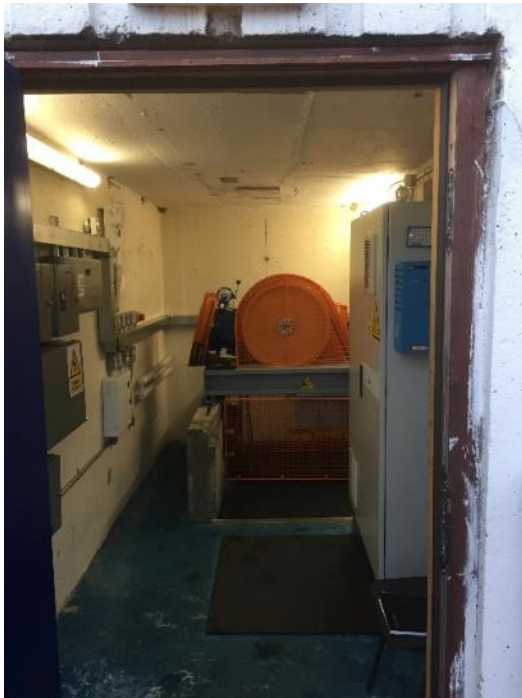
Figure 5-7 Lift motor room
Room in good condition with no obvious sources of water ingress

The lift motor room is accessible via a locked door from the top deck of the car park (Image 5-7). The room is weather tight and appeared in good condition, with no evidence of water ingress through the roof or walls. The floor covering appeared to be cracked but not delaminating.
