REPORT

West End MSCP Life Care Plan

Bristol City Council

May 2018

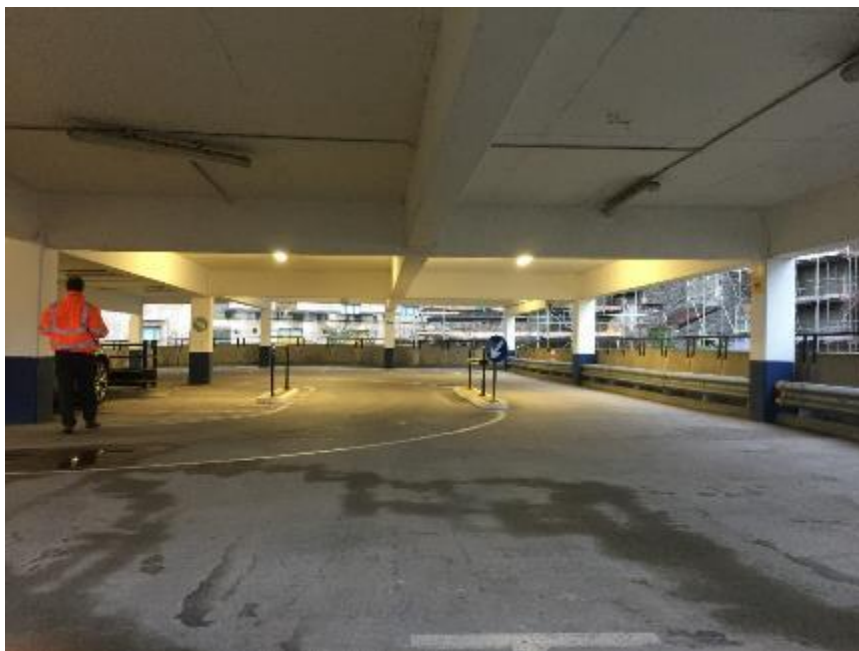
Figure 5-1. Structural arrangement

The columns and beams are painted white (see Figure 5-1). The coating is typically in good condition. There are a small number of defect in the beams and columns that relate to, or appear to relate to corrosion of embedded reinforcement. However, there is no evidence of distortion or significant structural damage, with the exception of one location affected by spalling at the southern stairwell (Figure 5-2). The damage here is historic and has been treated by installation of a square section steel prop. In 2017/18 the exposed reinforcement was covered over by a repair mortar.

Typical slab, column, beam, and soffit arrangement (at northeast end of car park)

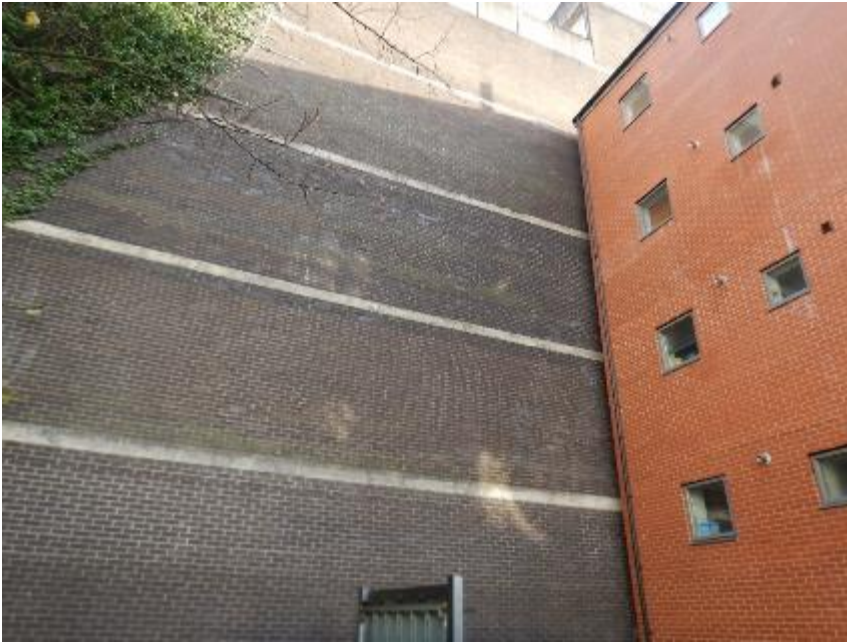
Figure 5-3. Southwest elevation

The southwest elevation can be inspected from the car parking areas to the residential properties behind Burton Court (see Figure 5-3). The brickwork was placed directly on top of the perimeter of the reinforced concrete deck slabs and the external face is nominally flush with the deck. There is minor irregularity to some courses, apparently most commonly at the bottom and top of the lifts. For the main part, the external brickwork appears in acceptable condition. There is some vegetation (ivy) growth at the west corner of the face, which may in the long term contribute to deterioration.

External brickwork off reinforced concrete decks in acceptable condition

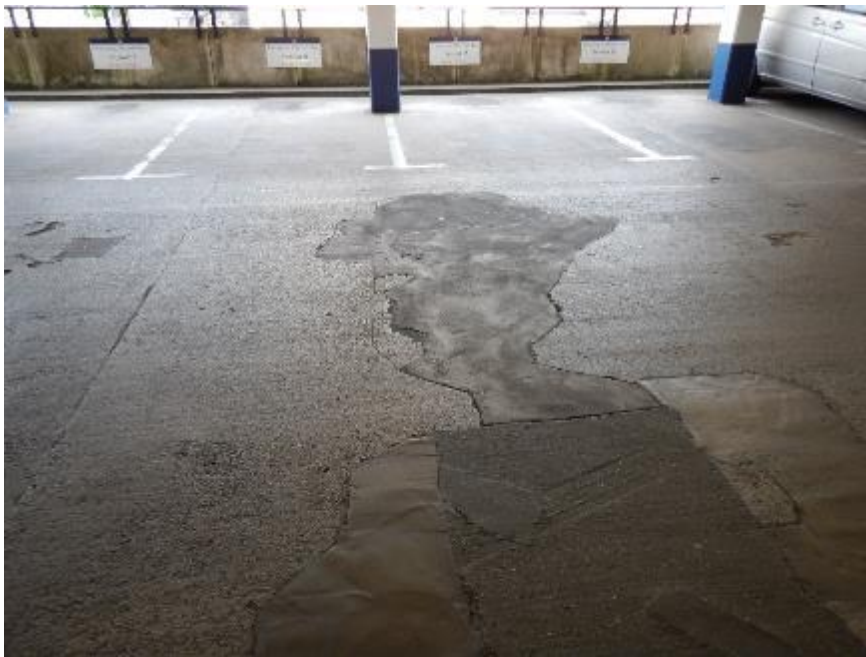
Figure 5-5. Spalling to lower level deck

The condition of the concrete is generally poor particularly on the lower levels. There is extensive spalling in the top surface, resulting in open spalls, unravelling of the surface, and some 'hollow' sounding incipient spalls, with the worst areas being on 1A, 2B and 2A. Some areas of deck contain multiple defects in the same vicinity and it is anticipated that it would be difficult to repair each in isolation (see Figure 5-5). The defects appear to relate to corrosion of embedded reinforcement; this is supported by the high chloride levels found in the decks.

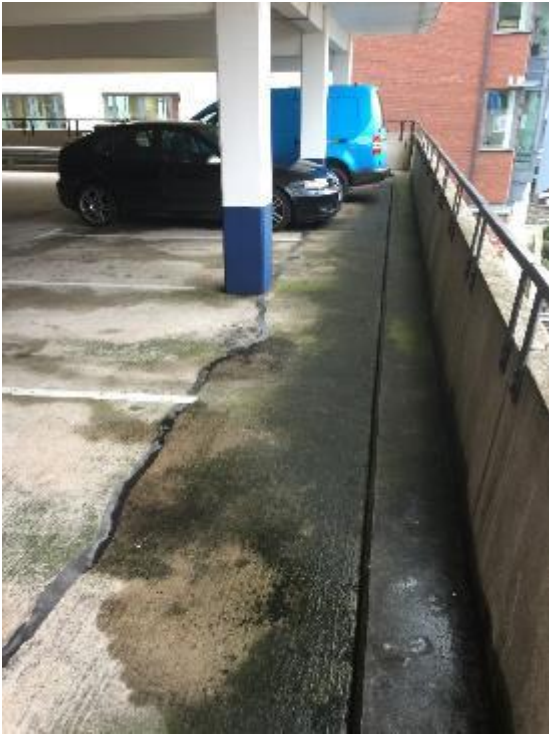
There are also cracks prevalent in the deck slab. These tend to radiate from columns, and are noted in the soffits as well as the top surfaces of the slabs. Commonly there are continuous cracks between columns along the sides of the car park decks, at the outermost (cantilevered) section (see Figure 5-6).

Figure 5-6. Southeast side of the car park looking toward the east corner of the car park
Note continuous crack in deck spanning between columns, sealed with bituminous material

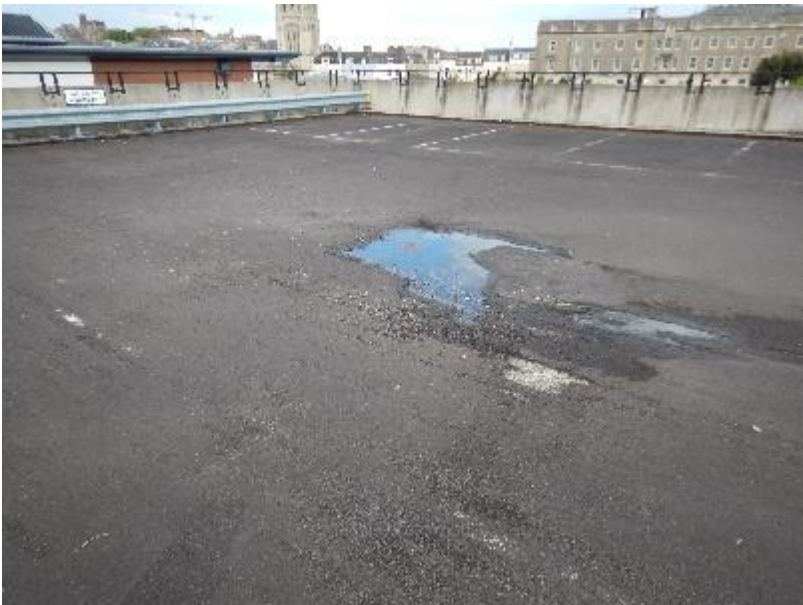
The roof decks (Levels 6A and 7B) are coated with a bituminous material which appears worn but remains largely intact. This was previously reported by Blue Sky (2012) to appear generally water-resistant with only a few locations of water ingress, but approaching the end of its life. The roof-level waterproofing appears little different some five years on, and is apparently largely still functional (see Figure 5.7).

Figure 5-7. Northeast corner of the car park, Level 7B
Worn area of bituminous surfacing material

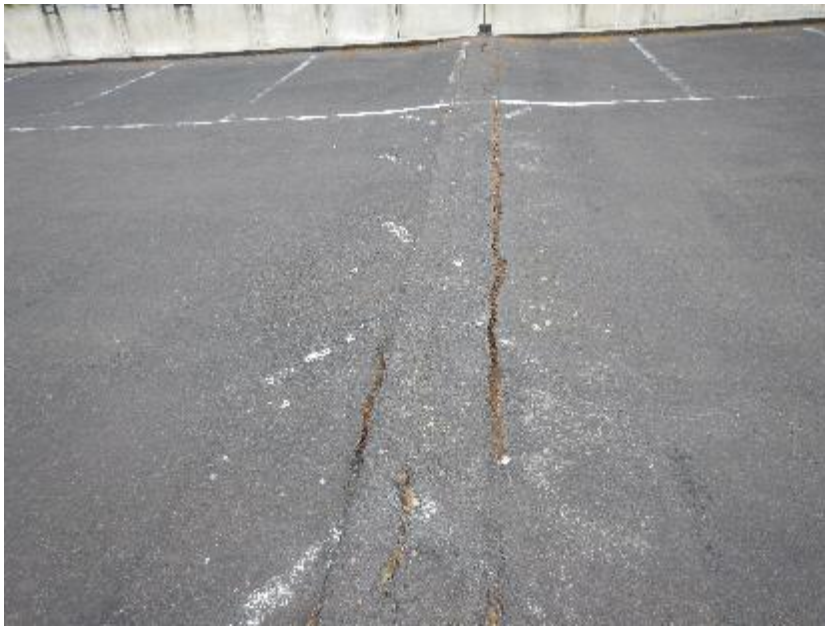
Figure 5-8. Roof-level (7B) expansion joint

At roof level the joint has a raised profile and is covered with the bituminous surfacing (see Figure 5-8). However, there are crack-like partings parallel to the joint through which rainwater can penetrate, and the joint is not fully water-resistant.

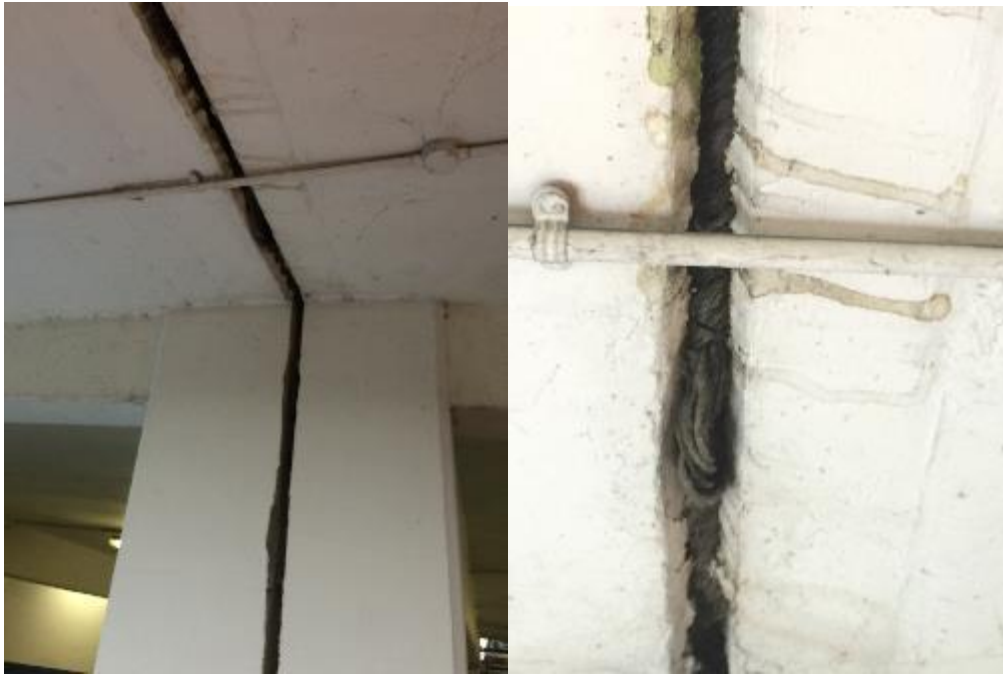
At the intermediate deck levels the joints are approximately 20mm wide and mastic-filled. There is clear evidence of water ingress through the joints, and it is suspected that the sealant has failed in numerous locations. Figure 5-9a shows evidence of seepage at the soffit, and Figure 5-9b shows that there is a rope-like material sagging from the joint. This is likely to have been part of the original joint filling media, and it is recommended this is inspected by a specialist company to assess its composition.

Figure 5-9a (left) and 9b (right). Expansion joint at columns and soffit, intermediate level
Note mastic-like sealant between the columns and rope-like infill to the soffit joint.

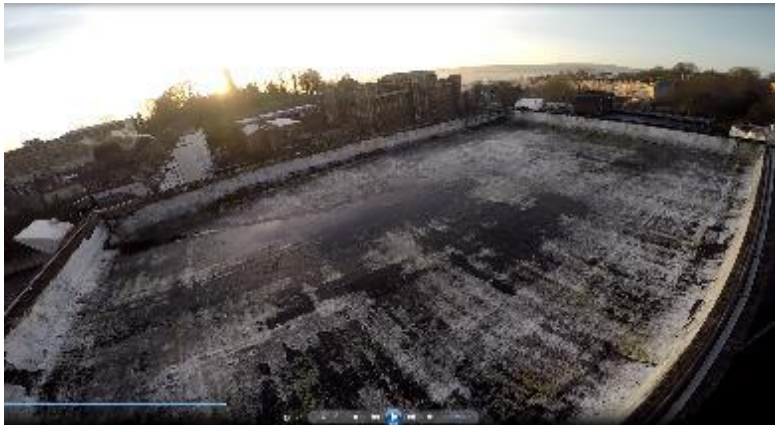
Figure 5-11 Lift motor room roof

Externally the roof comprises a covered concrete flat roof with perimeter upstands in concrete, with an attached lightning strip (see Figure 5-11). The roof appears to be covered with overlapping rolls of a sheet membrane, with additional lapping at the upstands, with a partly degraded white or silver painted coating.

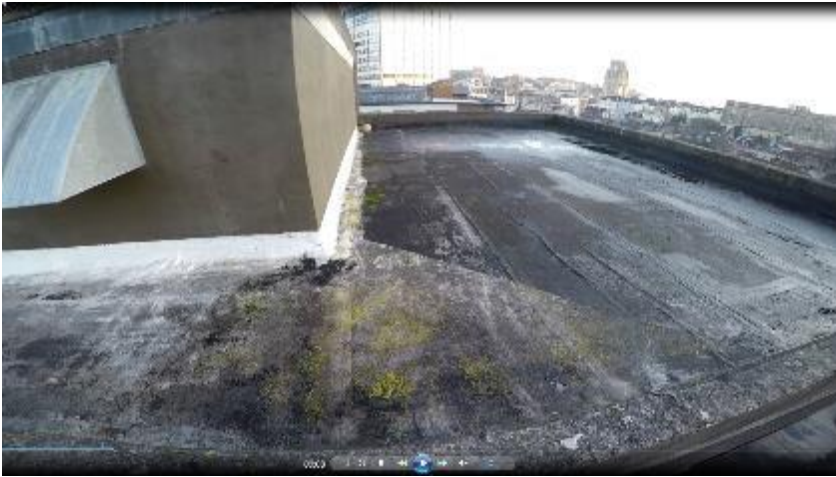
Figure 5-12 Main stairwell roof

There is an outlet at the southeast corner of the lower flat roof section, providing drainage to a hopper and downpipe.

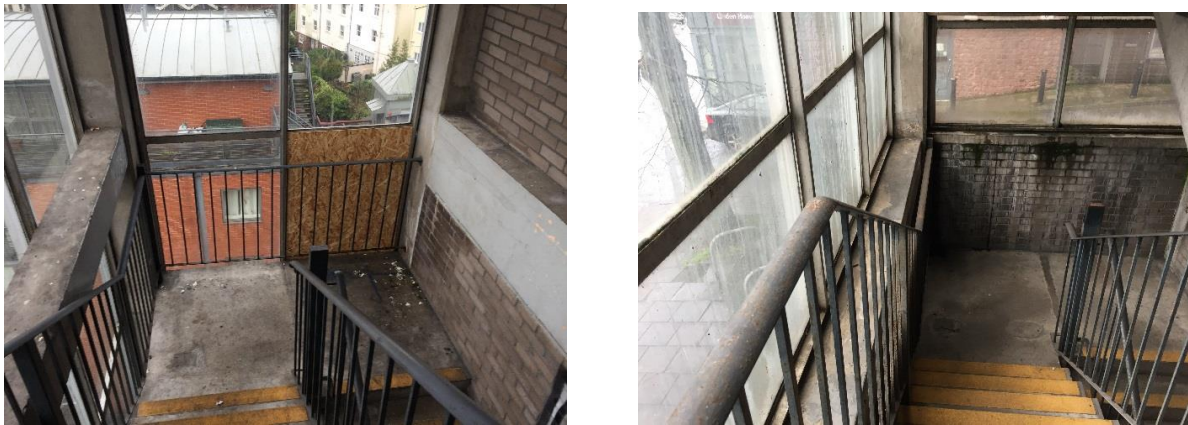
Figure 5-14 Internal views of stairwell

The handrailing is discontinuous on the 'outer' perimeter of the stairwell at the internal brickwork wall. Absent sections could to be readily added.

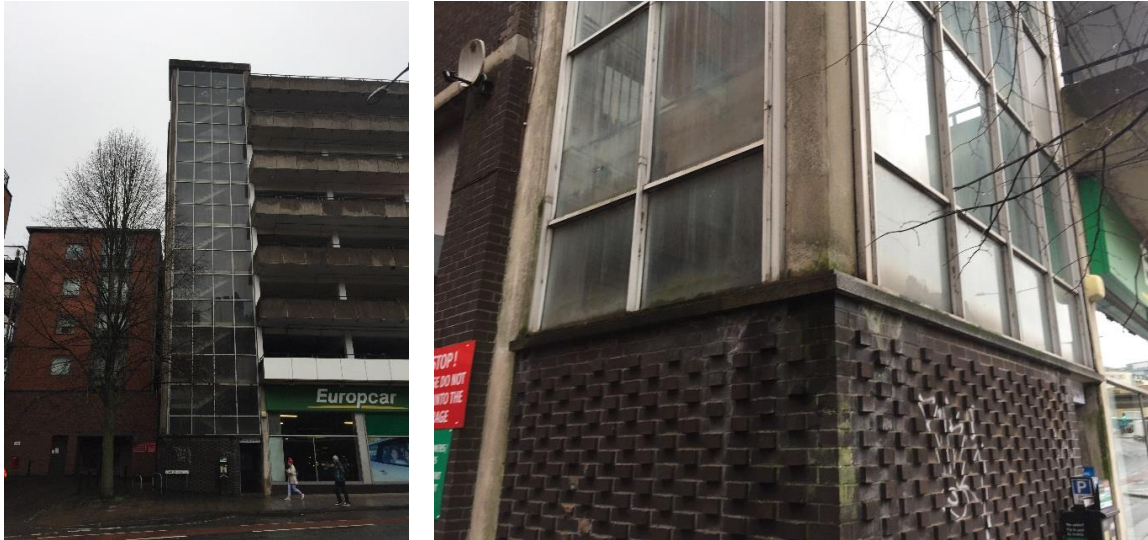
Figure 5-15 External views of stairwell

Overall, the glazing system is tired and damaged in part, with local areas of water ingress evident. One panel is missing and replaced with plywood. We noted that the glazing and bead sealing compound is generally beginning to extrude and crack and in time further water ingress will occur. The surface coating of the exterior is generally heavily soiled and faded. The expected serviceable life therefore, before major refurbishment is required, is less than five years.

In light of the above, the glazing system is in need of substantial refurbishment and repair within the next 12 – 24 months we suggest. Given the extent of the work required in terms of labour and storage, plus the general poor cosmetic appearance of the system installed, consideration should be given to replacing all of the façade glazing systems. New systems are likely to have a payback period of five to 10 years, given the life of the existing system and the need to continually maintain.

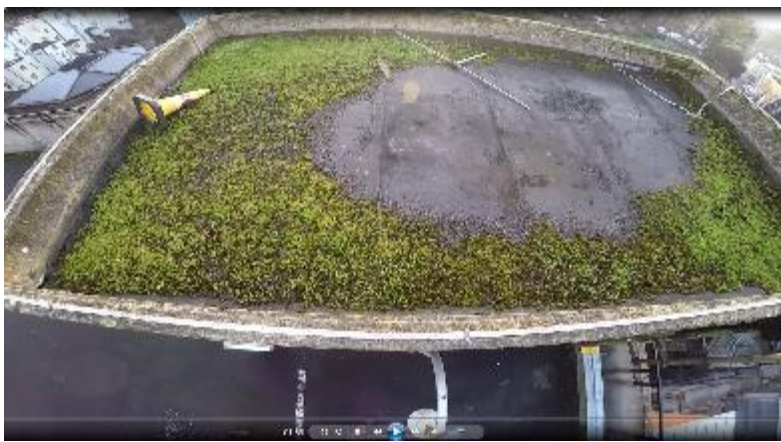
Figure 5-16 South corner stairwell roof

Drainage from the flat roof is provided via a lead-lined penetration through the upstand southwest corner, draining into a hopper then downpipe. Despite the vegetation apparently impeding the drainage, at the time of the survey drainage appeared to be effective, and there was no water leakage through the roof into the stairwell.

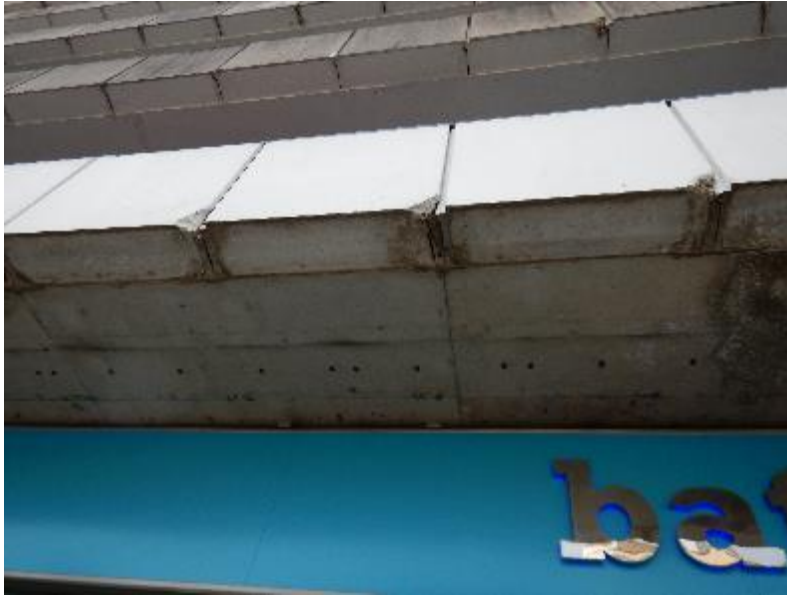
Figure 5-17 Southeast (front) elevation from pavement level

units. These processes might reduce the capacity of the parapet over time. As such it may not be prudent to rely on the parapet to provide vehicle restraint function in the long term.
