## **Appendix A1 – report from Senior Project Manager, Colston Hall**

### **Introduction**

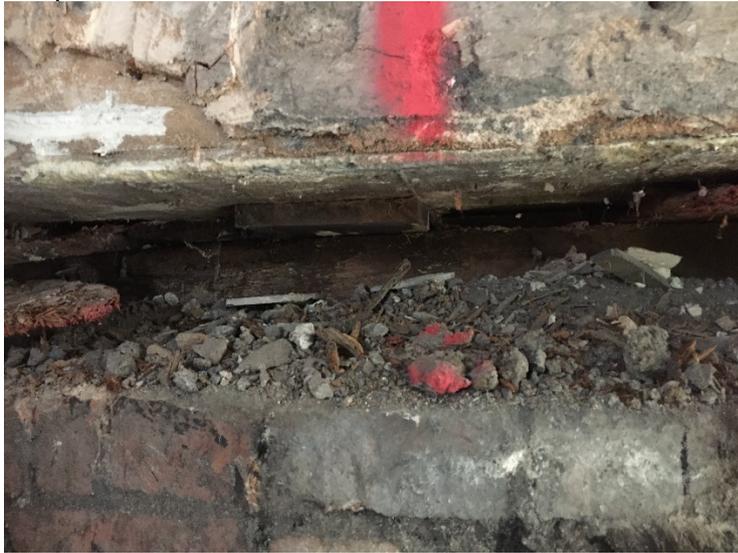
Sub-station

The sub-station enclosure could not be built immediately as during soft strip it was found that the existing wall which was due to provide support to the enclosure, was in poor condition and resting upon rotten timbers. Remedial works had to therefore be specified and this wall demolished and rebuilt before the sub-station works could proceed. This knocked on the demolition of Az wall and further works in the get in yard.

Suspected asbestos and area of structural concern.

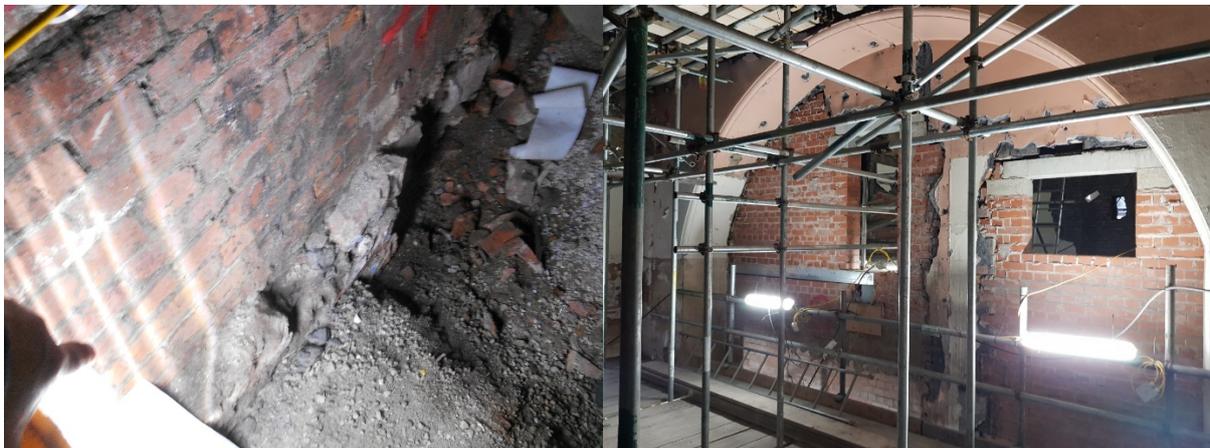
Poor condition and instability of wall- voids discovered

Remove plaster from face of wall to check condition of brickwork. Limited exposure to date suggests variety of types of brick forming this wall. Bonding between these units needs to be reviewed as we are increasing vertical loads.

Padstone size will need to be increased in length to offset discovery that wall thickness is reduced on site (300mm assumed from survey)

Investigation required to check whether this side of wall is also bearing onto timber floor boards. If this is found to be the case, clear out timber and debris, rebuild at low level in brick and pack with non shrink grout.

Investigation required to check that infill wall is packed tight to top of arch (remove plaster, local brick unit removal)

Void should be cleared of all debris. Concrete infill not preferred option as concrete may shrink. Wall requires a solid bearing. Suggest rebuild at low level in brick and pack with non-shrink grout.

Helibars may be required across interface between infill wall and arch - TBC once plaster has been removed and interface exposed.

Infill existing opening with 20N clay brick, with M2 mortar. Toothed in both sides. Refer to Arup masonry spec for more information.

Carry out Hilti tests on existing wall. Check both pull-out and shear to 5kN ULS. Refer to Arup general notes drawing for further information.

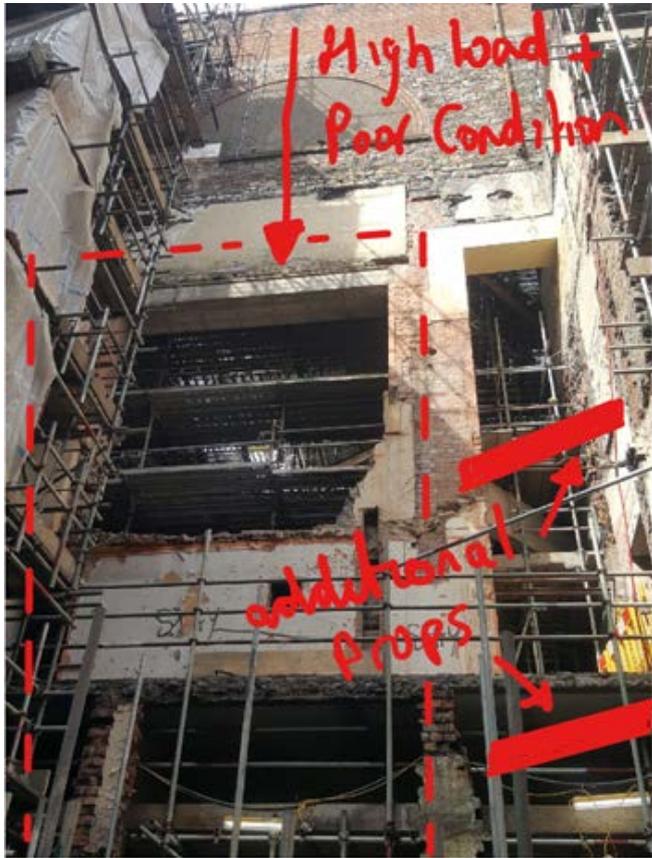
Get in Yard side

This area has been more complex than originally envisaged as, on further investigation, the walls connected to the roof space. Subsequently, the works could not be undertaken during the enabling works phase as the roof space was still contaminated with asbestos. Overall, this impacted the demolition works to the back of stage area and the wing walls had to be removed by hand due to the constraints with the scaffolding installed as part of the main works. A conveyer was also required to remove this material through the main hall and to avoid the mobile crane outside. Arup have produced a design which has led to additional works required, which was updated and re-issued 26.06. Additional cost incurred on additional propping for this area.

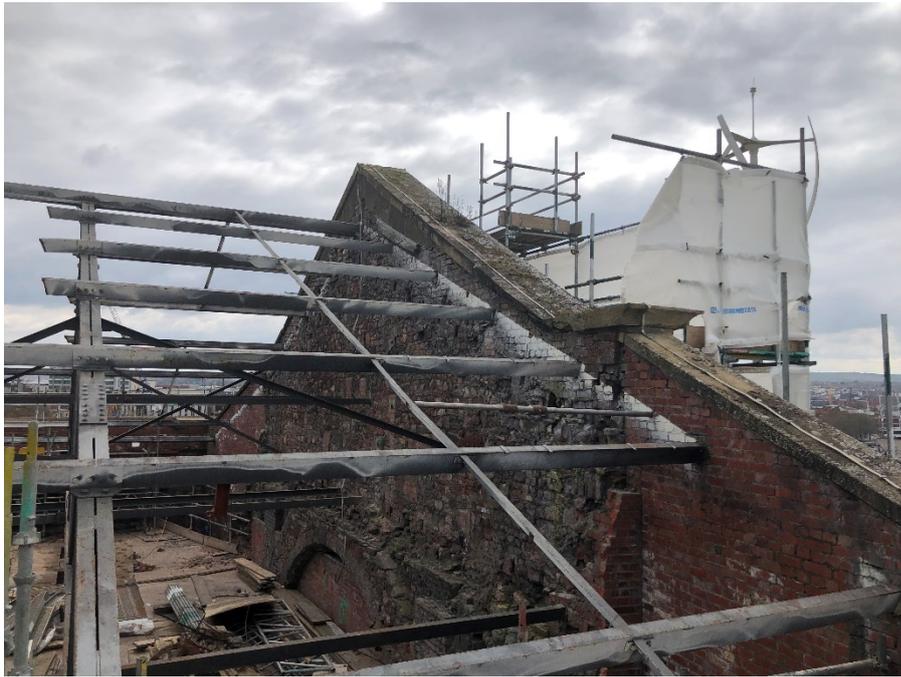
Hall 1 Gable end

Extremely poor condition of the gable end has led to complexities in achieving a temporary works design to stabilise the structure after removal of the roof. The instability of the piers at the back of hall 1, which were due to support the temporary works frame, were found to be in poor condition and masonry was crumbling. A decision was therefore taken to redesign this system rather than wait until the remedial works could be undertaken for the piers.

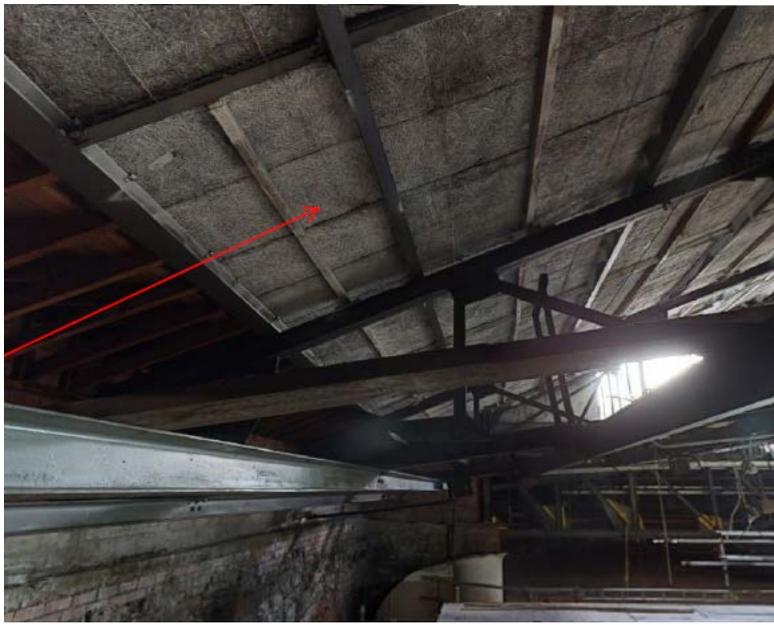
On removal of the main hall roof sheets and once works moved to the roof space it was discovered that additional wood wool panels were attached to the underside of the roof covering, which was not known of or recognised within the works information (this space could not be accessed). This slowed down removal of roof sheets which were due to simply be removed by crane, however a scaffold had to be erected to remove the wool panels from underneath as they contained traces of asbestos.

Wood wool panels to underside of hall 1 roof

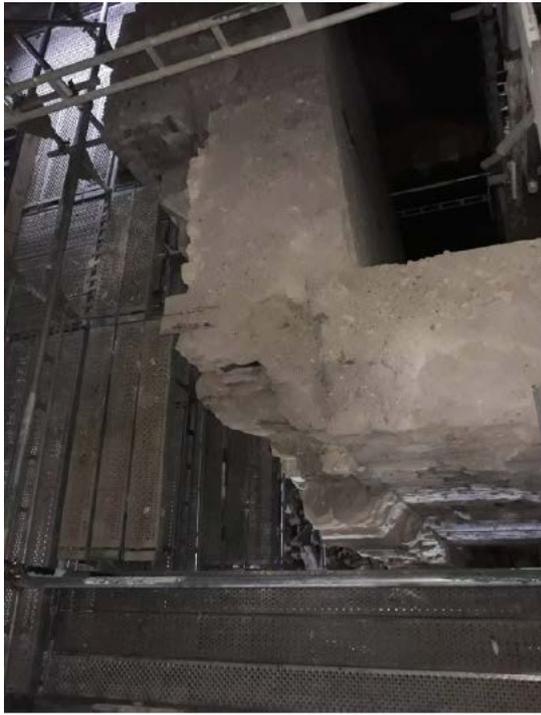
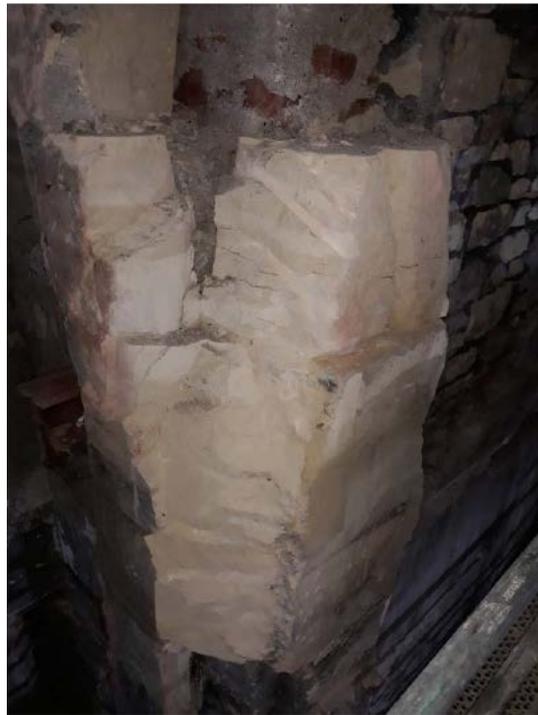
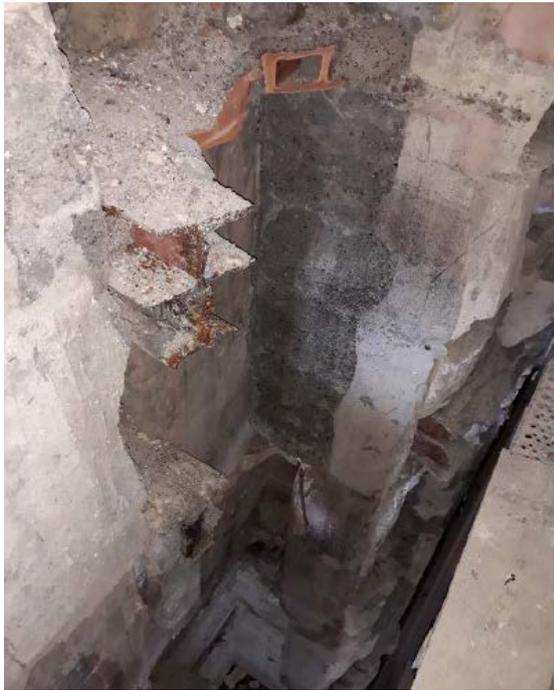
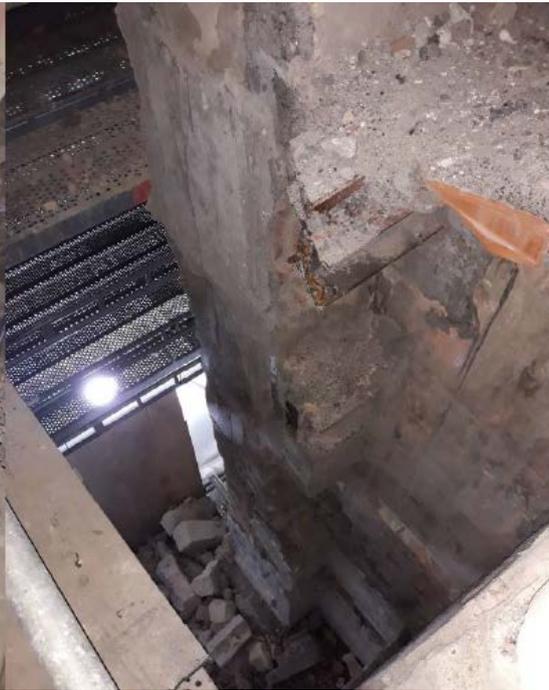
Condition of walls- hall 1

Following soft strip of hall 1, concerns have been raised regarding the condition of the walls in hall 1. Additional remedial works have been required to both the walls and padstones to facilitate the installation of the new steels and address loose and dangerous stonework. This has been a significant exercise scoped and undertaken by Structural Technicians who have been bought in to provide additional project support. Solutions include concrete jackets and general buildersworks.

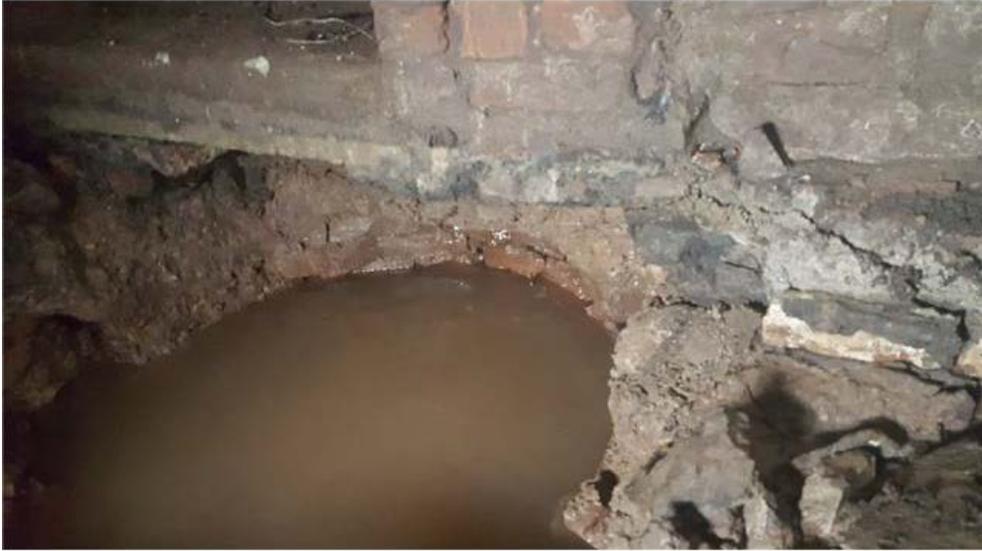
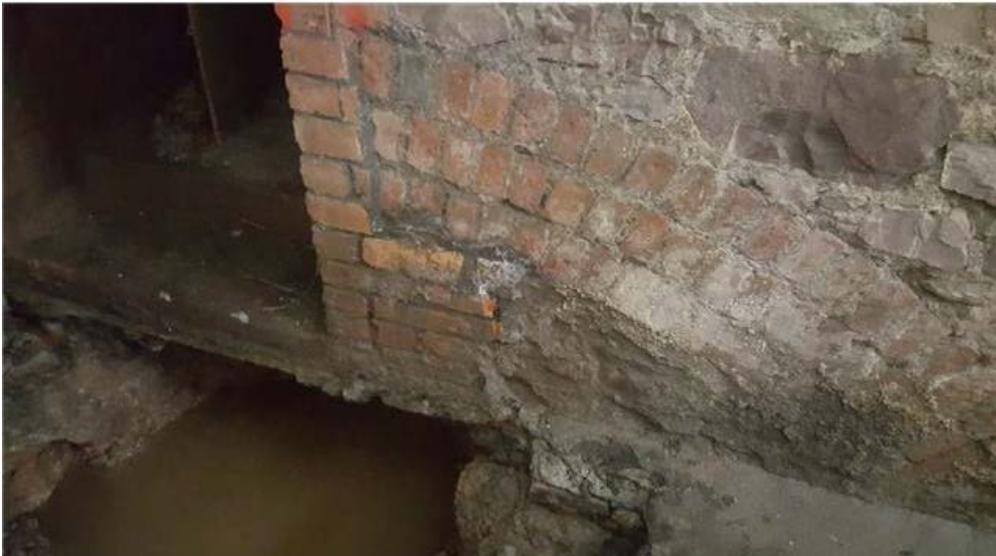
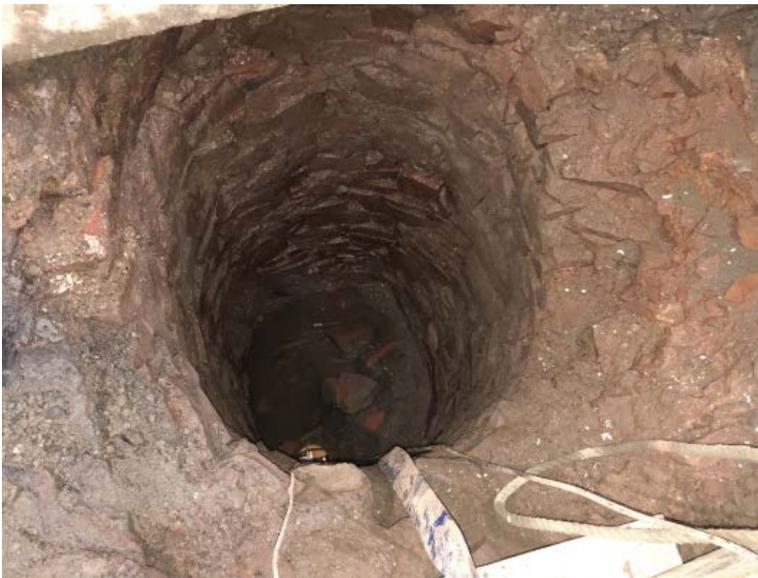
Well 1

A well was discovered in the lower basement of Colston Hall and a solution is still being reviewed following the unsuccessful investigations to reach the bottom of the well, which is over 10m in depth. This needs to be resolved to complete the hall 1 steelwork and is currently an area in abeyance.

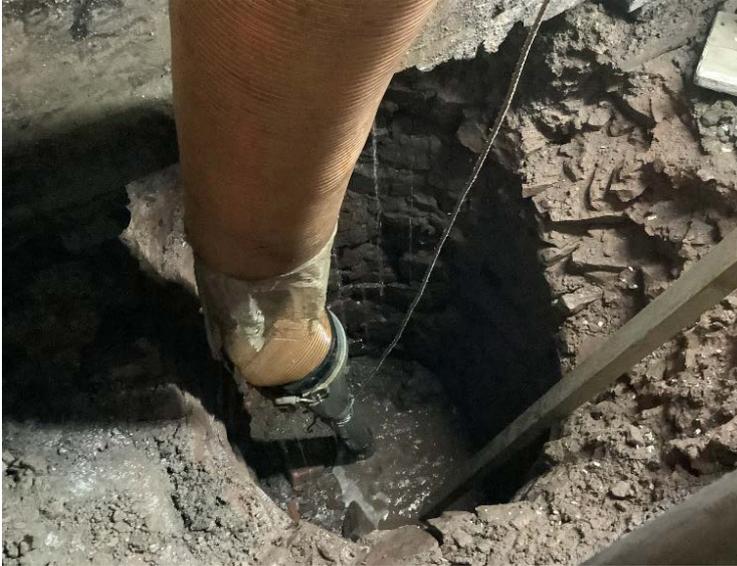
Vaccum excavation of well 1

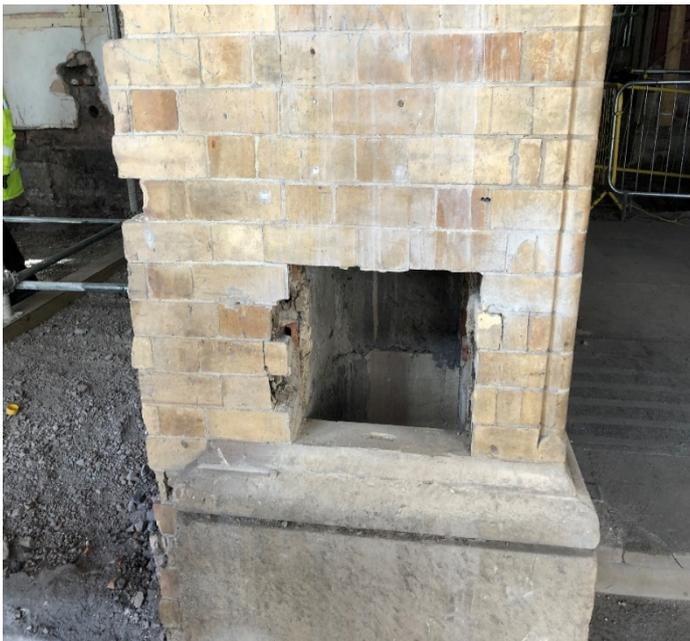
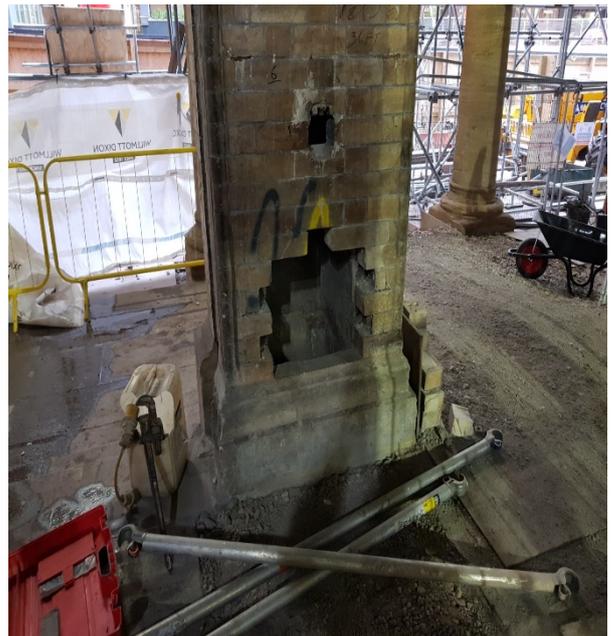
It was discovered that the columns in hall 2 were filled with loose rubble which led to concerns about the structural integrity and ability to support the new steels. Remedial works were specified which involved filling the columns with concrete where possible. Shuttering was also required due to discovery of voids and ducts in the lantern area which also had to be filled. Additional steel columns were added to the scheme where it was too dangerous to unzip the existing columns.

Rubble filled columns

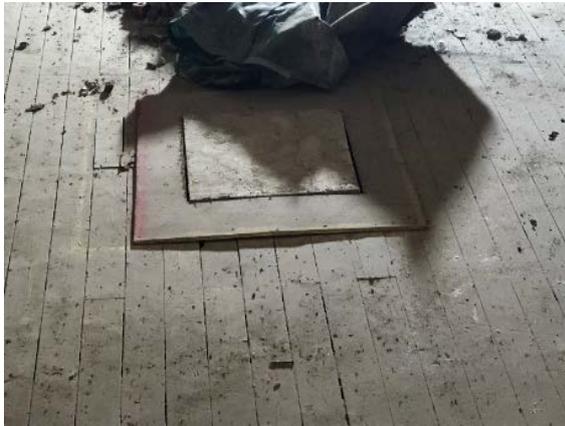
Top of hollow column

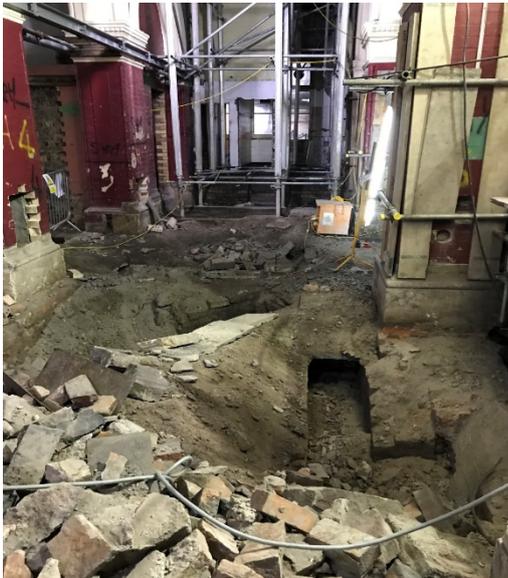
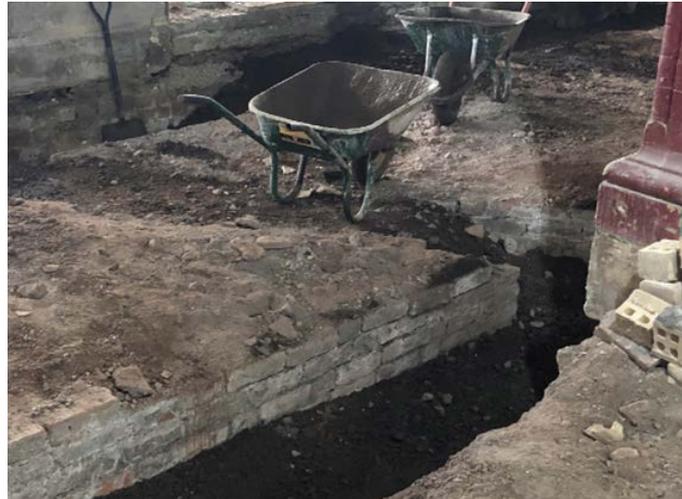
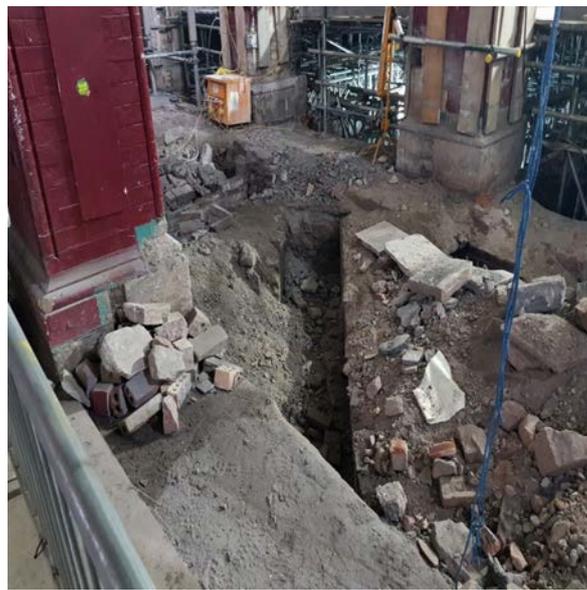
Discovered historic ventilation ducts

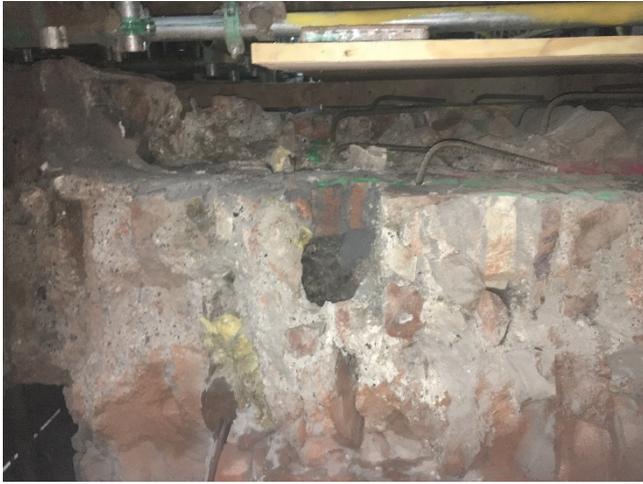
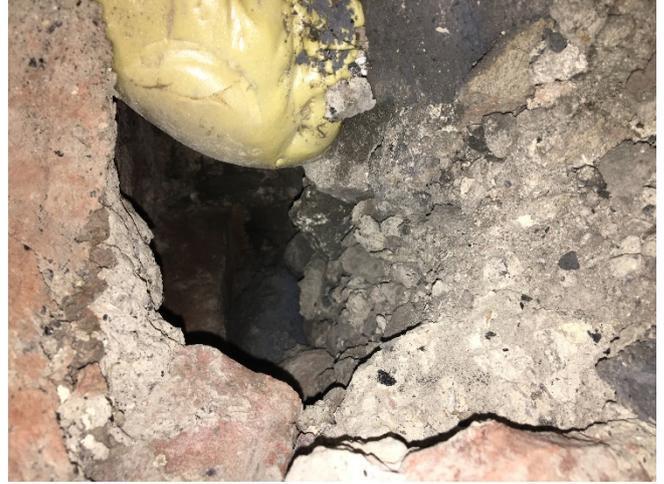
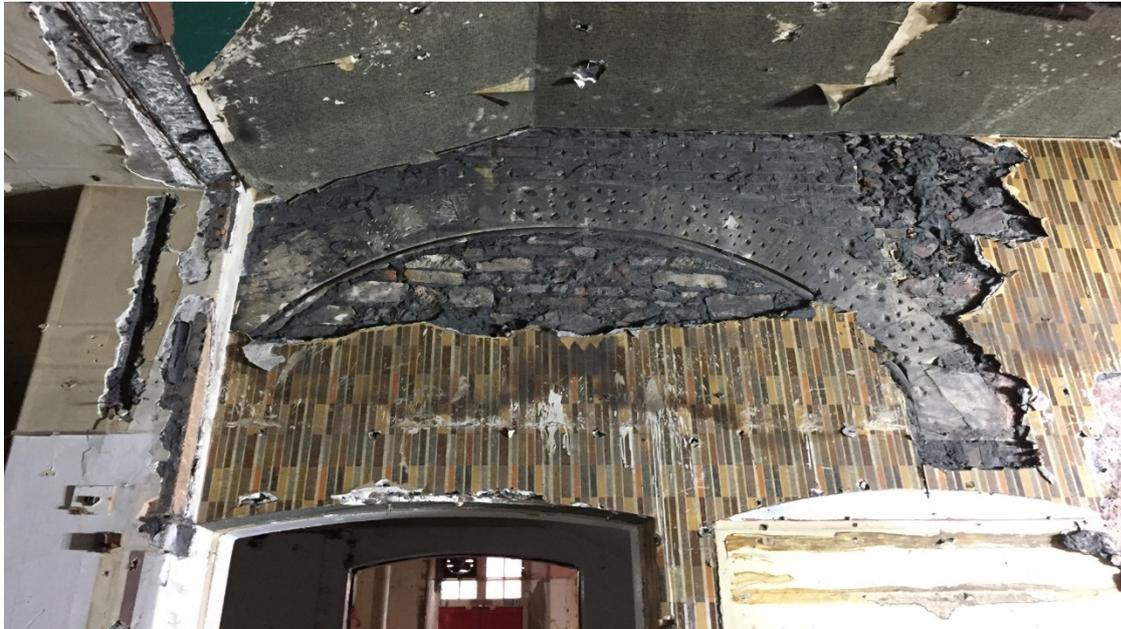
Basement Support Wall

This has been a complicated area to coordinate with arch opening up works due to the condition of the wall. Works have been stopped and started as contractors have undertaken the works and required structural input from other firms. Sequencing has also been further impacted by Covid-19 due to the tight working space.

Poor condition and loose masonry leading to complex sequencing.

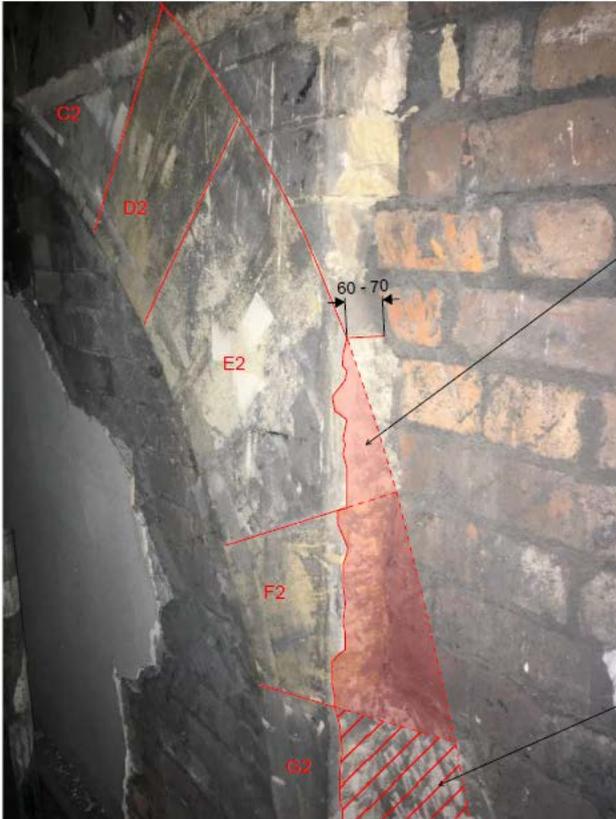
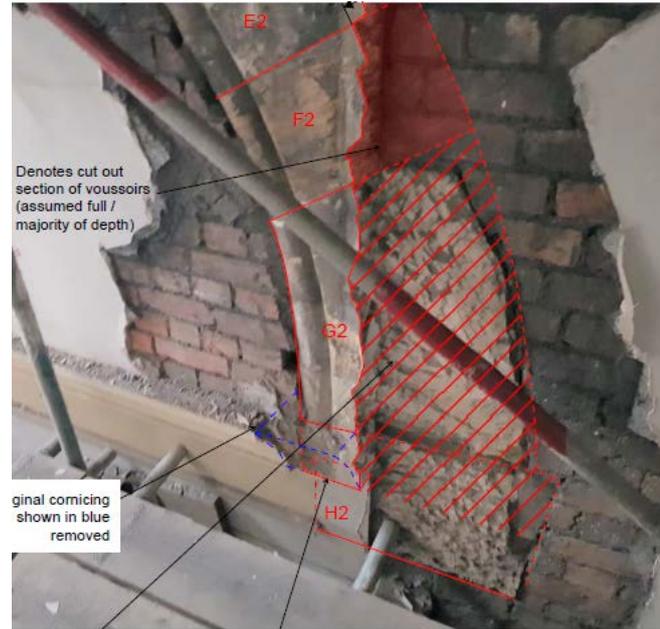
# Hauling Arch

The hauling arch coordination (area between the lantern and hall 1) has been ongoing for several months by the design team to accommodate discovered site conditions and the lift sizes. There is an arch, for example, which is not fully intact and requires complex remedial works to solve. Discussions have been ongoing regarding leaving the fill in the arch to reduce risk, however this is not acceptable to BCC Conservation.

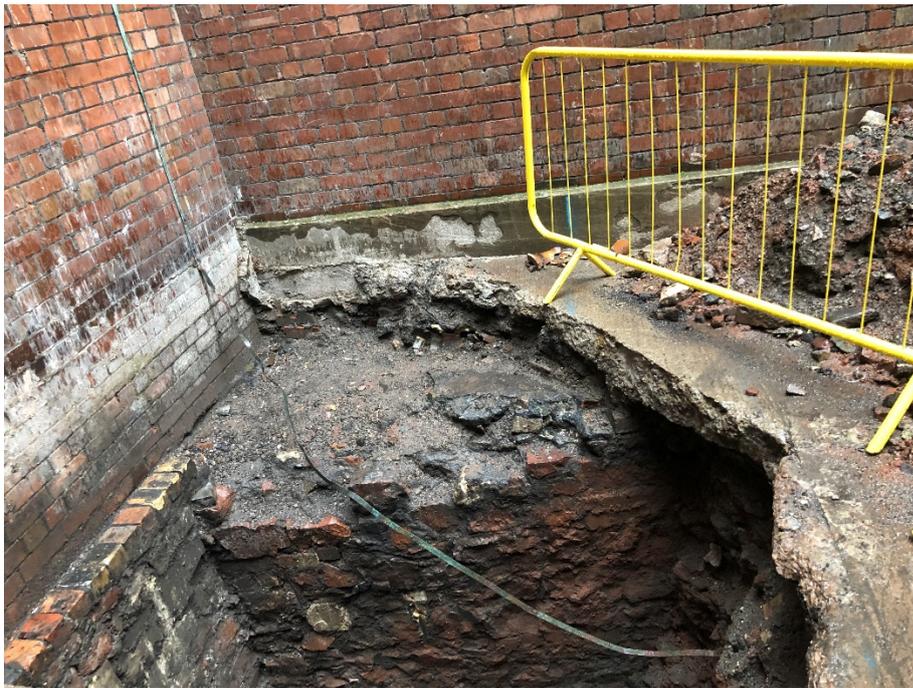
- Get in Yard lift: It was discovered during excavations in July that the get in yard wall was wider than expected and that this would impose on the proposed get in yard lift design. Following further investigations into whether this wall could be removed or integrated, this was ruled out as unfeasible. A redesign and space planning exercise is now being undertaken in this area to skew the lift and coordinate with the plant tower design which is due to conclude in July.

Lift- discovery of wall under No.15 where the lift was due to be located

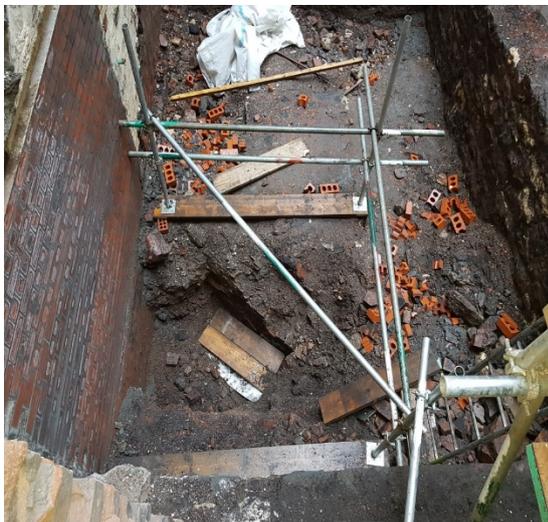
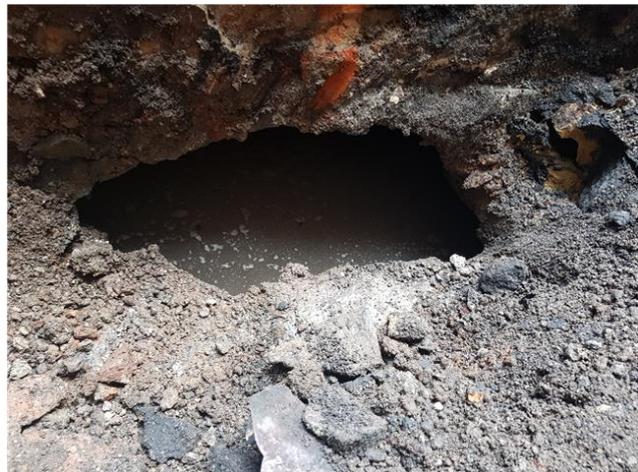
Well 2

- Well 2- A further well was discovered in the get in yard. This is being resolved through the amended substructure design to the plant tower, as this is where it has the most implications.

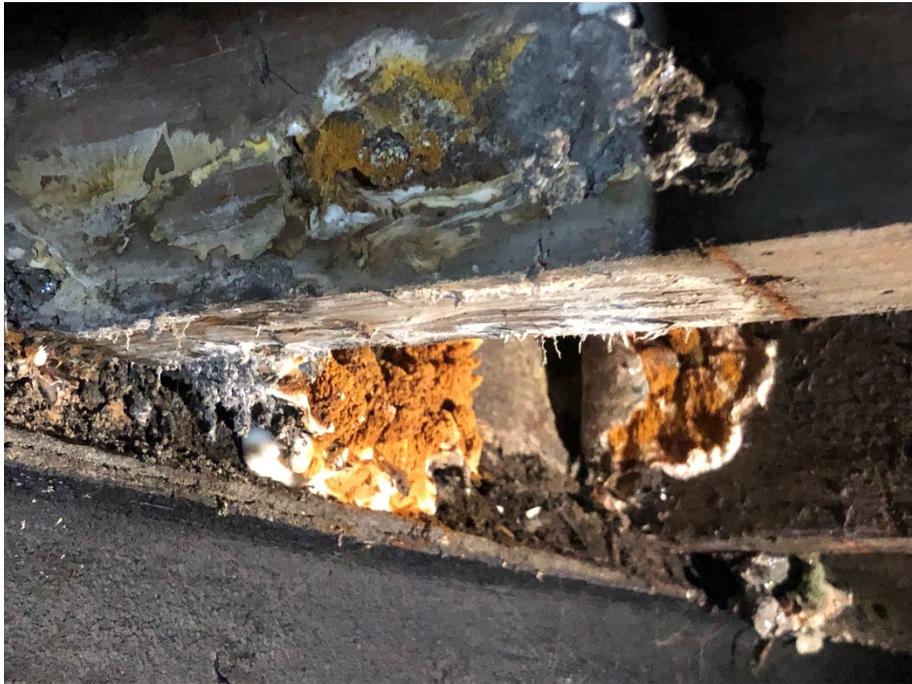
On further investigation of the hall 2 roof space, it has been discovered that the scope of works may be greater than what was previously specified. Closer inspection of the roof timbers has revealed dry and wet rot, with further investigations currently being undertaken to identify the remedial works and requirements which will be presented to BCC for further consideration.

'Fruiting bodies' and dry/wet rot discovered

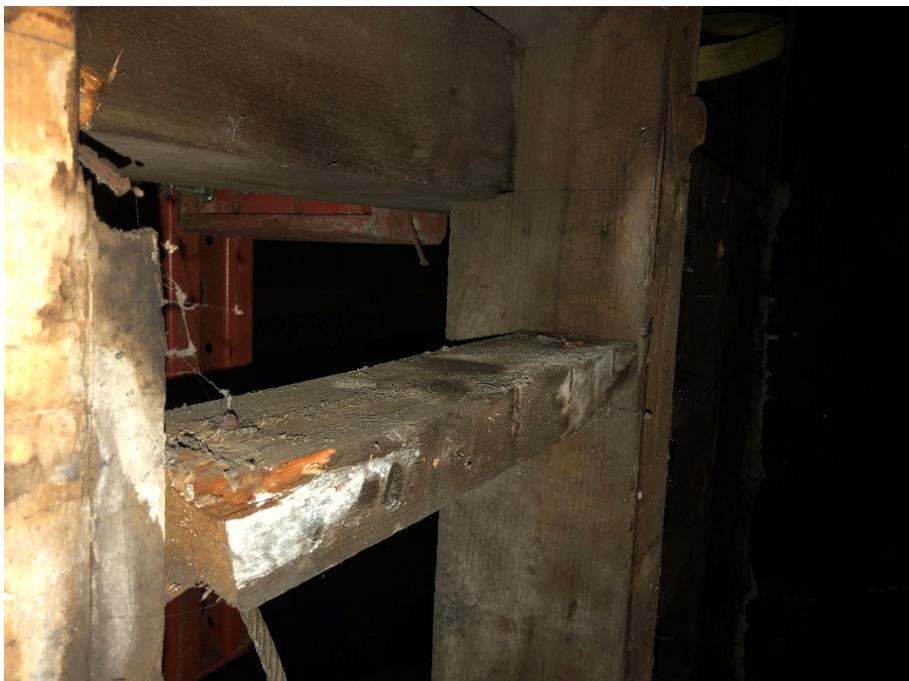
Poor condition timbers

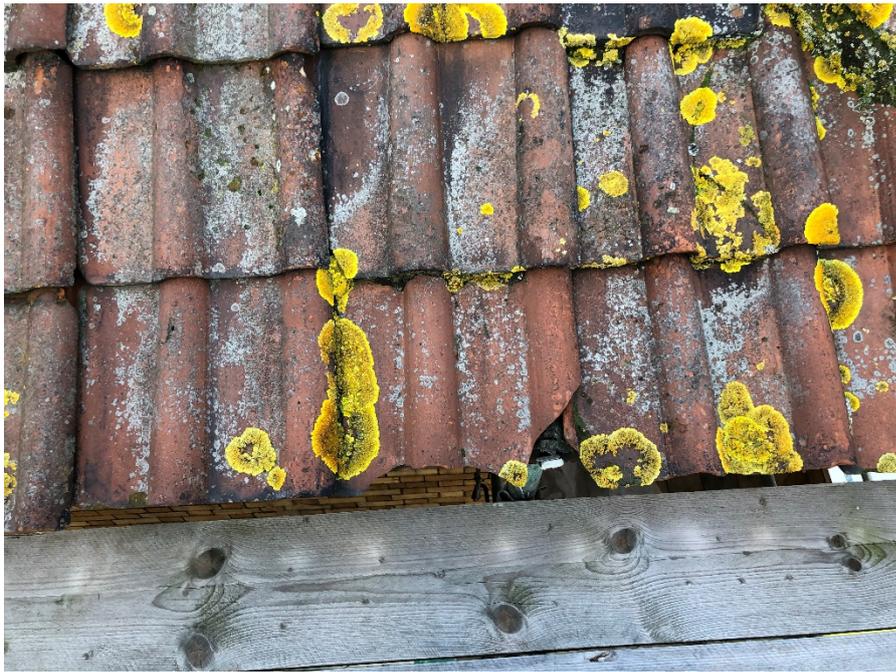
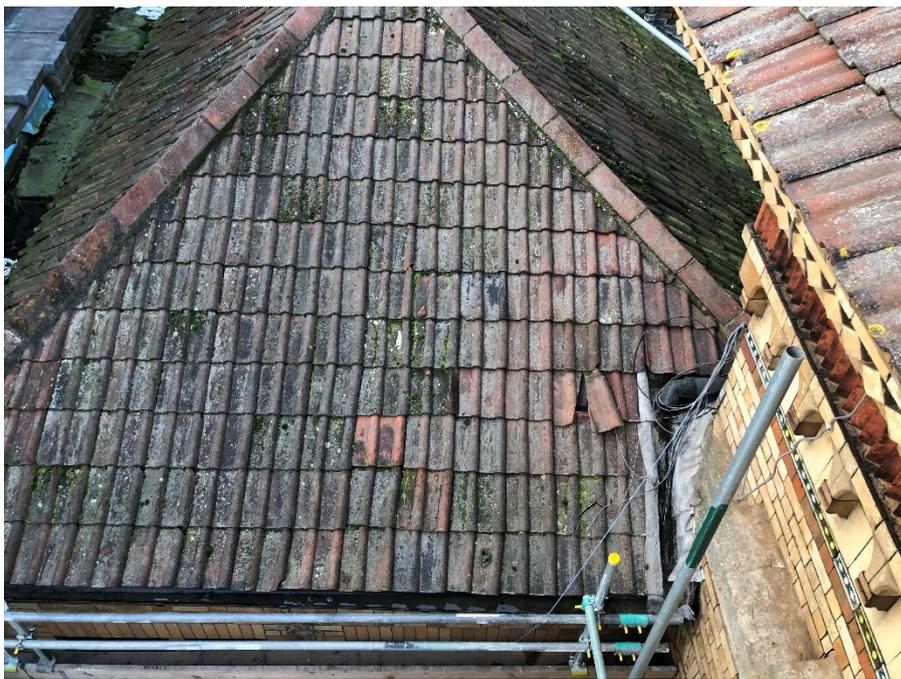
Poor condition of lead flashings and cracked tiles

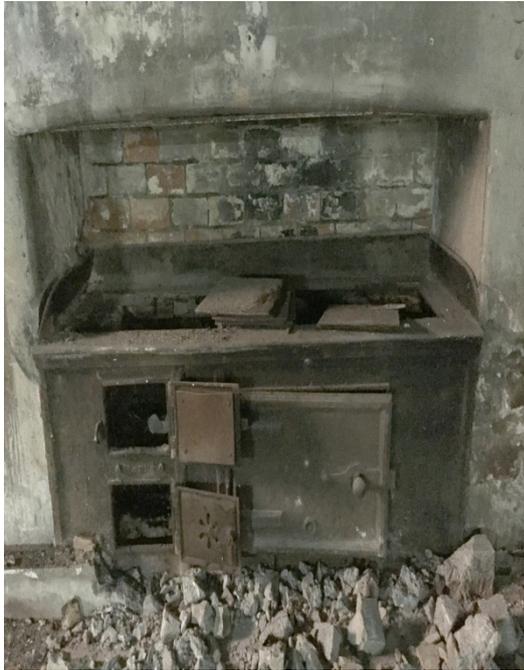
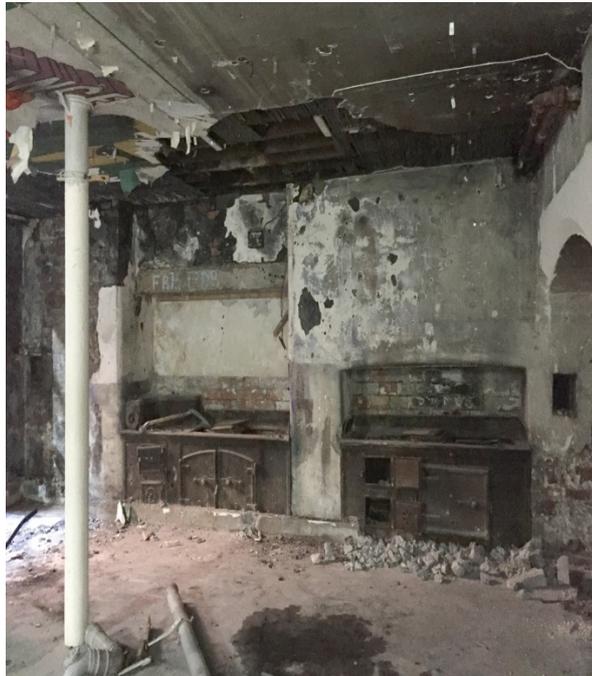
Victorian stoves uncovered during soft strip works.
