## PLANNED PREVENTATIVE MAINTENANCE REPORT

**Claremont Special School, Henleaze Park, Bristol, BS9 4LR**

**File Ref:** 3051095  
**Date:** 21st March 2017

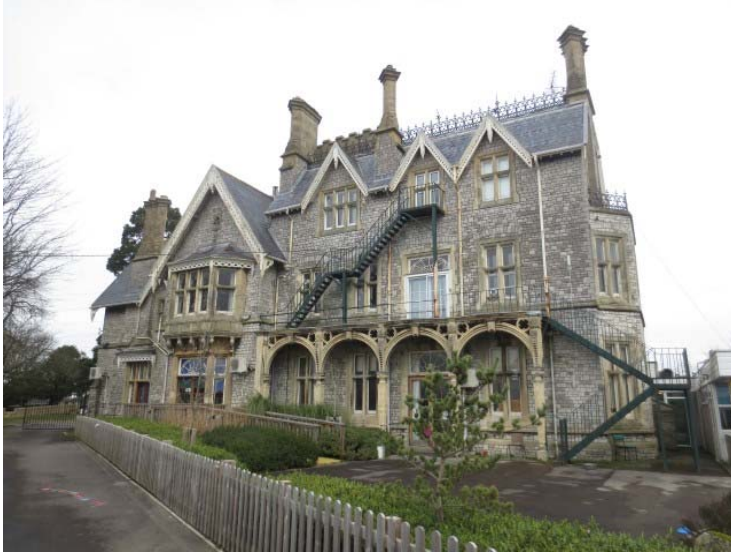
## SUMMARY: Claremont School, Block A

Property is a three storey structure with double pitched slate roof with period features including ashlar stone chimneys and decorative timber bargeboards and fascias.

**CONDITION: Poor**

- Maintenance to roof coverings and gutters
- Repairs and redecoration to external joinery and windows
- Repairs required to chimneys

- Cleaning and repairs to stonework

- Internal redecorations
- Phased floor covering replacement

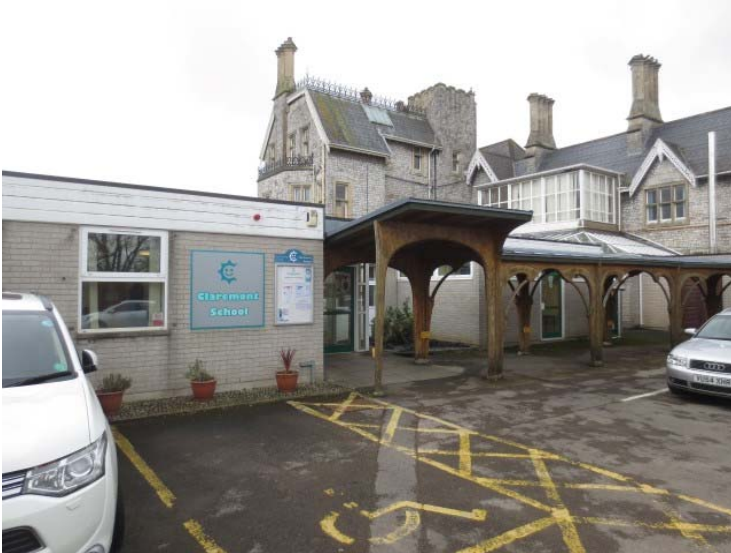
## SUMMARY: Claremont School, Block B

Property is a single storey structure with Mineral felt flat roof and Numerous Georgian wired glazed rooflights. External walls are fair faced brickwork and Powder coated aluminium double glazed opening casement windows. Internal finishes to the majority comprise of a combination of vinyl and carpet floor coverings decorative finishes to walls and suspend ceilings.

- Repairs and cleaning to flat roof covering and drainage outlets

- Allowance for flat roof replacement

- Cleaning to windows and uPVC cladding

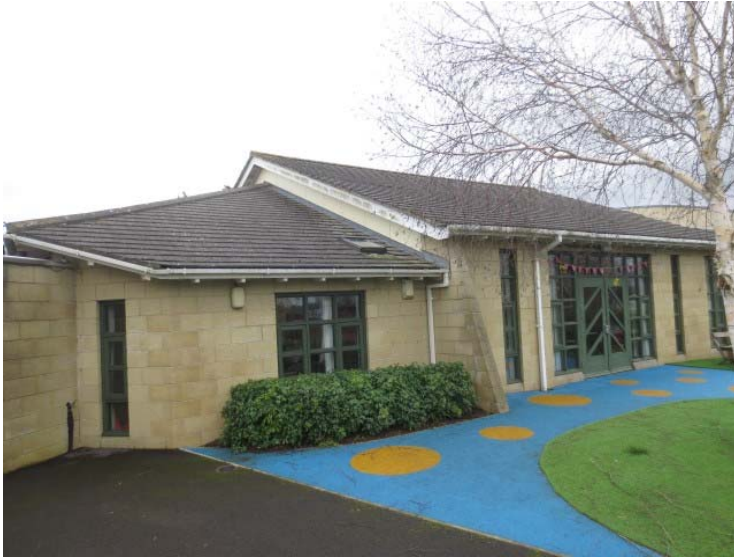
## SUMMARY: Claremont School, Block C, School Hall

Property is a single storey structure with pitched roof and Cement roof tiles. External walls consist of fair faced concrete blockwork and decorated timber opening casement windows & doors. Internal finishes to the majority comprise of a combination of vinyl and carpet floor coverings with decorative finishes to walls and joinery.

- Repairs and redecoration of timber windows and doorset to south elevation

- General cleaning maintenance

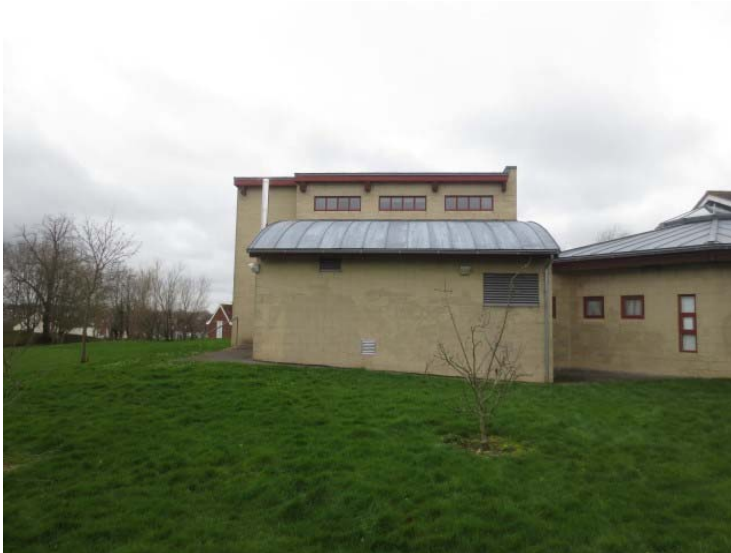
## SUMMARY: Claremont School, Block C, Swimming Pool

Property is a single storey structure with curved roof and standing seam zinc coverings.

**CONDITION: Fair**

- General cleaning maintenance

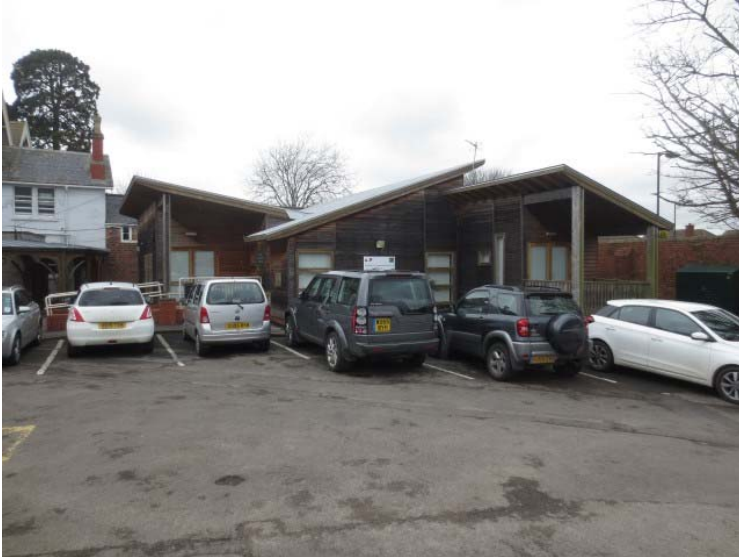
## SUMMARY: Claremont School, Paediatric Community Centre

Property is a single storey structure with double pitched standing seam aluminium roof covering. External walls are timber clad. Windows are timber framed and double glazed. Internal finishes to the majority comprise of a combination of vinyl and carpet floor coverings with decorative finishes to walls and joinery.

- General cleaning maintenance

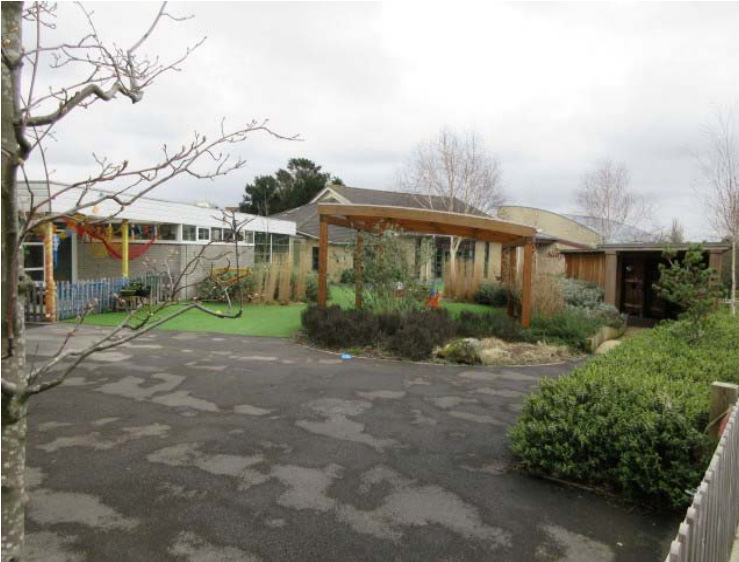
## SUMMARY: Claremont School, External Areas

External areas comprise of bitumen macadam, concrete paving slabs, Astro-turf and soft landscaping. Boundary and intermediate structures comprise of timber fencing, random rubble stone walls set to courses, and timber structures.

**CONDITION: Fair**

- Routine treating and redecoration, as required.

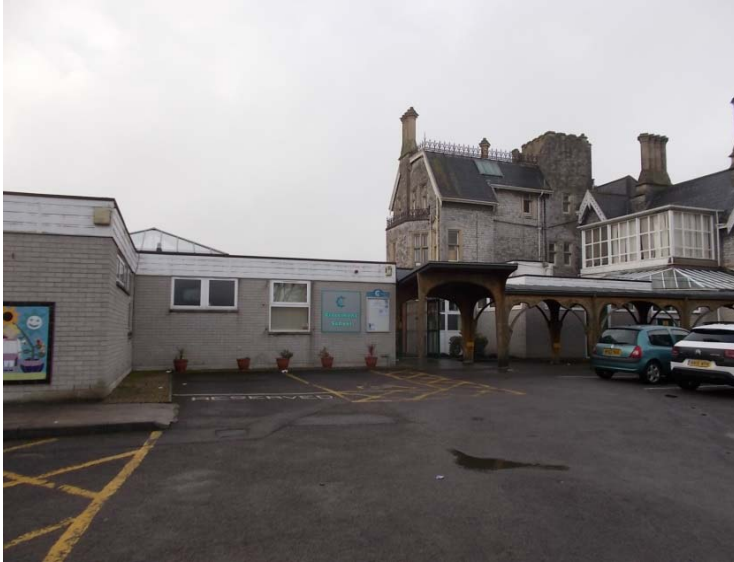
## SUMMARY: Claremont Special School, M&E

**CONDITION:** The Mechanical, Electrical, Swimming Pool and Lift systems are maintained in a satisfactory manner and are in fair condition and should operate for the term of this report without major repair or replacement unless as shown in the PMP review.

Carry out planned replacement of water heaters
