Appendix A

Harbour & River Avon asset condition surveys – high priority conclusions & recommendations

Executive Summary

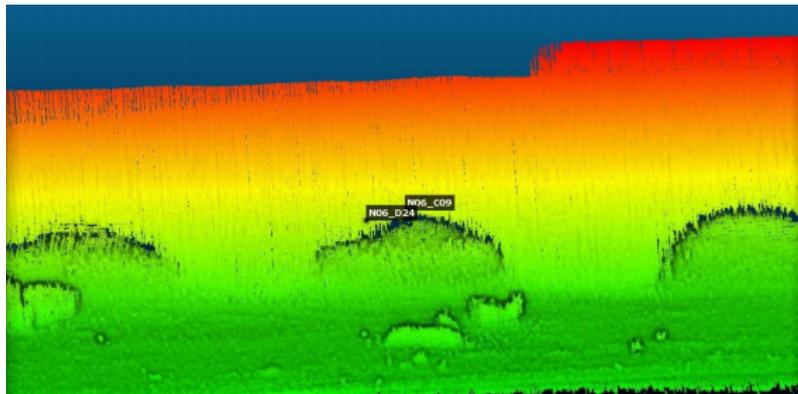
N06

Deformation of underwater arches and areas of lost masonry, see image below showing deformation of arches.

If the wall were to collapse, there is a risk that Hotwell Road will also be affected by a loss of support and lane closures would be necessary. There are boats moored along the asset in the vicinity of the critical defects and there is the potential for them to be damaged by falling masonry

- Install and monitor survey points
- Dive inspection of affected arches

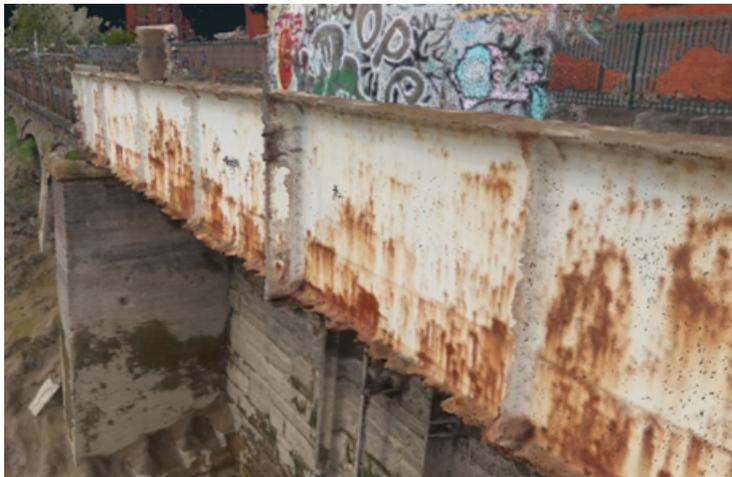
NCN03a

Severe corrosion of steel beam as shown in image below

Collapse of the structure poses risk to life, reputational risk, financial risk and loss of function of Underfall sluice gates. Loss of the sluice gates would result in a loss of the ability to control the water level in the harbour with far reaching consequences.

- Cordon off bridge to prevent pedestrian access (actioned)
- *Motts recommendation*: Investigation to determine the capacity of the girder and place load restrictions on the bridge. Action subsequent recommendations accordingly
- BCC structures recommendation: no further investigation required. Replace girder

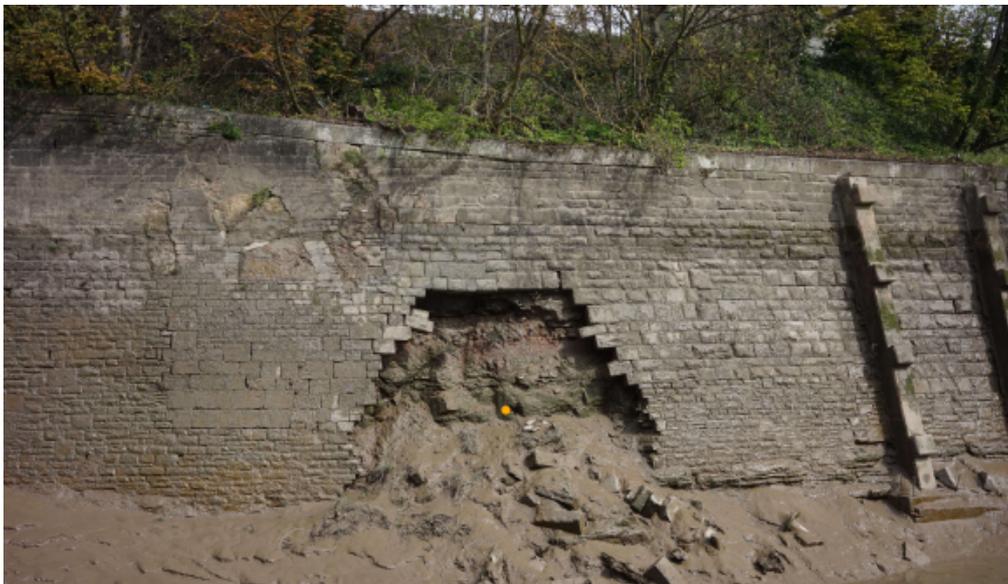
The critical section of the asset is an area of lost masonry measuring 6m x 4.5m

The failure of NCN16 could cause a failure in NCN17 resulting in a collapse of the footpath and partial collapse of Cumberland Road. There is a risk of major travel disruption.

- Install and monitor survey points
- Undertake repairs of the critical section

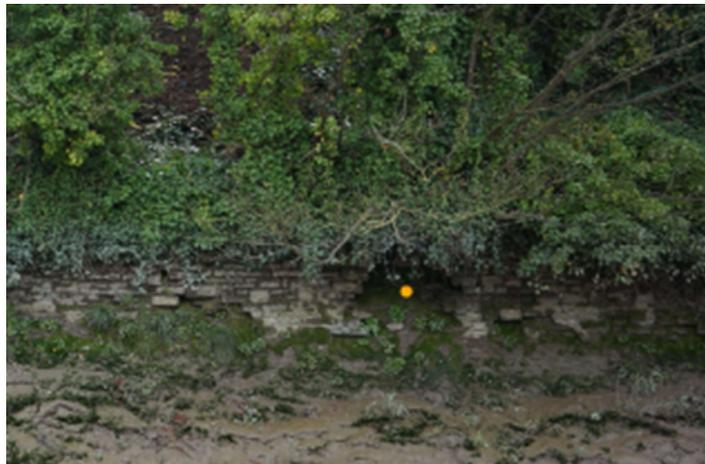
NCS06

Several areas of collapsed wall along the length of the asset and the remaining masonry is generally in a poor condition as shown the image below.

Potential for a loss of support to building foundations and the building could collapse, presenting risk to life.

- Conduct investigation to gauge whether the asset is providing direct support to the building at the western end and to confirm the depth of foundations of the building behind

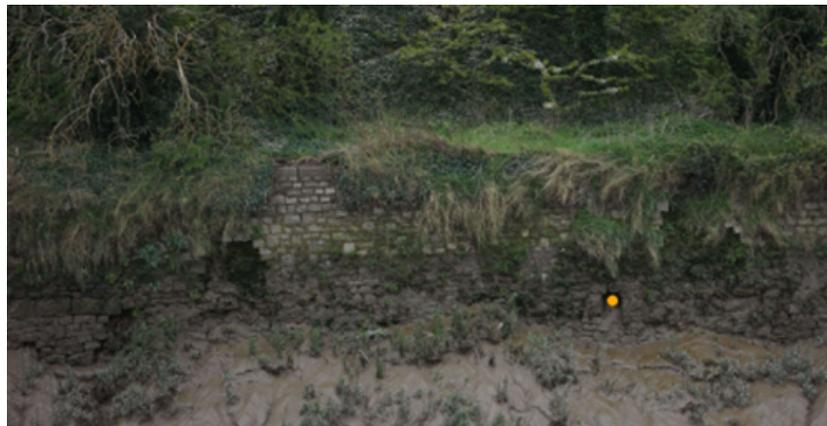
NCS13

Numerous collapsed sections along the full length of the asset and the masonry is in a poor condition with deformations noted. Scour is affecting the rock outcrops which the asset is constructed on.

If there was a loss of support to the embankment, Coronation Road may be affected. There is a risk of major disruption to travel.

- Install and monitor survey points
- Repairs to eastern section of the asset where the embankment is directly supported by the wall

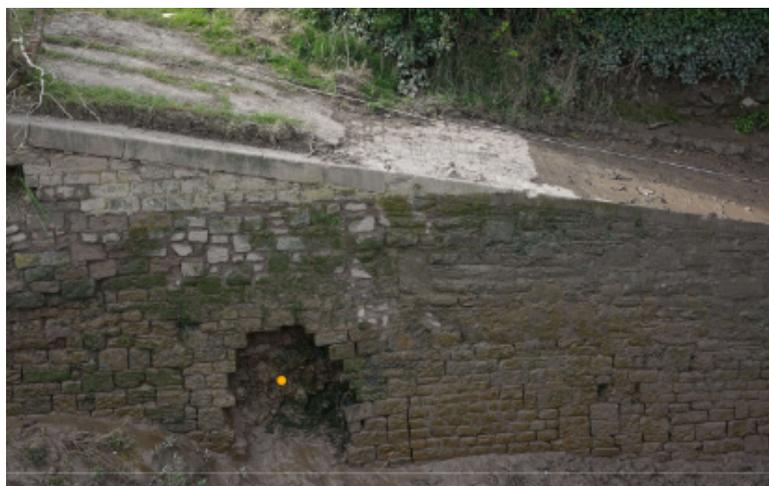
NCS18

Several collapsed sections and areas of deformation along the length of the asset including slipway

Coronation Road may be affected by a loss of support and failure. There is a risk of major travel disruption

- Install and monitor survey points
- Repairs to the areas of deformation and collapsed sections where the wall directly supports the embankment

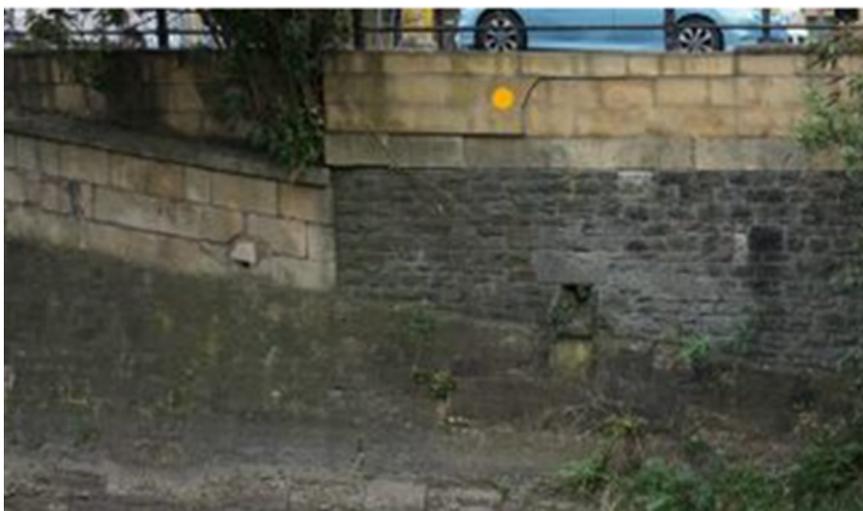
NCS21

Significant deformed area situated at the eastern end of the asset

Loss of support/collapse of the footpath is likely in the event of a failure. Load restrictions and a partial closure would be necessary. There is a risk of major travel disruption.

- Protect rear of the footpath with barrier
- Undertake vegetation removal at critical location and repairs to the area of deformation

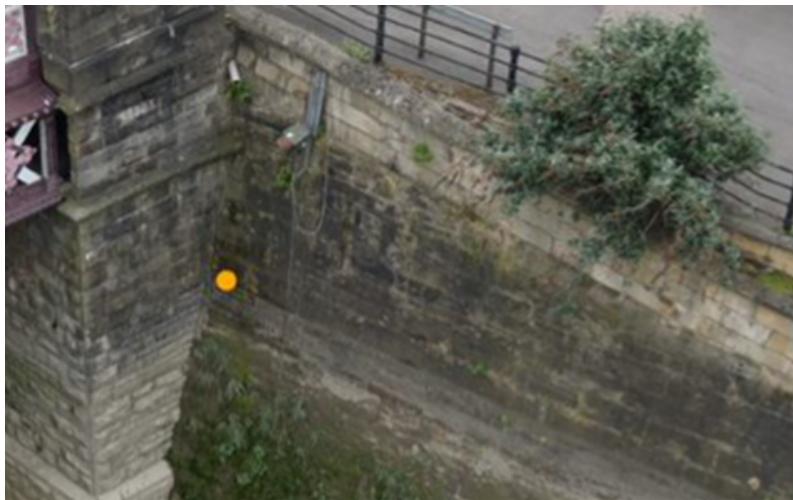
NCS23

Area of deformation at the crest of the wall adjacent to Bedminster Bridge roundabout

Loss of support to footpath and a collapse is likely in the event of a failure. Load restrictions or a partial closure may be necessary. There is a risk of major travel disruption.

- Protect rear of the footpath with barrier
- Vegetation removal at critical location
- Repairs to the area of deformation

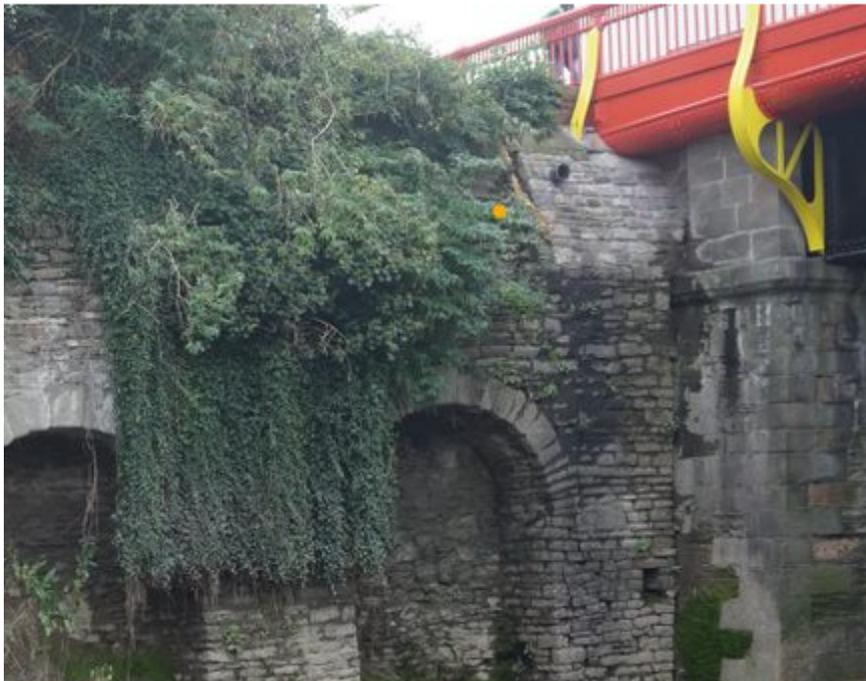
NCS30

The arch adjacent to Bath Bridge Roundabout has failed from its springing point and the masonry is bulging significantly. There are also areas of collapsed masonry above this arch

Collapse of the arch will cause a loss of support to the retained material leading to a collapse of Network Rail land. It would also expose the edge of the bridge abutment and is likely to affect the stability of the road approaching the bridge. Bath Bridge Roundabout is not expected to be damaged as a result of a failure, there is potential for the road approaching the bridge to require a partial closure. The NR access road is likely to be affected, risk to life if people are on the land close to the river used for car parking.

- Install barrier to prevent pedestrian access
- Installation of props or ties to restrain the bulging area and carry out repairs / reconstruction

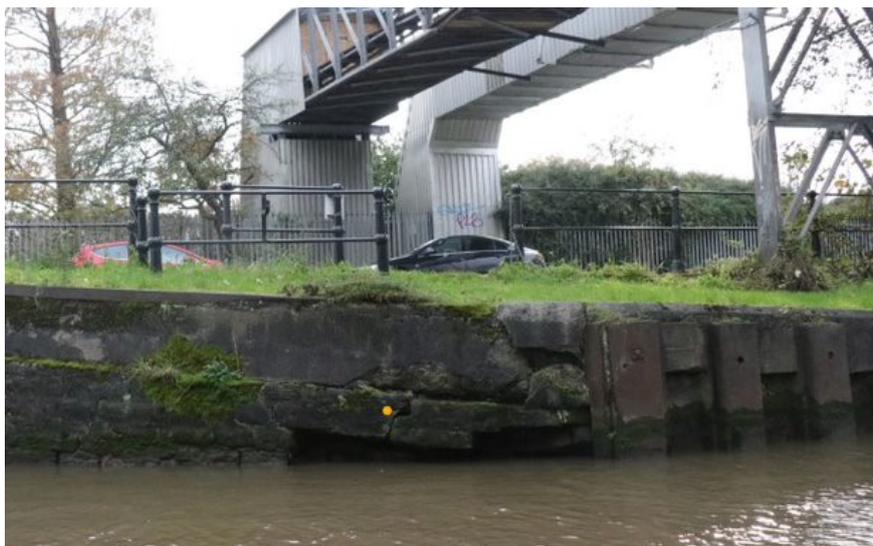
S28b

There are large areas of lost masonry underwater at the western end and numerous capping beam failures along the length. There is an extensive amount of vegetation growth from gaps between the concrete planks. There are several large areas of deformation visible on the capping beam

Loss of support to the retained material would result in a collapse of the footpath and potentially a partial collapse of Feeder Road. Risk of minor travel disruption

- Install survey points to monitor the asset for movement
