## Harbour Condition Survey - Appendix B - Structural Recommendations

**Figure 1. Location of all identified 11 highest priority assets (Refer to following Asset information)**

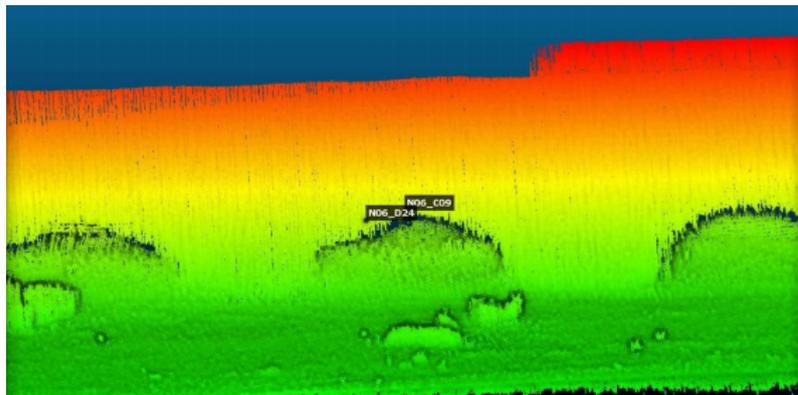
Deformation of underwater arches and areas of lost masonry, see image below showing deformation of arches.

If the wall were to collapse, there is a risk that Hotwell Road will also be affected by a loss of support and lane closures would be necessary. There are boats moored along the asset in the vicinity of the critical defects and there is the potential for them to be damaged by falling masonry

- Install and monitor survey points
- Dive inspection of affected arches

- Undertake full diving inspection and stabilise Arch and install scour protection measures
- Estimated Cost = **£500,000.00**

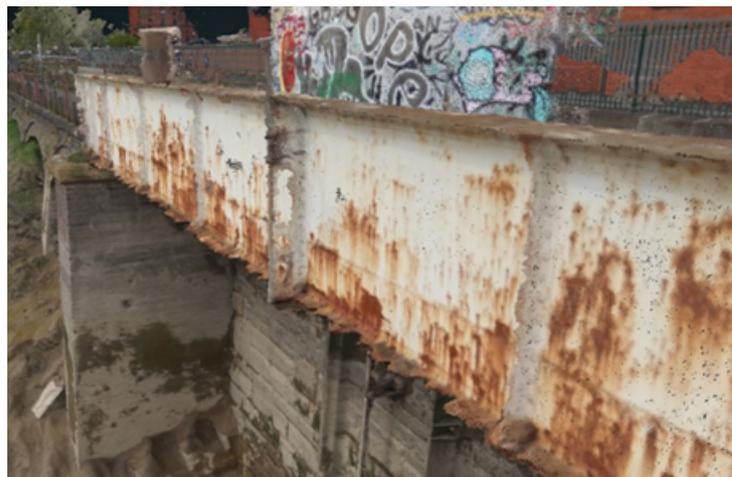
Severe corrosion of steel beam footbridge as shown in image below

Collapse of the structure poses serious risk to life, reputational risk, financial risk and loss of function of Underfall sluice gates. Loss of the sluice gates would result in a loss of the ability to control the water level in the harbour with far reaching consequences. Flooding and damage to property.

- Cordon off bridge to prevent pedestrian access (actioned)
- Investigation to determine the capacity of the girder and place load restrictions on the bridge. Action subsequent recommendations accordingly

- Replace whole Structure. Estimated Cost = **£1,000,000.00**

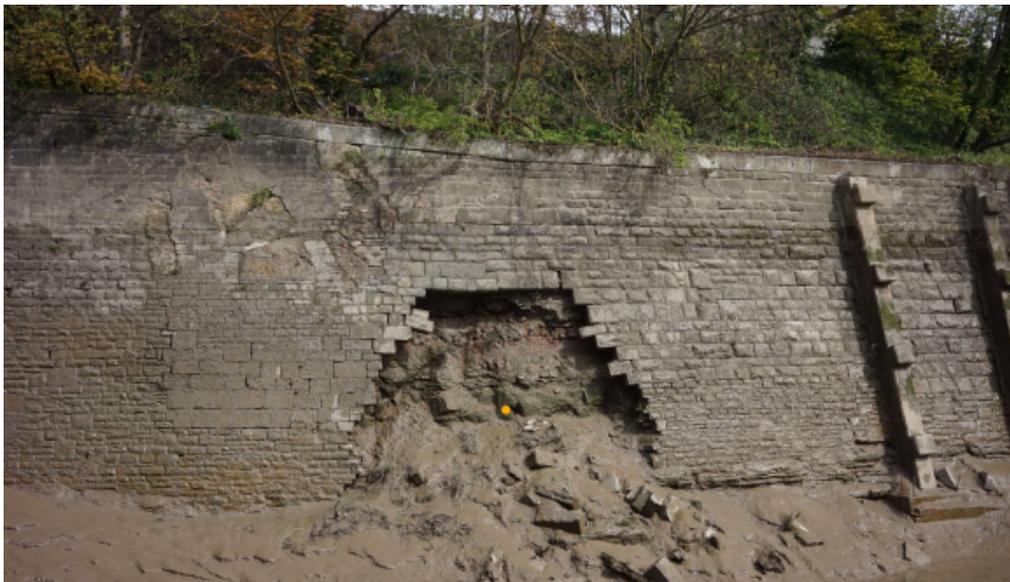
The critical section of the asset is an area of lost masonry measuring 6m x 4.5m

The failure of NCN16 could cause a failure in NCN17 resulting in a collapse of the footpath and partial collapse of Cumberland Road. There is a risk of major travel disruption.

- Install and monitor survey points
- Undertake repairs of the critical section

- Undertake full masonry reconstruction/masonry Repairs and underpinning at base  
Estimate = **£1.550,000.00**

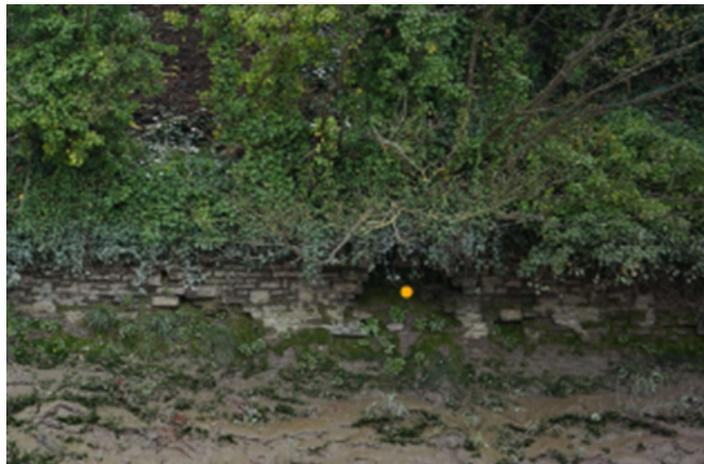
Several areas of collapsed wall along the length of the asset and the remaining masonry is generally in a poor condition as shown the image below.

Potential for a loss of support to building foundations and the building could collapse, presenting risk to life.

- Conduct investigation to gauge whether the asset is providing direct support to the building at the western end and to confirm the depth of foundations of the building behind.

- Masonry Repair and rebuild along with some foundation underpinning  
Estimated Cost = **£550,000.00**

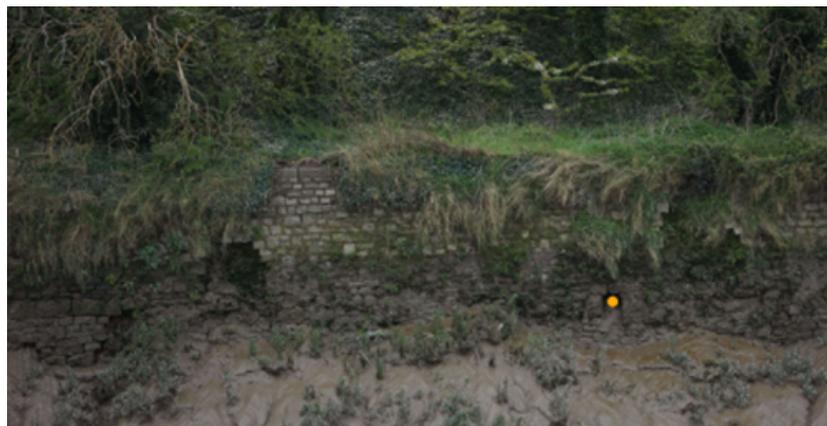
Numerous collapsed sections along the full length of the asset and the masonry is in a poor condition with deformations noted. Scour is affecting the rock outcrops which the asset is constructed on.

If there was a loss of support to the embankment, Coronation Road may be affected. There is a risk of major disruption to travel.

- Install and monitor survey points
- Repairs to eastern section of the asset where the embankment is directly supported by the wall.

- Masonry Rebuilds and repair along with some underpinning and rock anchoring at base.  
Structural Estimate = **£850,000.00**

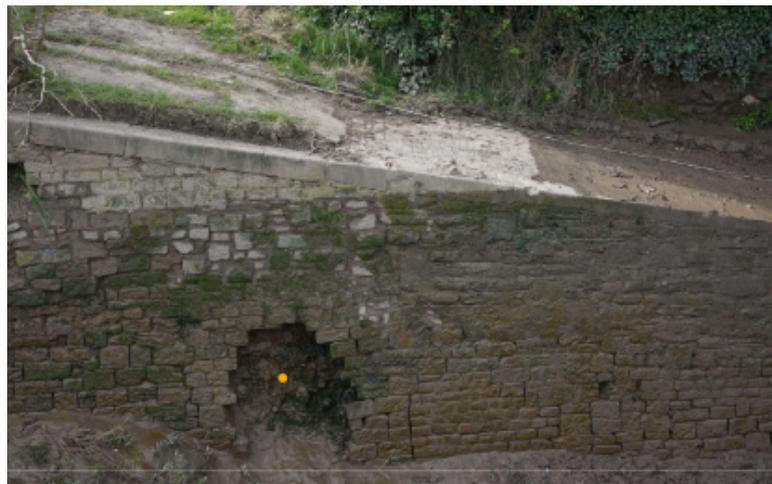
Several collapsed sections and areas of deformation along the length of the asset including slipway

Coronation Road may be affected by a loss of support and failure. There is a risk of major travel disruption.

- Install and monitor survey points
- Repairs to the areas of deformation and collapsed sections where the wall directly supports the embankment.

- Masonry Rebuilds and repair along with some underpinning and rock anchoring at base.  
Structural Estimate = **£1,600,000.00**

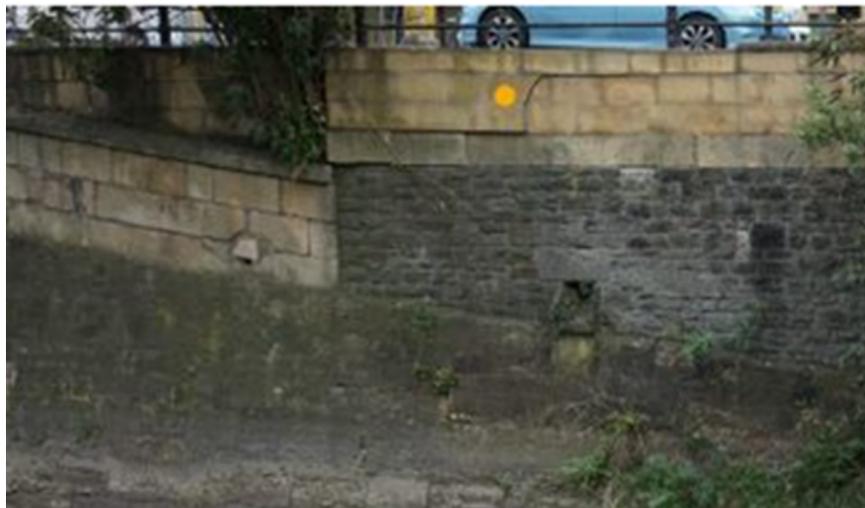
Significant deformed area situated at the eastern end of the asset

Loss of support/collapse of the footpath is likely in the event of a failure. Load restrictions and a partial closure would be necessary. There is a risk of major travel disruption.

- Protect rear of the footpath with barrier
- Undertake vegetation removal at critical location and repairs to the area of deformation.

- Remove upper Blockwork Wall and Railings and stabilise and then reconstruct.  
Structural Estimate = **£300,000.00**

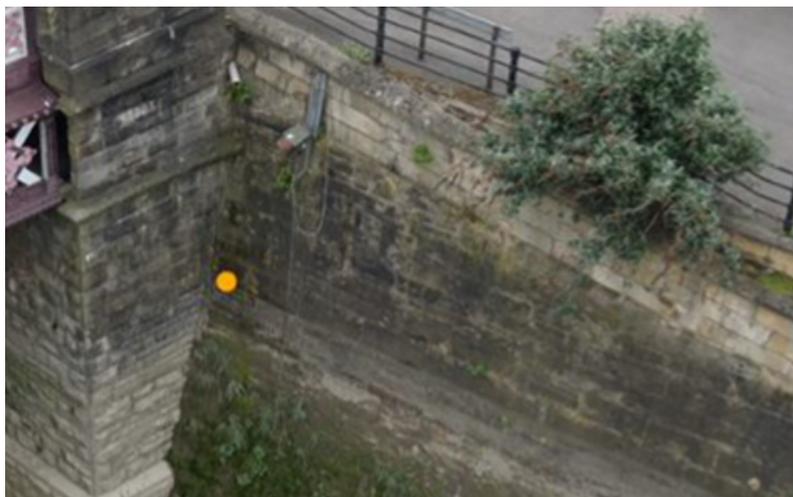
Area of deformation at the crest of the wall adjacent to Bedminster Bridge roundabout

Loss of support/collapse of the footpath is likely in the event of a failure. Load restrictions and a partial closure would be necessary. There is a risk of major travel disruption.

- Protect rear of the footpath with barrier
- Vegetation removal at critical location
- Repairs to the area of deformation

Stabilise lower level wall with rock anchors and repair masonry facing. Structural Estimate = **£400,000.00**

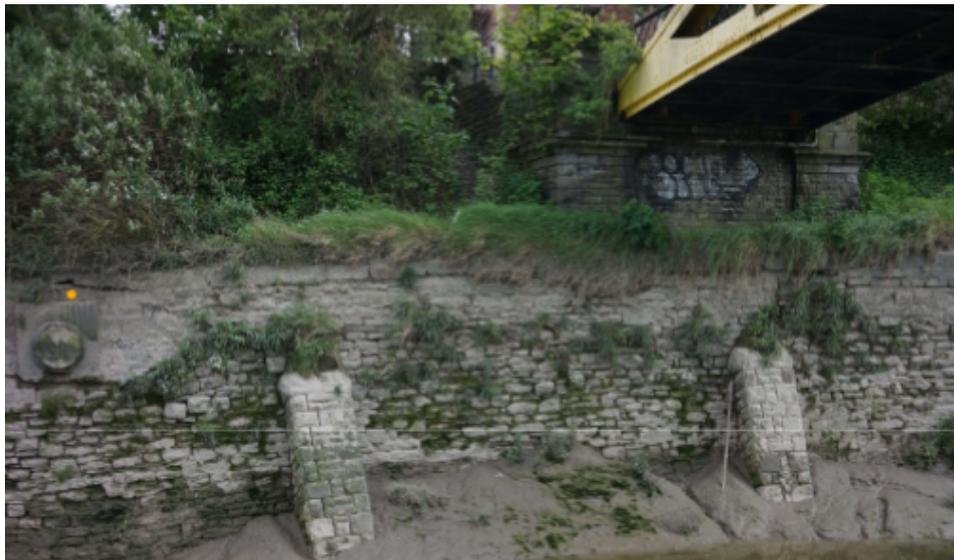
There are several areas of significant masonry loss and extensive deformed sections, particularly in the vicinity of Langton Street footbridge. The asset is generally in a poor condition along the entire length

Immediate loss of support to York Road and to Abutments of Langton Court Road footbridge

- Confirm the depth of foundations for Langton Street footbridge
- Installation of survey points on the asset and bridge
- Installation of survey pegs on the fill behind the asset

Undertake full structural assessment and based on findings. Stabilise full extent of retaining wall  
Structural estimate = **£2,750,000.00.**

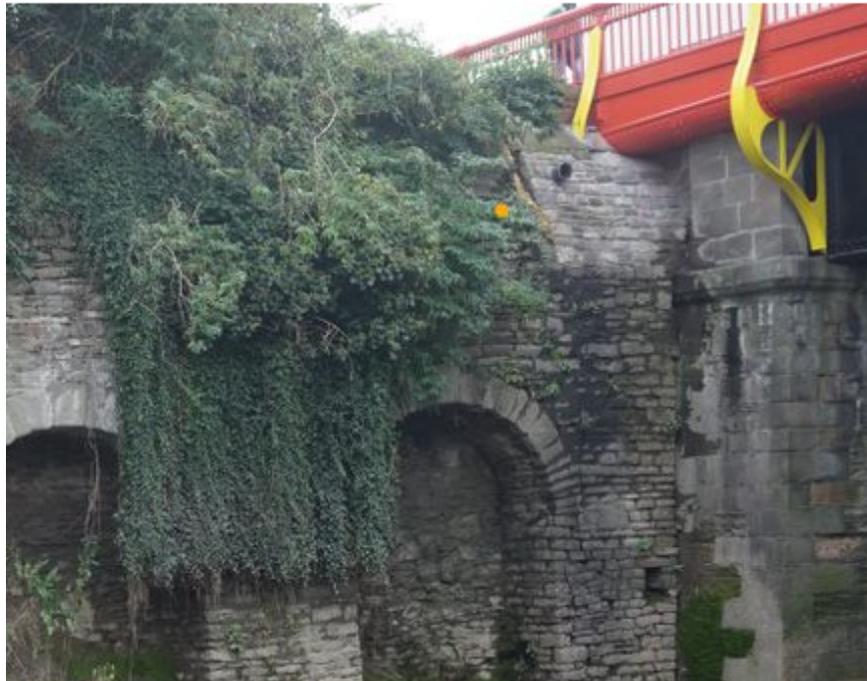
The arch adjacent to Bath Bridge Roundabout has failed from its springing point and the masonry is bulging significantly. There are also areas of collapsed masonry above this arch

Collapse of the arch will cause a loss of support to the retained material leading to a collapse of Network Rail land, exposing the edge of the bridge abutment and is likely to affect the stability of Bath Road

- Install barrier to prevent pedestrian access
- Installation of props or ties to restrain the bulging area and carry out repairs / reconstruction

Undertake full assessment of deformed arches and take appropriate stabilisation measures and stabilise full masonry wall. Structural Estimate = **£300,000.00**

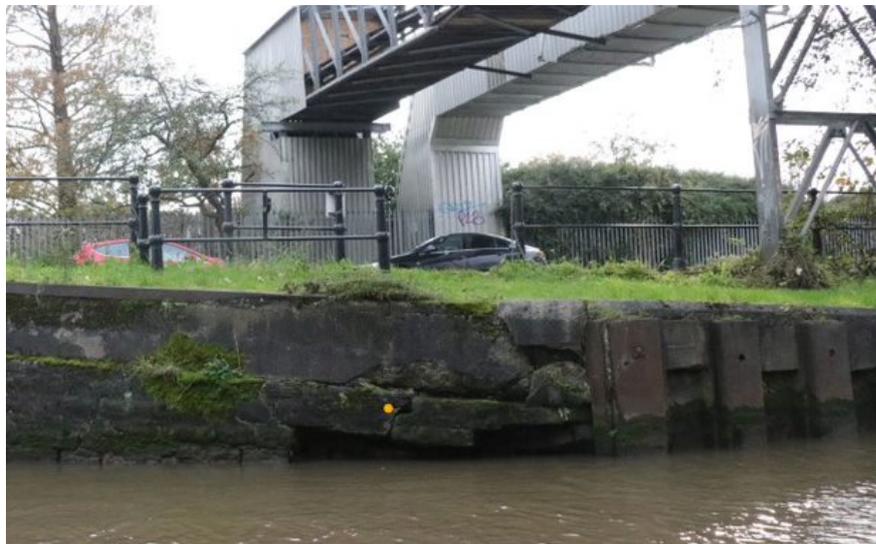
There are large areas of lost masonry underwater at the western end and numerous capping beam failures along the length. There is an extensive amount of vegetation growth from gaps between the concrete planks. There are several large areas of deformation visible on the capping beam

Loss of support to the retained material would result in a collapse of the footpath and potentially a partial collapse of Feeder Road. Risk of minor travel disruption

- Install survey points to monitor the asset for movement

Underpin base of wall and stabilise retaining wall/ capping beam. Structural estimate = **£450,00.00**
