## **Appendix A4 – Report from Senior Project Manager, Bristol Beacon**

### **Introduction**

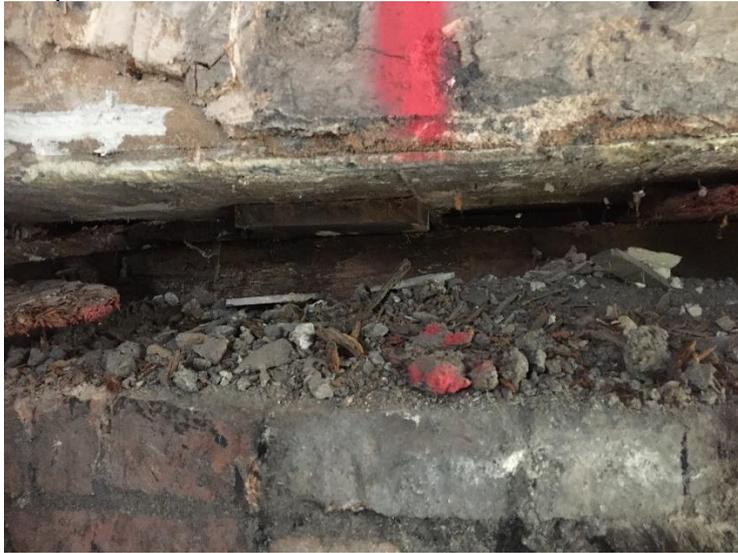
## Sub-station

The sub-station enclosure could not be built immediately as during soft strip it was found that the existing wall which was due to provide support to the enclosure, was in poor condition and resting upon rotten timbers. Remedial works had to therefore be specified and this wall demolished and rebuilt before the sub-station works could proceed. This knocked on the demolition of Az wall and further works in the get in yard.

Suspected asbestos and area of structural concern.

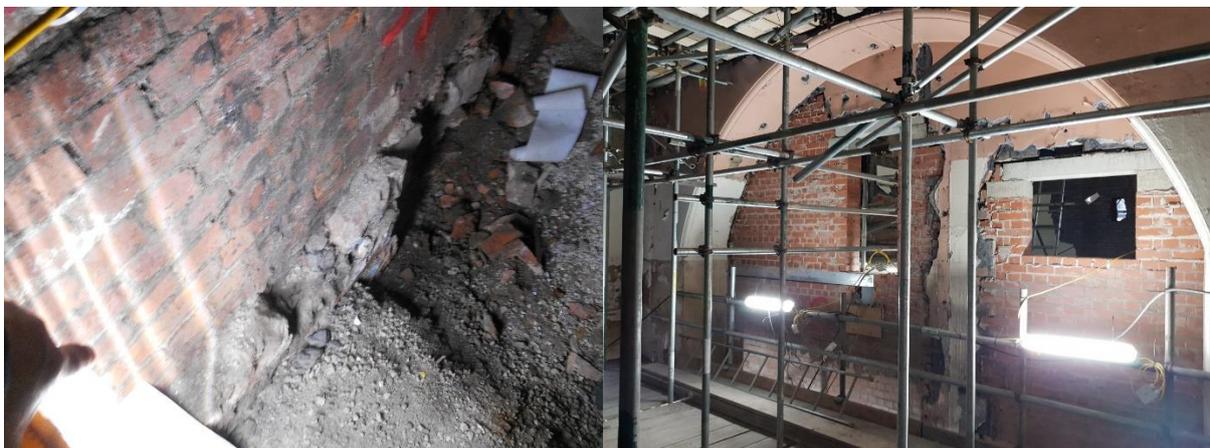
## Poor condition and instability of wall- voids discovered

Investigation required to check that infill wall is packed tight to top of arch (remove plaster, local brick unit removal)

Remove plaster from face of wall to check condition of brickwork. Limited exposure to date suggests variety of types of brick forming this wall. Bonding between these units needs to be reviewed as we are increasing vertical loads.

Padstone size will need to be increased in length to offset discovery that wall thickness is reduced on site (300mm assumed from survey)

Helibars may be required across interface between infill wall and arch - TBC once plaster has been removed and interface exposed.

Void should be cleared of all debris. Concrete infill not preferred option as concrete may shrink. Wall requires a solid bearing. Suggest rebuild at low level in brick and pack with non-shrink grout.

Infill existing opening with 20N clay brick, with M2 mortar. Toothed in both sides. Refer to Arup masonry spec for more information.

Carry out Hilti tests on existing wall. Check both pull-out and shear to 5kN ULS. Refer to Arup general notes drawing for further information.

Investigation required to check whether this side of wall is also bearing onto timber floor boards. If this is found to be the case, clear out timber and debris, rebuild at low level in brick and pack with non shrink grout.

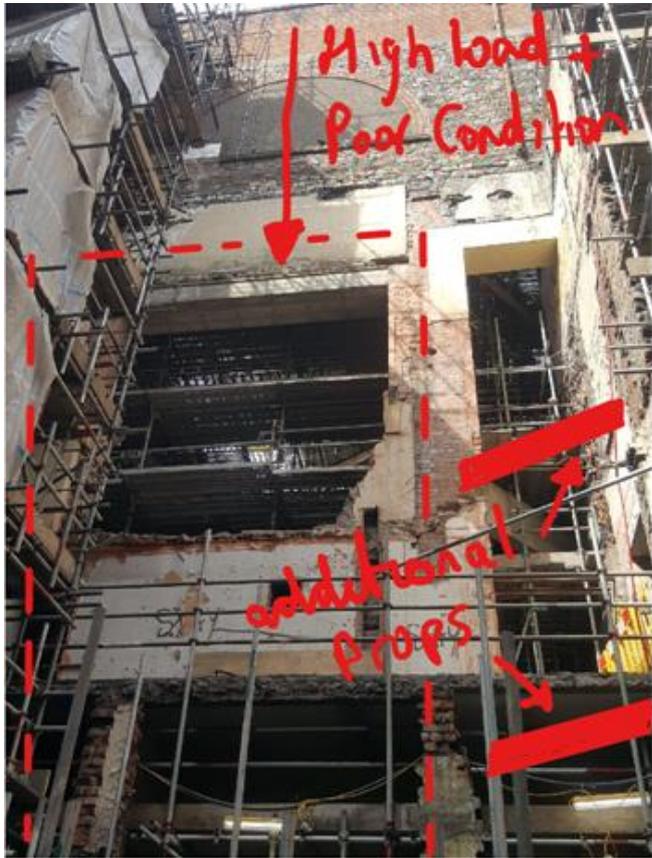
Get in Yard side

This area is more complex than originally envisaged as, on further investigation, the walls connected to the top of the roof space. Subsequently, the works could not be undertaken during the enabling works phase as the roof space was still contaminated with asbestos. Overall, this impacted the demolition works to the back of stage area and the wing walls had to be removed by hand due to the constraints with the scaffolding installed as part of the main works. A conveyer was also required to remove this material through the main hall and to avoid the mobile crane outside. Arup have produced a design which has led to additional works required, which was updated and re-issued 26.06. Additional cost incurred on additional propping for this area.

This area has continued to cause further issues for the project following concerns from WD's engineer about the structural integrity of the piers and risk of installing padstones. MSP and Arup have developed a design which overcomes this risk with a series of steel angles and is to be finalised for construction w/c 15.02. They have worked closely with WD's temporary works engineer to ensure that the works are phased appropriately and are coordinated by the adjacent Az wall.

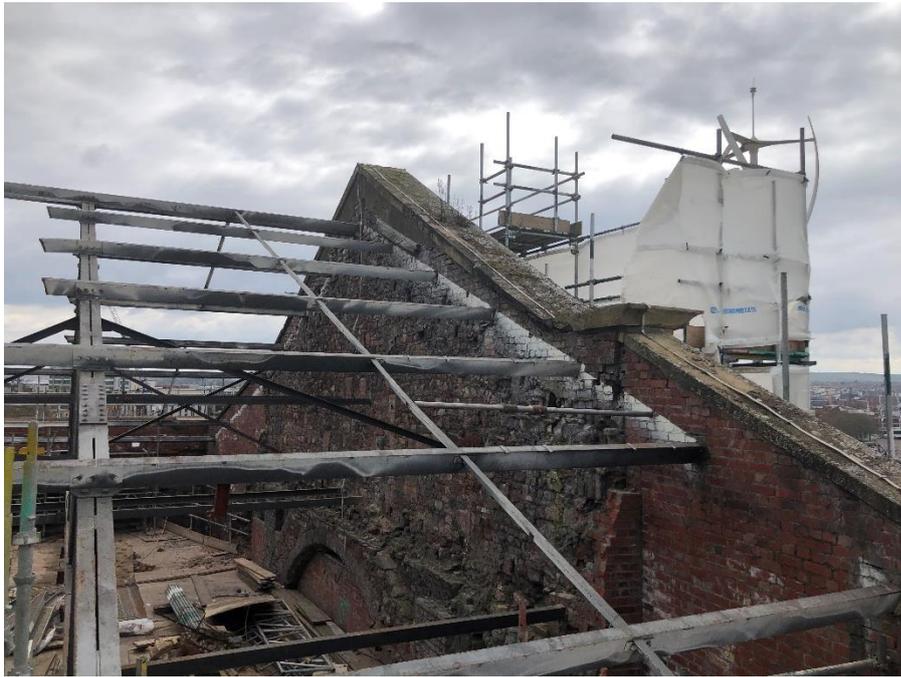
Hall 1 Gable end

The extremely poor condition of the gable end has led to complexities in achieving a temporary works design to stabilise the structure after removal of the roof. The instability of the piers at the back of hall 1, which were due to support the temporary works frame, were found to be in poor condition and masonry was crumbling. A decision was therefore taken to redesign this system rather than wait until the remedial works could be undertaken for the piers.

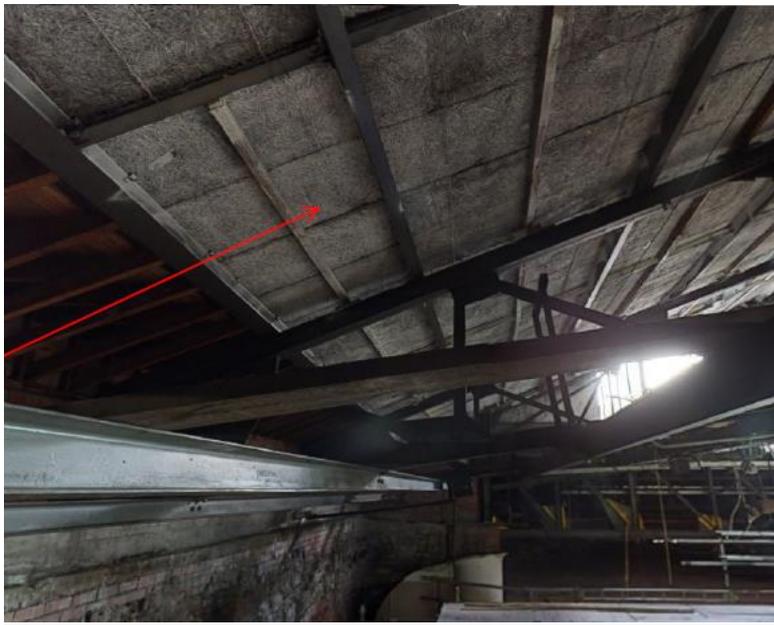
On removal of the main hall roof sheets and once works moved to the roof space it was discovered that additional wood wool panels were attached to the underside of the roof covering, which was not known of or recognised within the works information (this space could not be accessed). This slowed down removal of roof sheets which were due to simply be removed by crane, however a scaffold had to be erected to remove the wool panels from underneath as they contained traces of asbestos.

Wood wool panels to underside of hall 1 roof

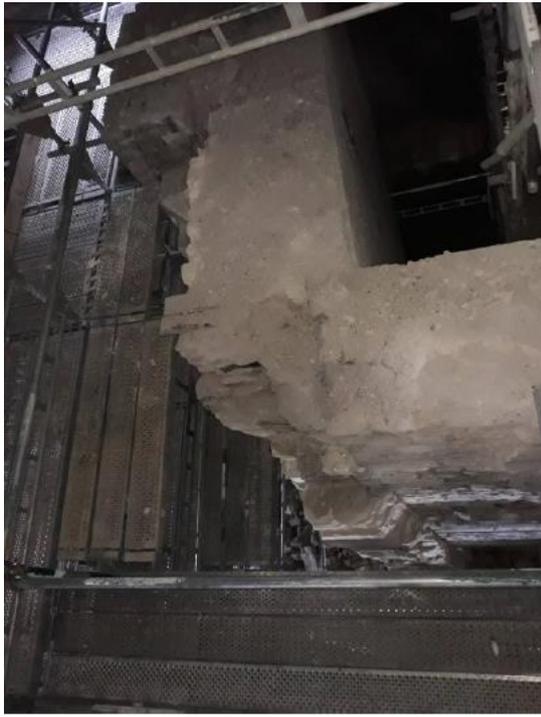
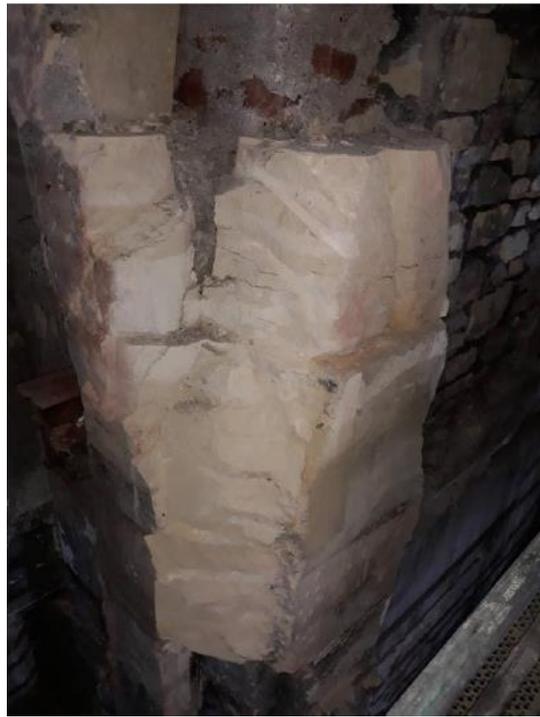
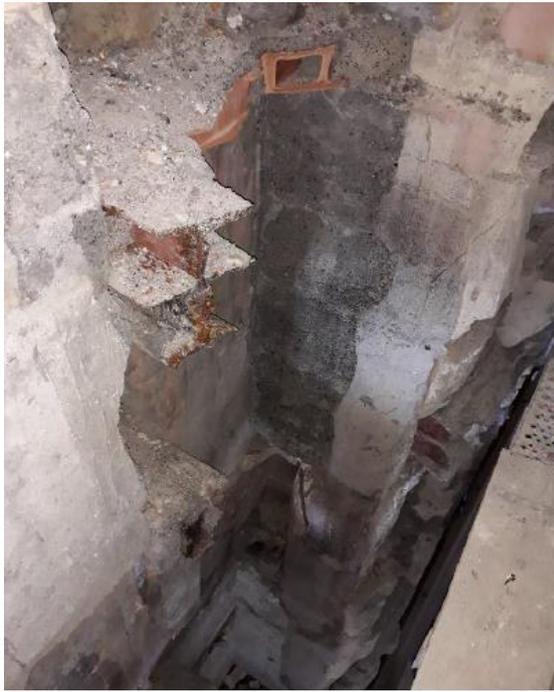
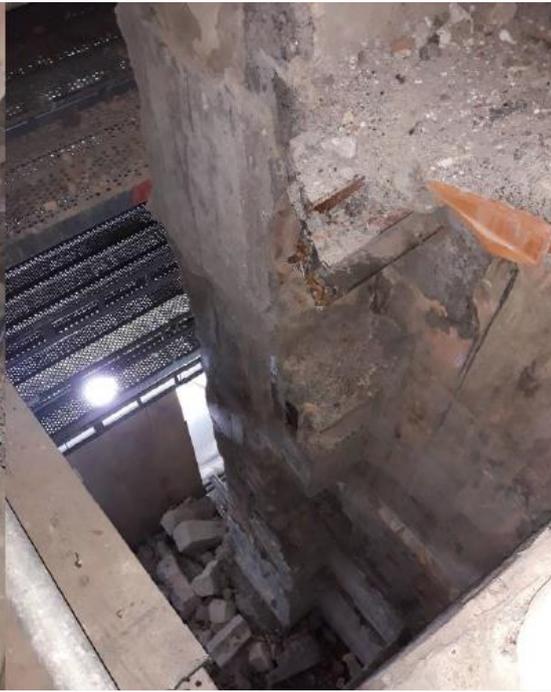
Condition of walls- hall 1

Following soft strip of hall 1, concerns have been raised regarding the condition of the walls in hall 1. Additional remedial works have been required to both the walls and padstones to facilitate the installation of the new steels and address loose and dangerous stonework. This has been a significant exercise scoped and undertaken by Structural Technicians who have been bought in to provide additional project support. Solutions include two phases of concrete jackets and significant general buildersworks.

Contractors have also revised their balcony fixing designs to suit site conditions. Recent additional concerns over whether the balconies can fix safely to the existing walls in addition to the acoustic brickwork. This item is currently under further investigation.

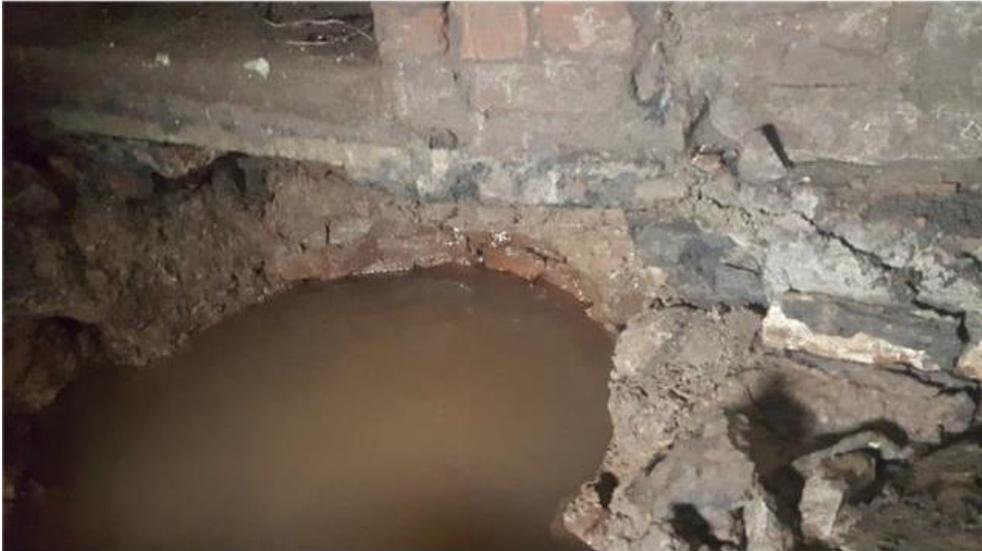
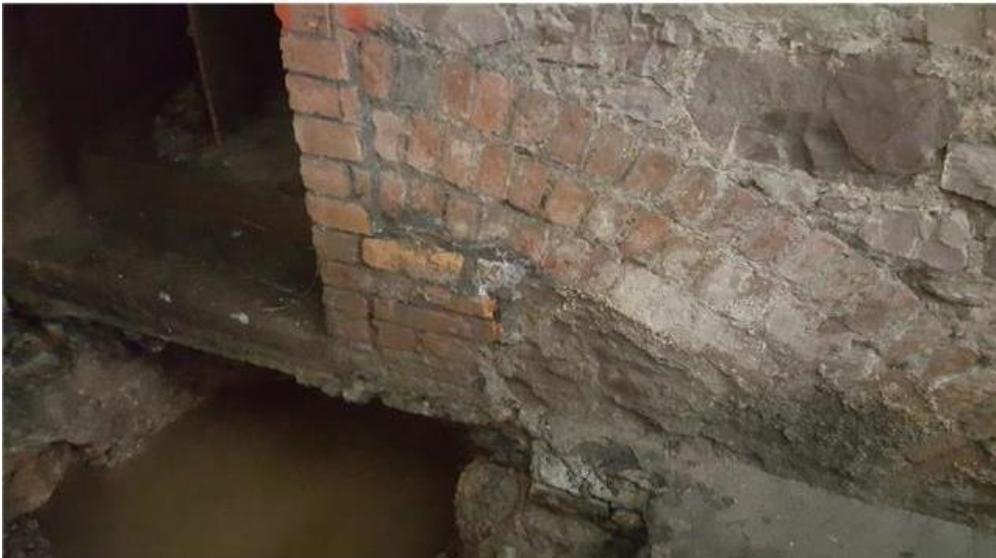
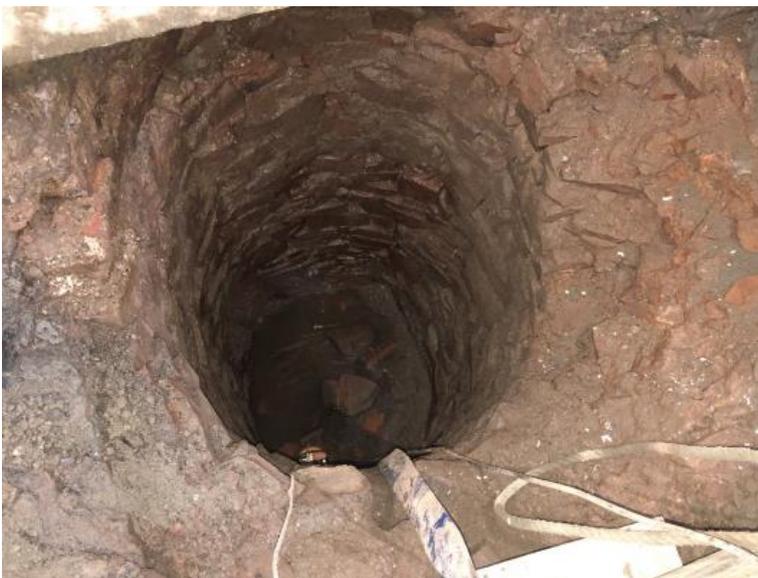
Well 1

A well was discovered in the lower basement of Colston Hall the well has been plugged but there is still a significant amount of water the source of which is still unclear, the plug and water ingress is continually monitored. Design work is still ongoing as a solution need to be found to enable the completion the of hall 1 steelwork .

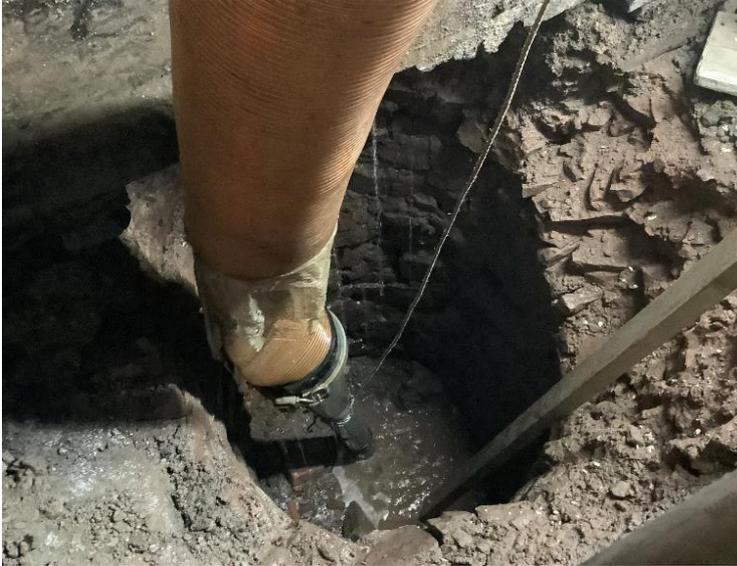
Vaccum excavation of well 1

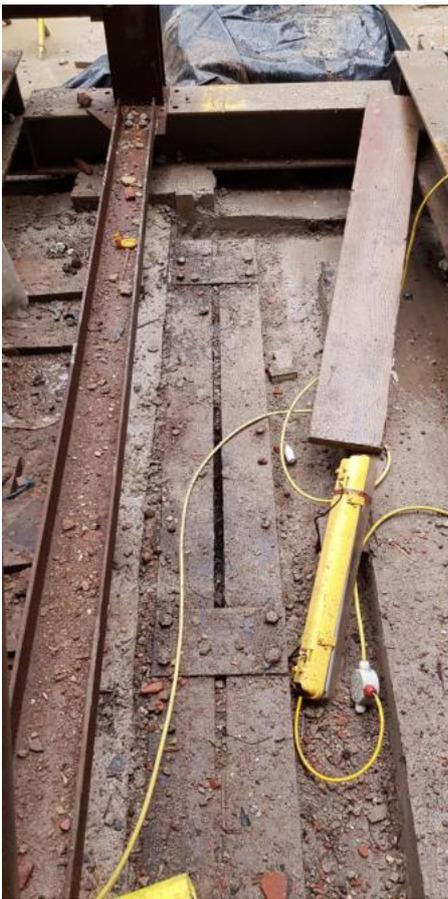
Embedded foundation beams

Whilst excavating the areas for the new embedded foundation transfer beams, existing beams were discovered, to allow space for the new beams, the discovered beams were removed there has been difficulty removing the existing beams causing time delays relating to the installation of new steelwork. This has been mitigated through working with the steel fabricators Overdale on their phased installation programme.

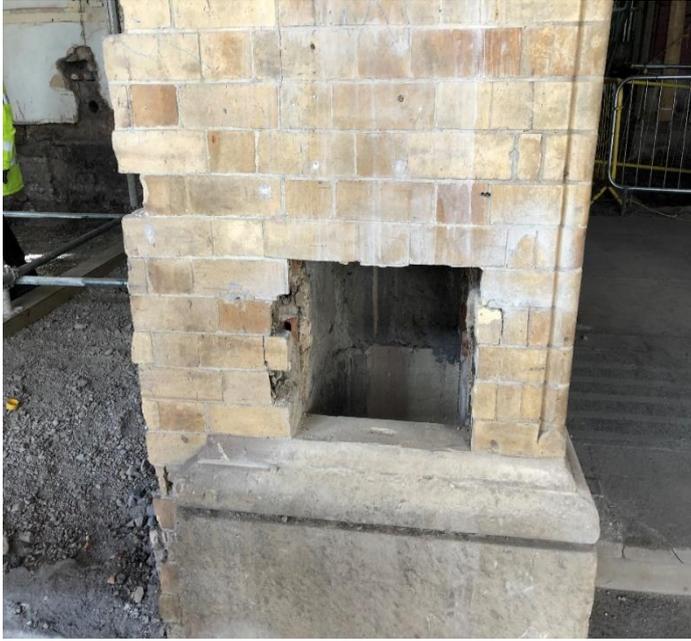
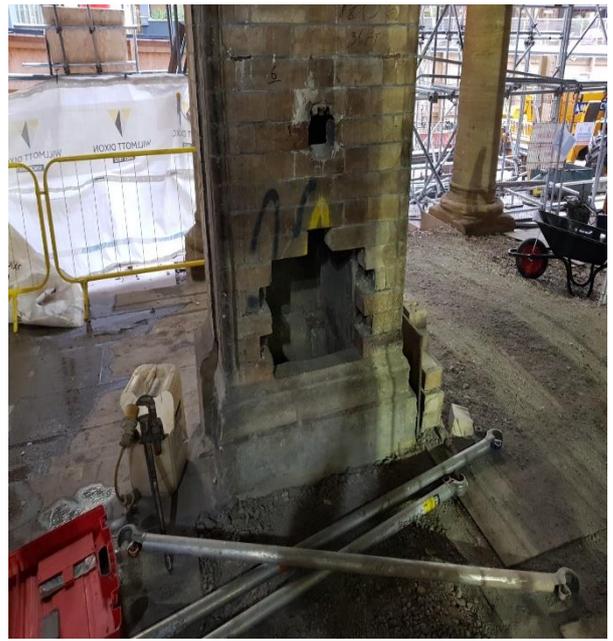
It was discovered that the columns in hall 2 were filled with loose rubble which led to concerns about the structural integrity and ability to support the new steels. Remedial works were specified which involved filling the columns with concrete where possible. Shuttering was also required due to discovery of voids and ducts in the lantern area which also had to be filled. Additional steel columns were added to the scheme where it was too dangerous to unzip the existing columns.

Rubble filled columns

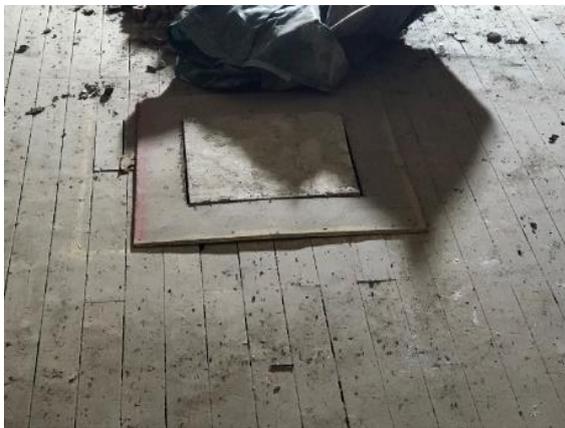
Top of hollow column

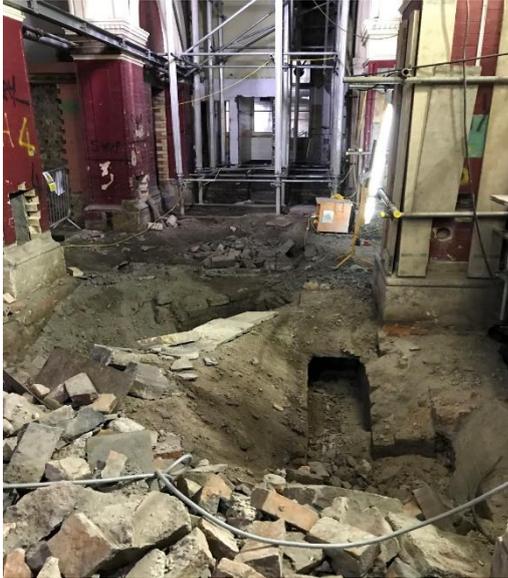
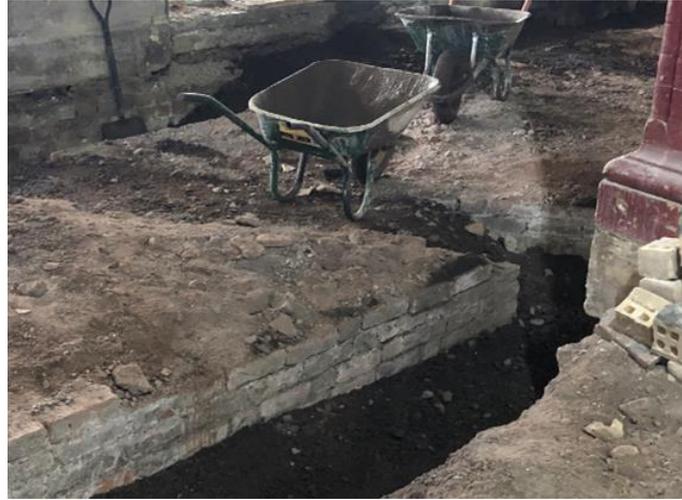
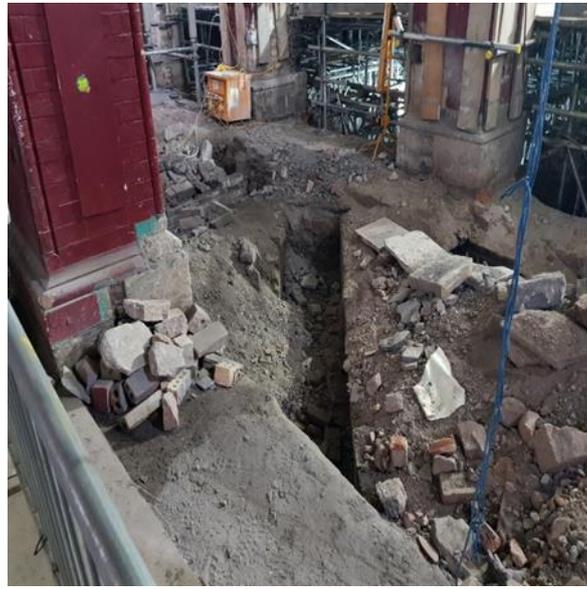
Discovered historic ventilation ducts

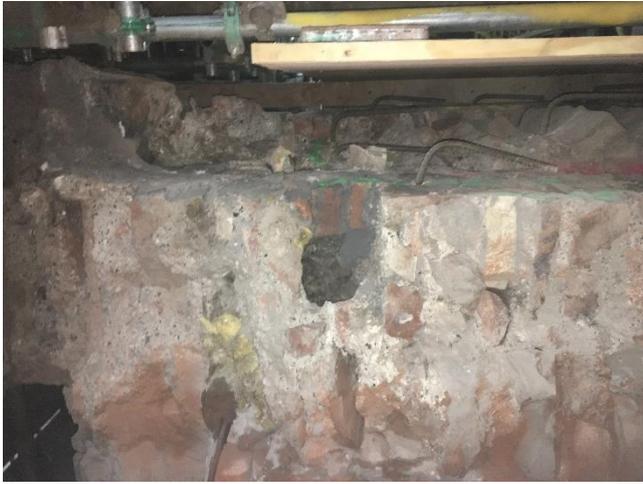
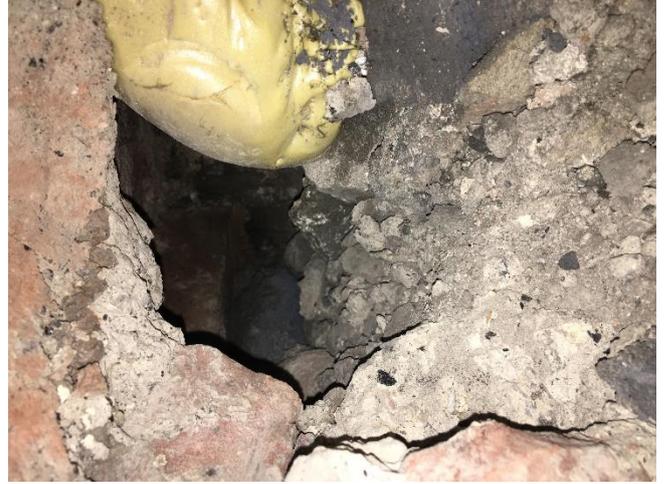
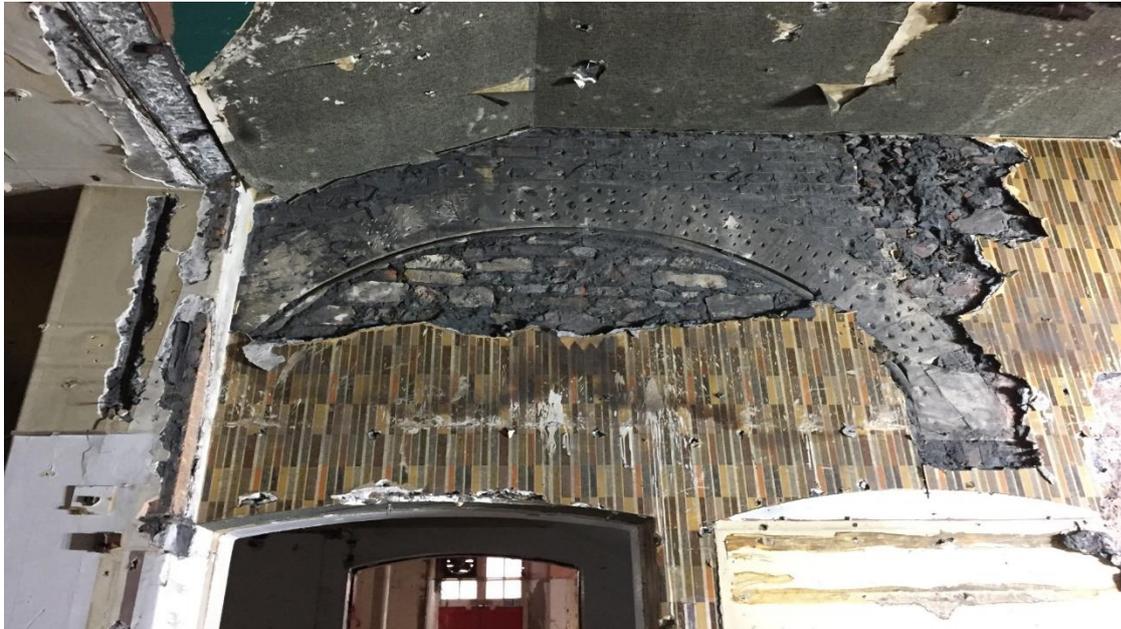
## Basement Support Wall

Poor condition and loose masonry leading to complex sequencing.

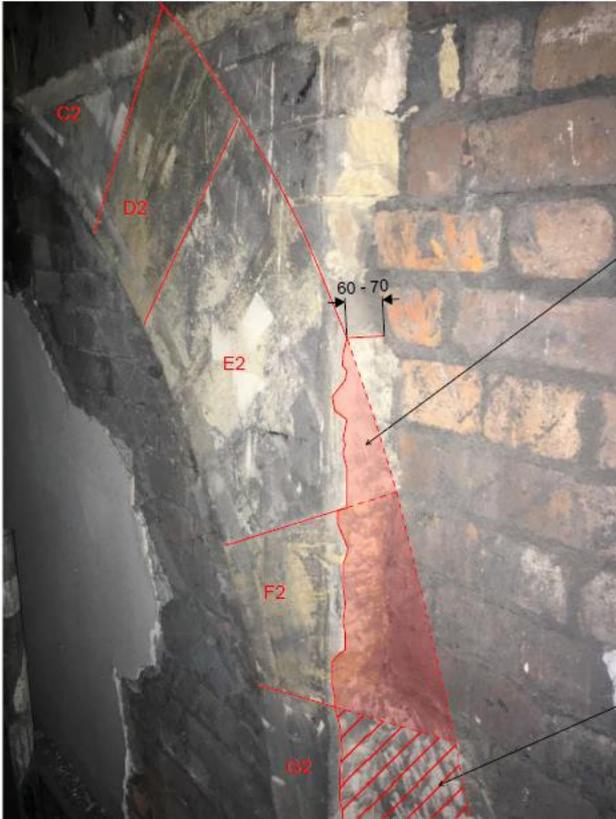
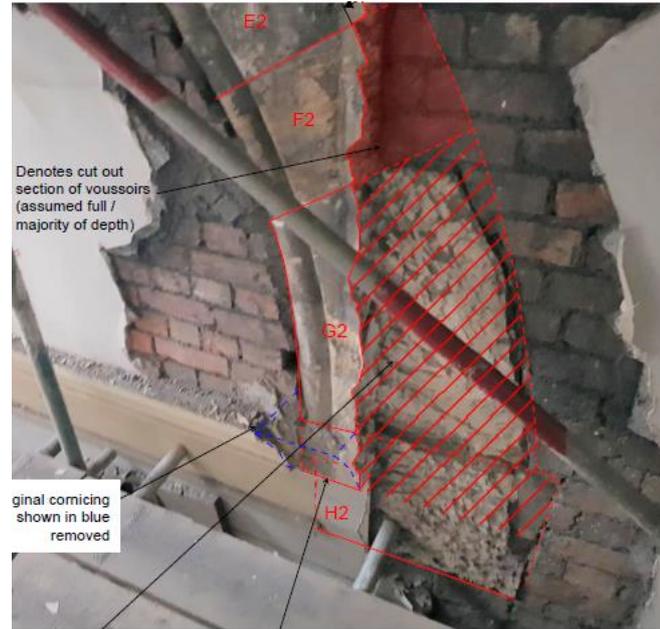
# Hauling Arch

The hauling arch coordination (area between the lantern and hall 1) has been ongoing for several months by the design team to accommodate discovered site conditions and the lift sizes. There is an arch, for example, which is not fully in-tact and requires complex remedial works to solve.

Discussions have been ongoing regarding leaving the fill in the arch to reduce risk, however this is not acceptable to BCC Conservation. Further in-situ roof repairs and remedial works have been specified to the hauling arch this is more than previously scoped.

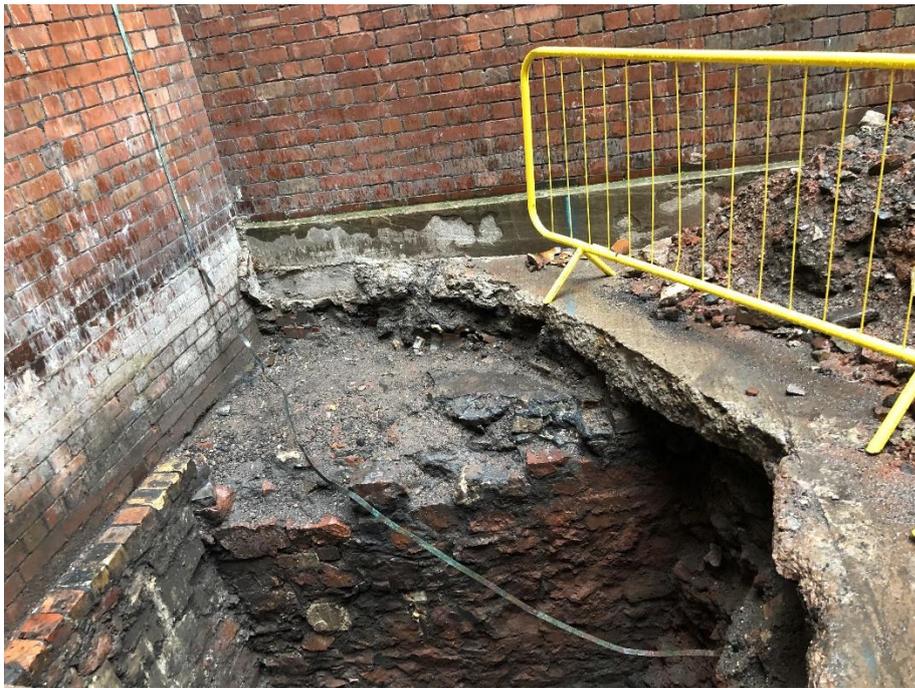
- Get in Yard lift: It was discovered during excavations in July that the get in yard wall was wider than expected and that this would impose on the proposed get in yard lift design. Following further investigations into whether this wall could be removed or integrated, a redesign and space planning exercise was undertaken in this area to skew the lift  
Time: works to the plant tower and lift have been re-sequenced to after the hall 1 steels are in, meaning that works in this area are not critical path.

Lift- discovery of wall under No.15 where the lift was due to be located

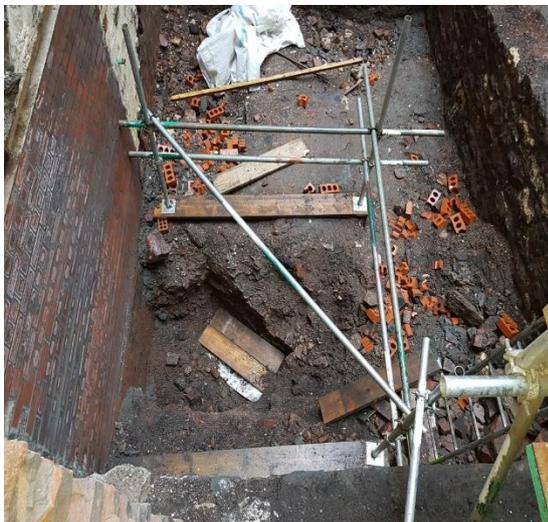
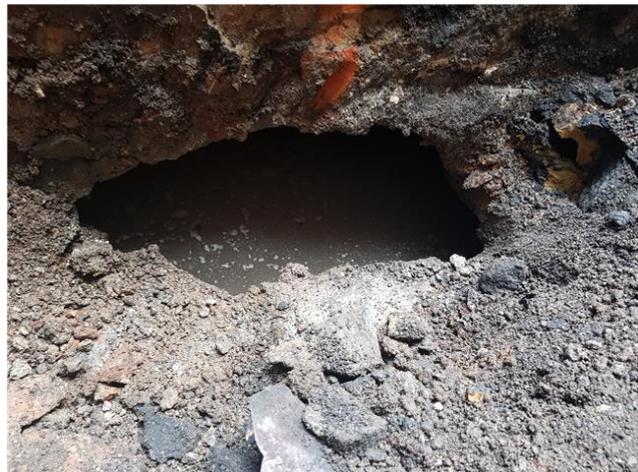
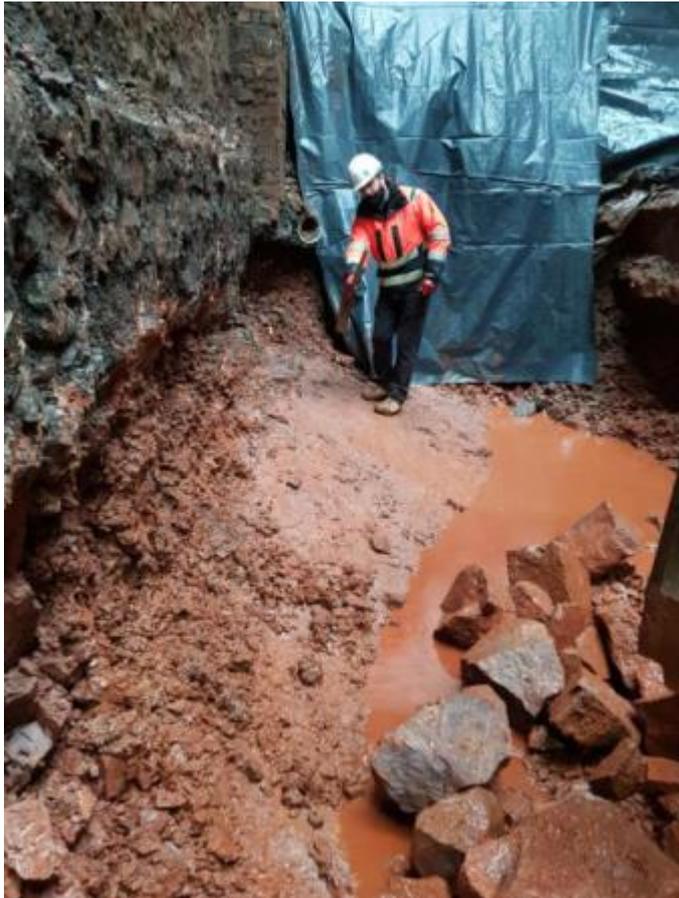
Well 2

- Well 2- A further well was discovered in the get in yard. This was resolved through the amended substructure design to the plant tower, remedial works to plug the well have been completed.  
Time: resolved within substructure, no critical path impact.

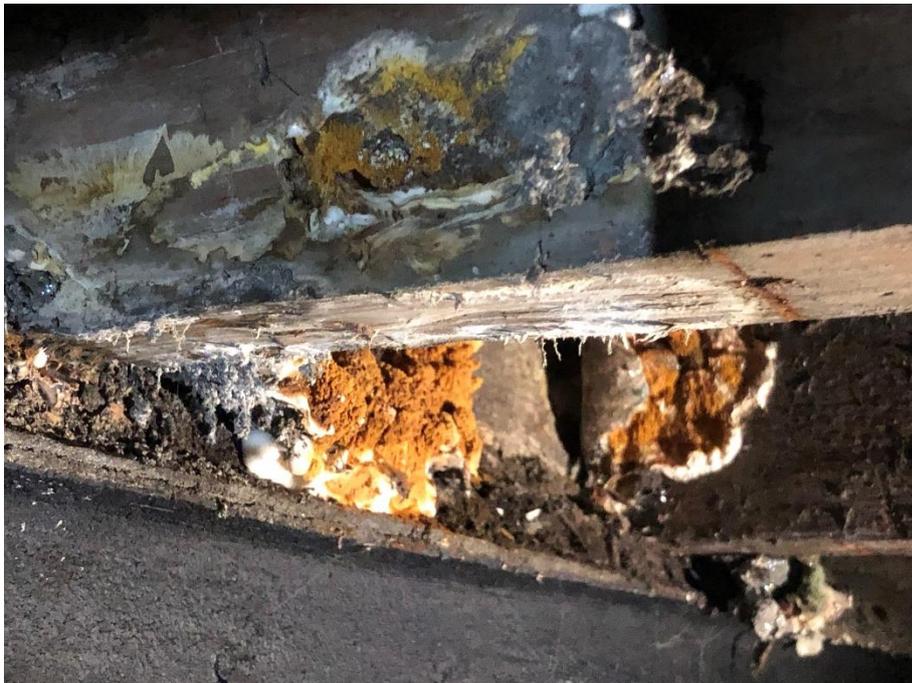
On further investigation of the hall 2 roof space, it has been discovered that the scope of works were greater than what was previously specified. Closer inspection of the roof timbers has revealed dry and wet rot, with further investigations currently being undertaken to identify the remedial works and requirements which will be presented to BCC for further consideration. Through various surveys and consultation significant remediation works have been recommended to remediate the roof, works such as strengthening works to the roof trusses and associated timbers, replacement of concrete guttering works carried out in accordance with heritage requirements.

'Fruiting bodies' and dry/wet rot discovered

Arup and LB have specified repairs and remedial works to suit on site conditions and discoveries. These works are now ongoing.

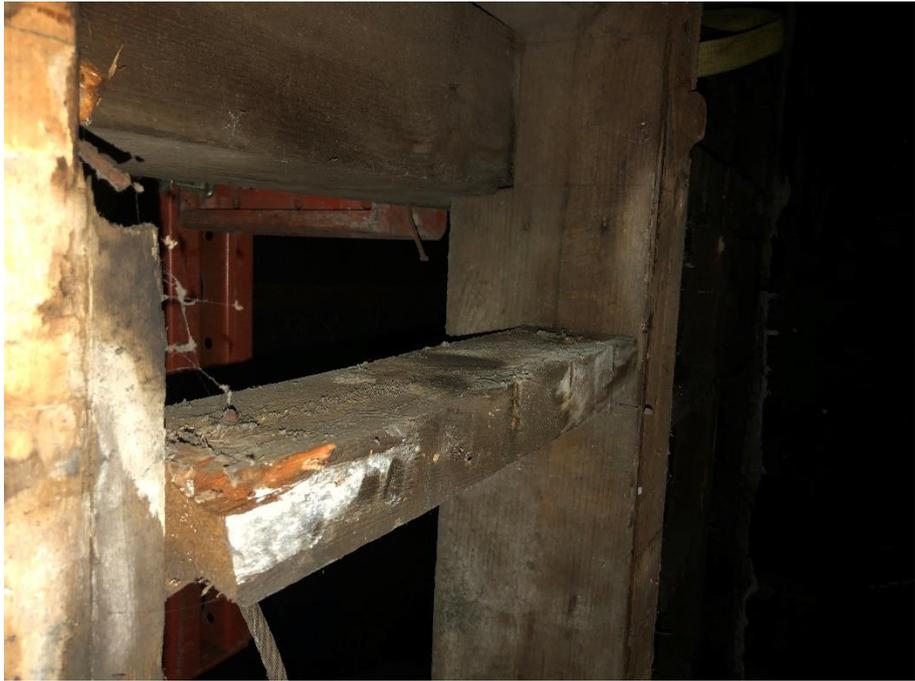
Poor condition timbers

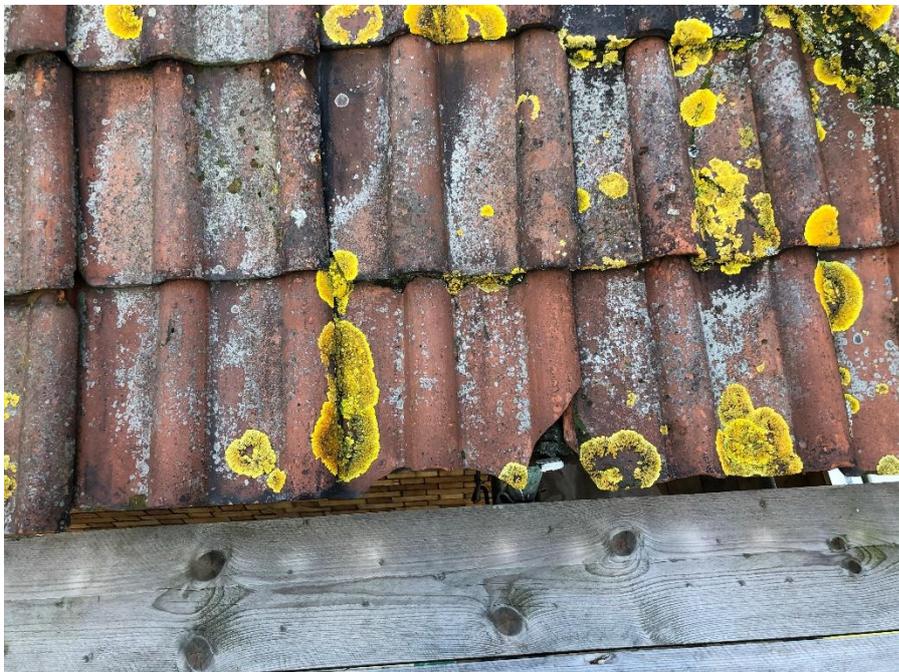
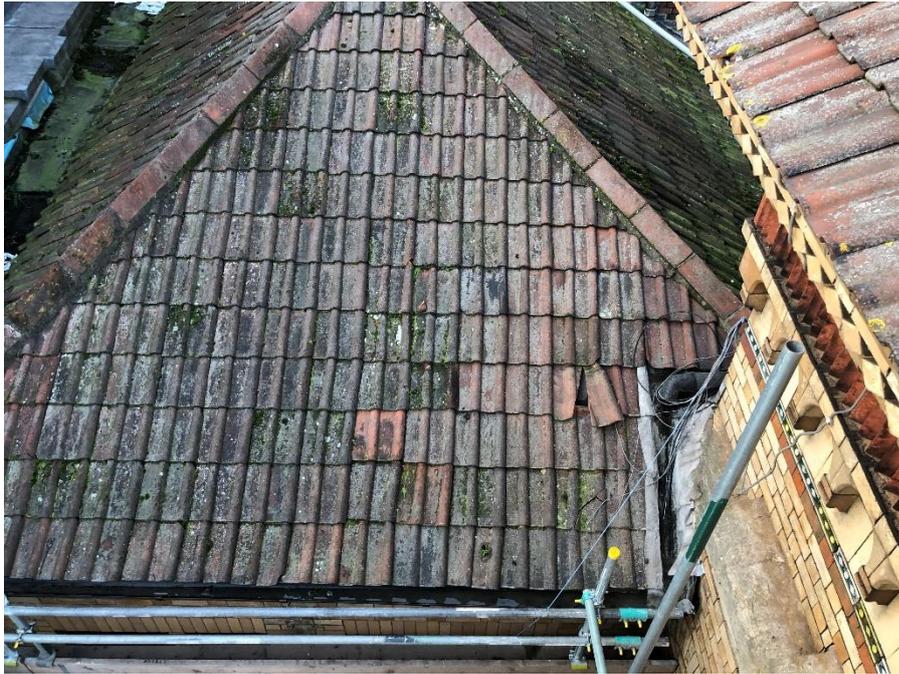
Poor condition of lead flashings and cracked tiles

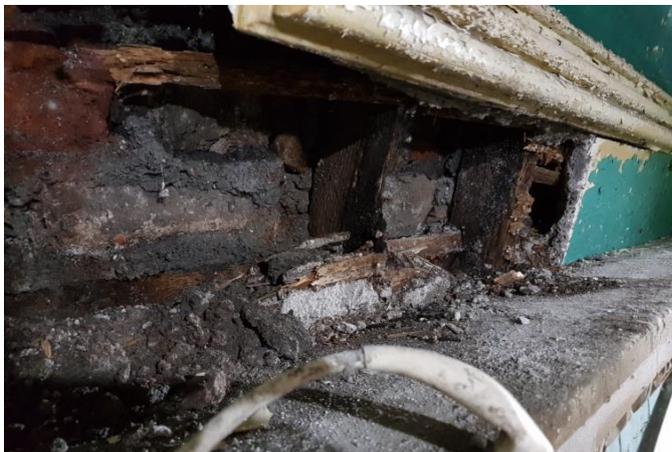
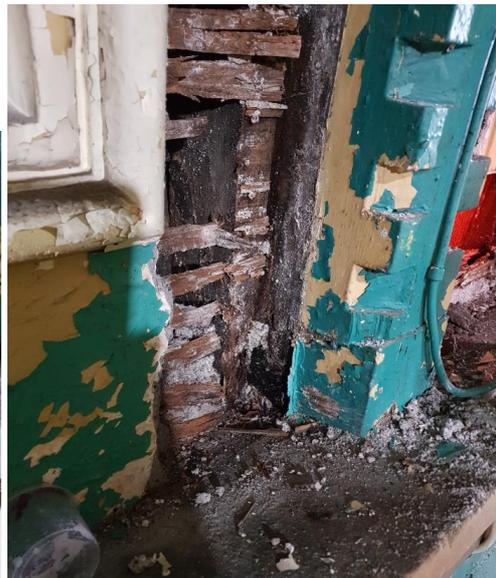
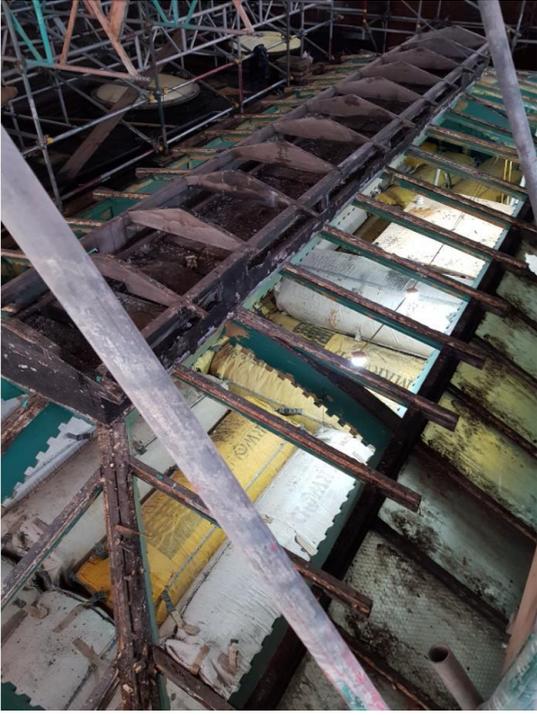
Lantern rooflight

Structural investigations in preparation for the restoration of the lantern and lantern rooflight have been carried out discovering that the rooflight structural integrity has been compromised further. Opening-up works revealed significant rot to the base of the structural timber frame caused by water ingress. To prevent further water ingress and allow timber and plaster restoration works including replacing the glazing to continue, a temporary roof has been installed, covering the lantern rooflight to allow these repair works to continue and for more areas to be investigated.

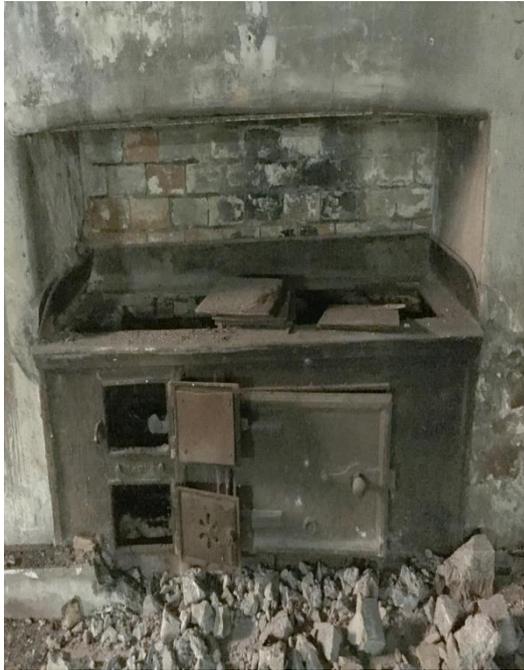
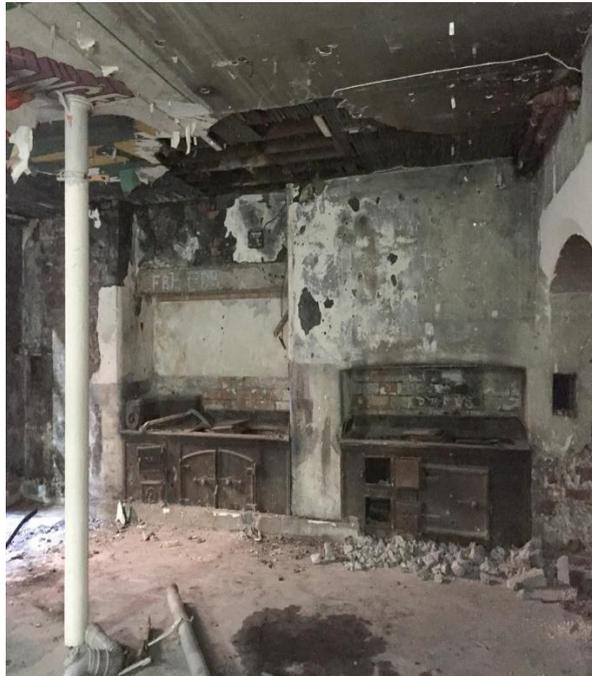
Victorian stoves uncovered during soft strip works.
