Underfall Yard MEICA Inspection Report

24 May 2019

Bristol City Council

Document reference: WS1718-MEICA-INSP-B01

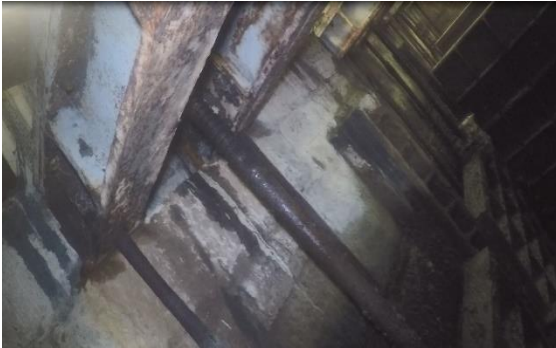
Some minor corrosion was found at the top of the actuator rising stem of sluice gate one. This is shown in Figure 4. Some marine growth and zebra mussels were found at the base of the stem. This is shown in Figure 5. A significant amount of zebra mussels was found on the gates which increased towards the centre of the gate as shown in Figure 6.

Figure 4: Corrosion on actuator rising stem - main sluice gate 1

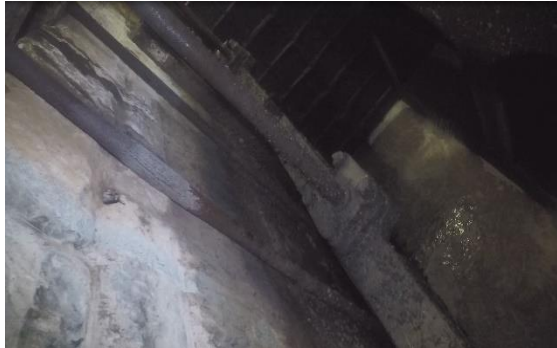
Figure 5: Zebra mussels and corrosion on actuator rising stem base - main sluice gate 1

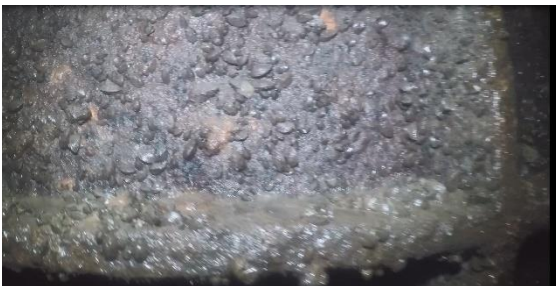
Figure 6: Corrosion and zebra mussels - main sluice gate 1

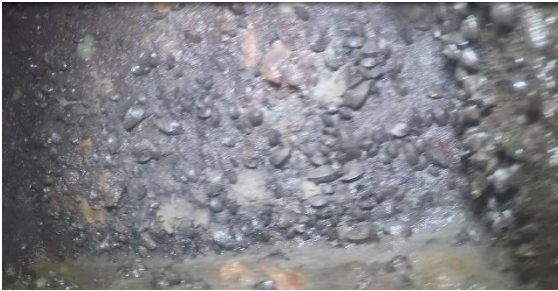
Significant amounts of zebra mussels and marine growth were found on the main sluice gate no.2, which increased towards the centre of the gate as shown in Figure 7. Patches of surface corrosion were found at the bottom of all gate's flanges (Figure 8). All rivets, nuts and bolts were intact.

Figure 7: Corrosion and zebra mussels – main sluice gate 2

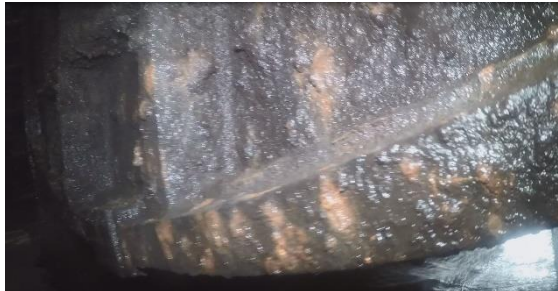
Figure 8: Moderate corrosion on the bottom flange - main sluice gate 2

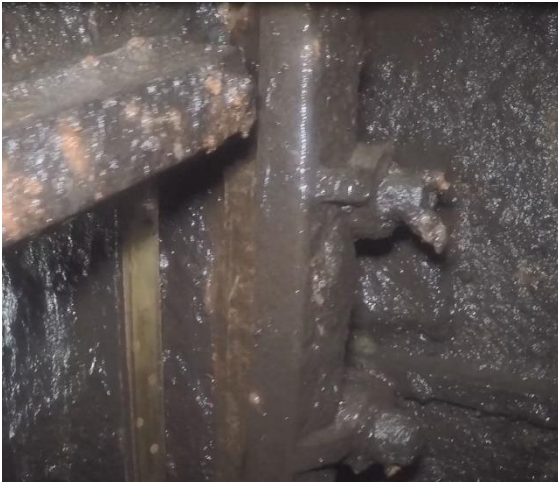
The guides appeared to have corroded to an undetermined depth; this is shown in Figure 9. The parts of the bronze seal on the side of the gate, which could be seen, were in good condition. A redundant corroded pole, which ran to the top of the chamber, is shown in Figure 10.

Figure 9: Corroded gate and guide – main sluice gate 2

It is recommended that the wear on the guides is monitored and recorded regularly. Monitoring of any water leakage is also recommended. This will allow more predictive, as opposed to reactive, asset management strategies.

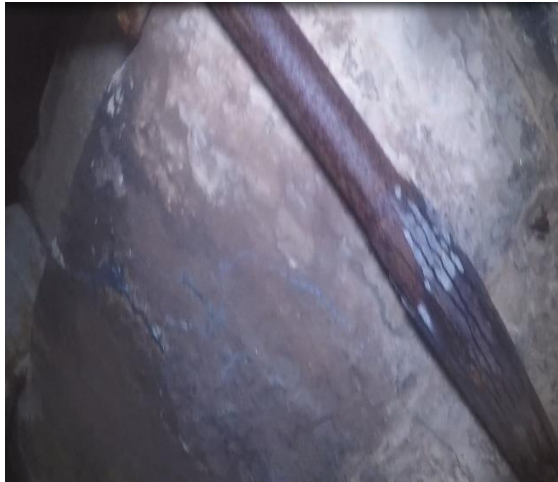
Figure 10: Corroded pole – main sluice gate 2

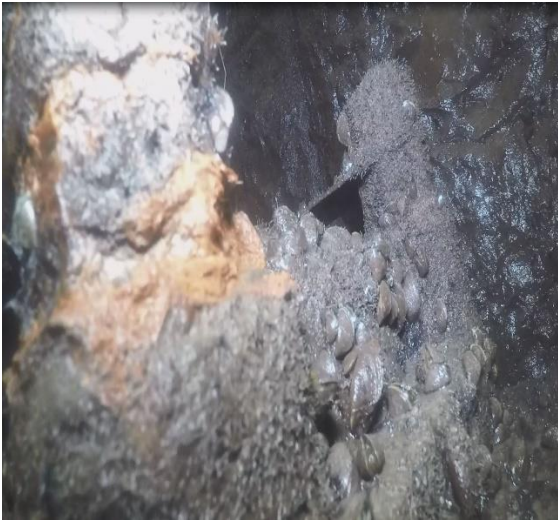
The actuator rising stem for the main sluice no.2 appears to be deflected. The operators informed the surveyors that the gate is over-driven in its closed position, which has resulted in the deflection of the stem. Some corrosion was also found on the actuator rising stem of sluice gate no.2. (Figure 11).

Figure 11 Corrosion at base of rising stem – main sluice gate 2

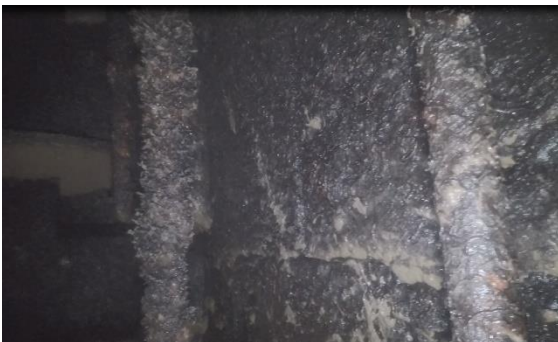
No structural defects were found on the actuator shaft for main sluice gate no.3, however some surface corrosion was present on the shaft. The redundant poles behind the sluice gate were severely corroded and covered in hard silt. They may be seen in Figure 12. There were significant amounts of hard and soft silt lodged in the corners of the sluice gate compartments which increased towards the bottom of the gate. This may be seen in Figure 13. The gate was also covered in a large amount of marine growth and was significantly corroded in some areas. The condition of the gate may be seen in Figure 14.

Figure 12: Corrosion on redundant poles– main sluice gate 3

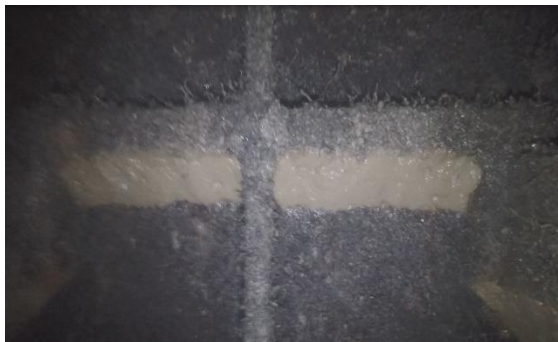
Figure 13: Siltation on gate – main sluice gate 3

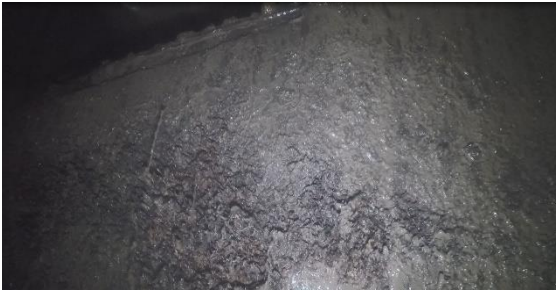
Figure 14: Condition of gate – main sluice gate 3

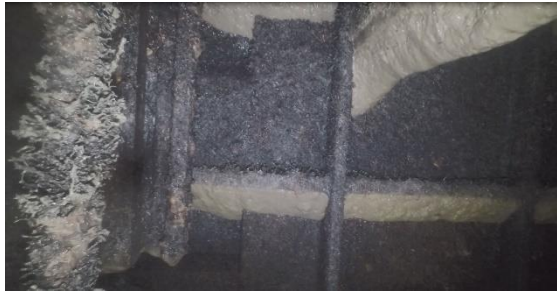
A significant amount of corrosion was also found on the sluice gate guides as shown in Figure 15. The issues found on main sluice gate three may be due to the gate being operated infrequently. This is because emergency plate 3 is neither sealed nor operational, meaning that the culverts and chamber will eventually fill to the level of the Floating Harbour.

Figure 15: Corrosion on guides– main sluice gate 3

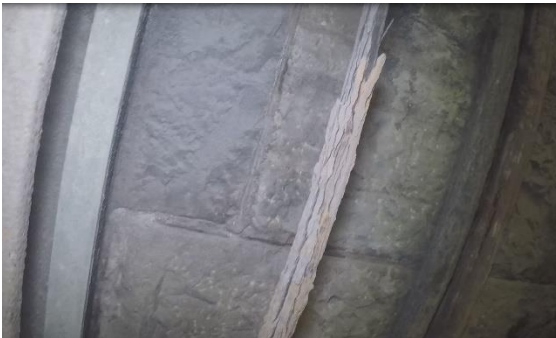
The redundant poles behind main sluice gate 4 were heavily corroded. The base of the actuator shaft was also corroded. They may be seen in Figure 16 and Figure 17 respectively. Hard silt deposits were found in the corner compartments of sluice gate 4. Otherwise the gate appeared to be in good condition.

Figure 16: Severely corroded pole – main sluice gate four

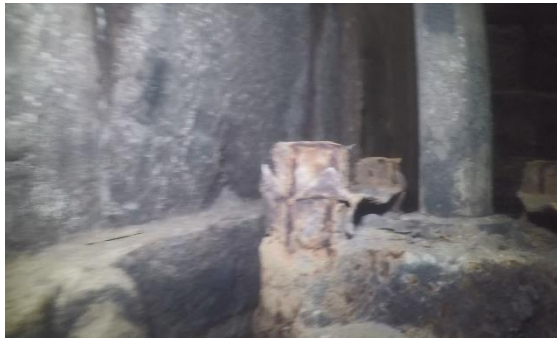
Figure 17: Actuator shaft base - main sluice gate f4

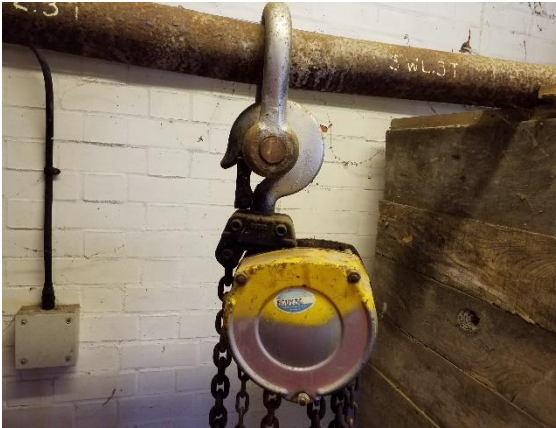
The support bar holding emergency blanking plate 3 appears to be permanently deformed under the sustained load. The Safe Working Load SWL was shown at the back and appears to be 5 tonnes for the chain block and 3 tonnes for the support bar this may be seen in Figure 22 and Figure 23. The bar showed signs of bending and failure may occur unexpectedly. No evidence was found that the lifting equipment had undergone a thorough examination under, the Lifting Operations and Lifting Equipment Regulations 1998, (LOLER) in a long time. The chain block itself appears to be in good condition. However, there is an open hook attached to the gate which is not secure, and there are no guide grooves on the wall of blanking plate 3, so there is nothing preventing the gate from detaching.

Figure 22: Chain block – emergency plate three

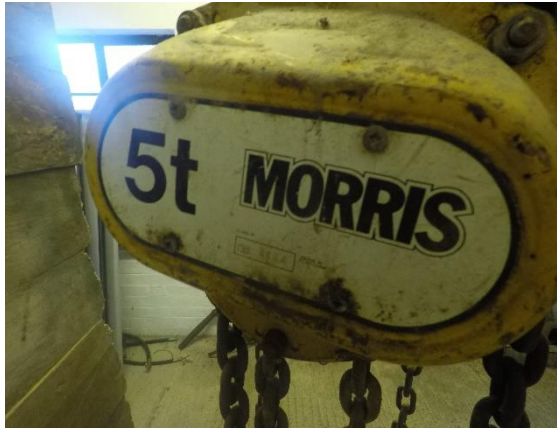
Figure 23: Back of Chain block – emergency plate three

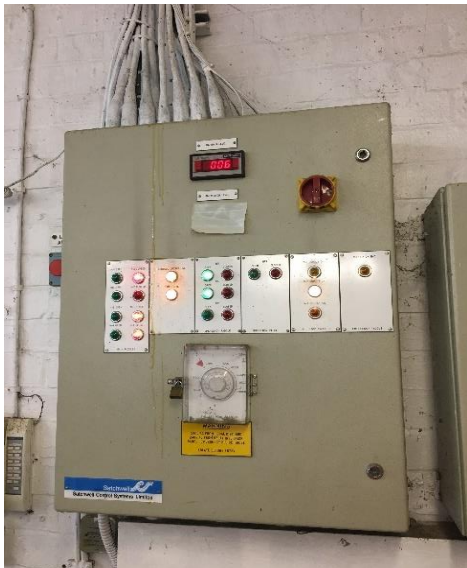
The main sluices control panel has signs of physical wear. The dial switch which controls the level of the harbour has a padlocked cover which is easily accessible with just a pin as the cover does not close firmly. This could trigger unwanted harbour levels when the area is accessed by unauthorised personnel. Signs should have been posted on the entrance to warn for authorised personnel access only. The lock should also be removed, and a new cover should be placed over the dial switch. The panel has a level display socket which is not used and covered with a piece of tape, therefore this could possibly reduce the ingress protection level of the panel. Additionally, not all indication LEDs are functional.

Figure 28: Main sluices main control panel

- As described in detail in section 5.2.1 the main sluice gate control panel has signs of physical wear and needs to be repaired. The dial level switch cover, functional LEDs which are not functional and seal slots which are not in use all need to be repaired or replaced.
- Panels with moderate to fair corrosion should be scheduled for replacement to ensure secure operation in the long term.
- Replacement of main sluice gate actuators 3 and 4 to ensure future reliability.
- Warning signs to be installed on the entrances of both the emergency sluices room and main sluices room to warn for authorised personnel access only.
- Lock to be removed and dial switch cover to be replaced.

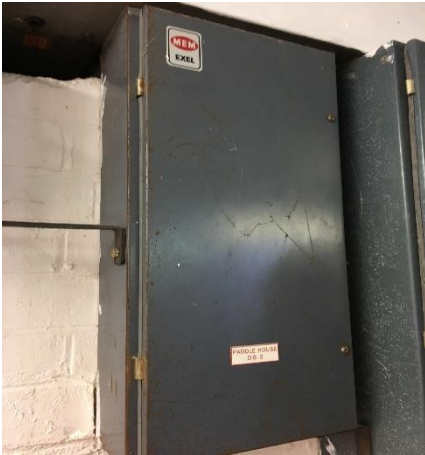
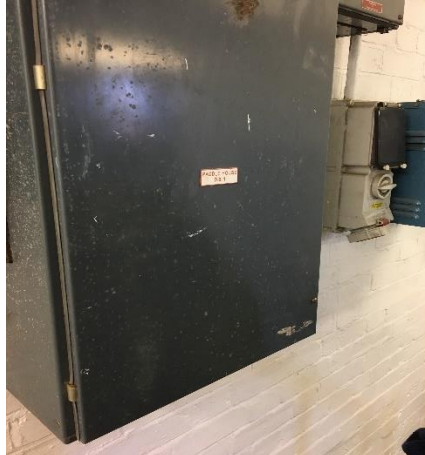
Moderate corrosion on some electrical panels was noted. In future the corrosion could affect the operation and integrity of the internal components and cabling. It is recommended that remedial works are carried out on these panels to prevent further corrosion or the other option is to replace these panels.

Figure 32: Corrosion on electrical distribution panels

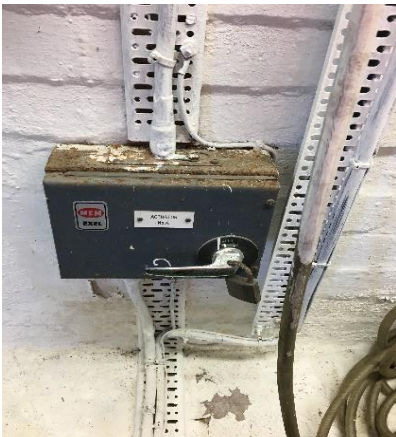
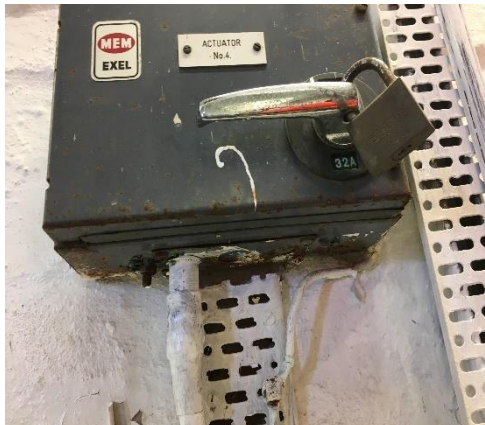
Figure 34: Corrosion on actuators isolators

Figure 34 and Figure 35 above show the actuator isolators, and Figure 36 and Figure 37 show the cable termination and glands on the sluice actuators number 2 and number 1 respectively. There are two glands which appear to be a modified installation not appropriately sized for the cable termination and covered with a piece of green and yellow insulation tape to provide insulation and cable fixing. It is recommended that these cable glands should be replaced with appropriately sized glands to ensure secure cable termination at the actuators.

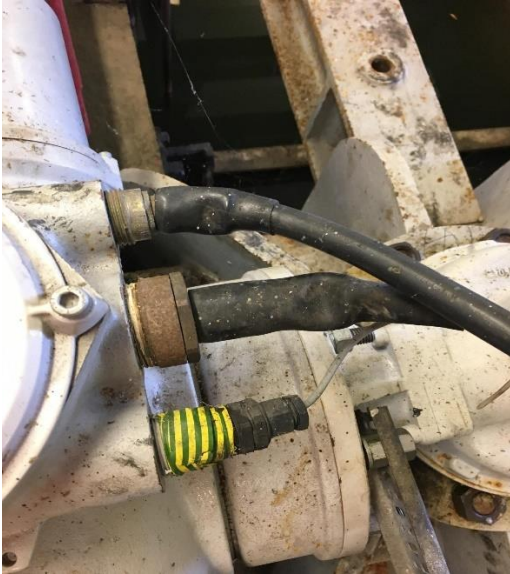
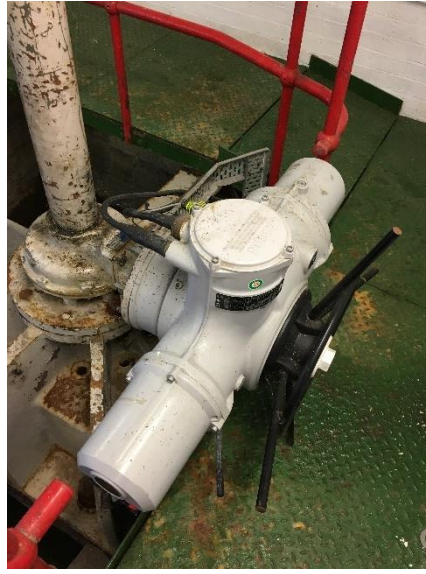
Figure 36: Actuator No.2 cable glands

- Cable glands on actuators which are not appropriately sized should be replaced with appropriately sized glands to ensure secure cable termination.
- Painted over cable terminations and equipotential bonding should be inspected and tested in accordance to the procedures by BS7671 wiring regulation to ensure conductors integrity and good continuity of electrical path.

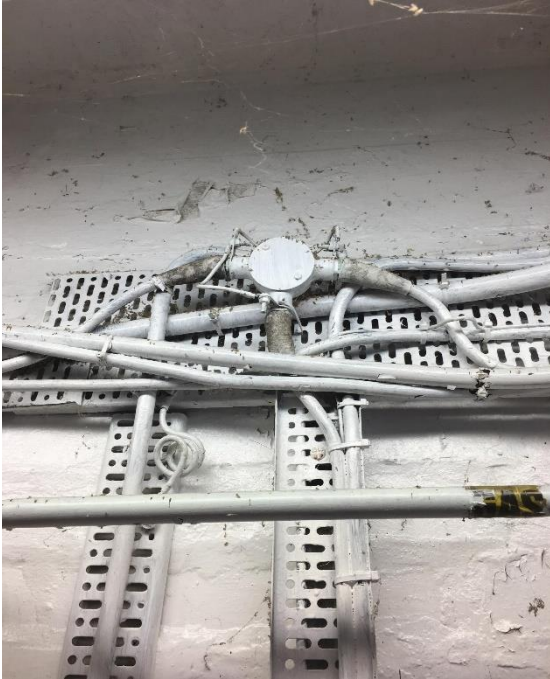
There are cables and earthing lugs covered in paint as shown in Figure 38 following cable installation. This is not considered to be good practice as it will possibly cover any cable insulation defects and make them difficult to detect. Also, the painting of the cable terminals could reduce the cable conductance. In Figure 38 it can be seen that some parts of the cable conduits are deteriorated and should be restored locally to enhance the conduit protection.

Figure 38: Painted cables and earthing lugs

- Painted cable conduits should be further inspected for physical wear and restored where damage is detected in the appropriate manner to ensure cable good cable insulation.

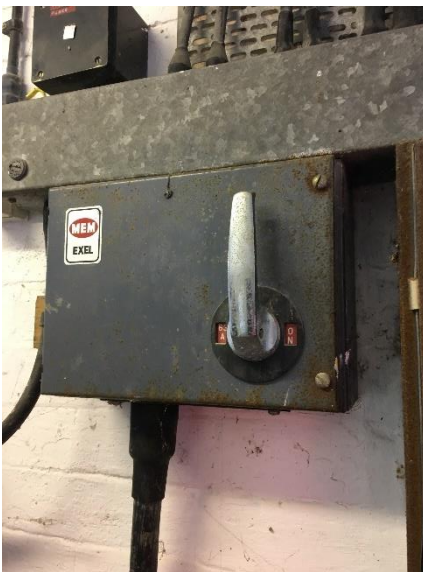
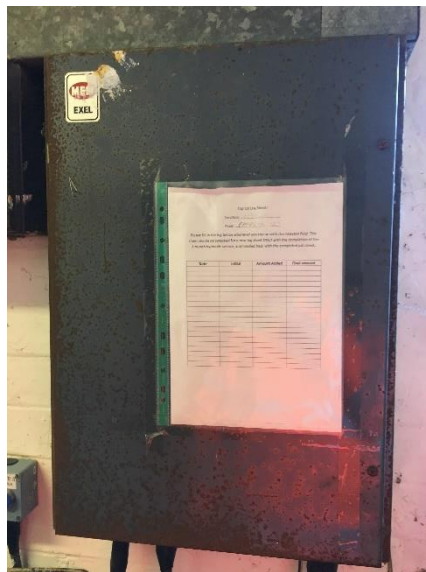
The electrical isolator and the distribution panel within Underfall Yard shown in Figure 43 and Figure 44 are both fairly corroded. In future this could possibly have a negative impact on the normal operation and integrity of the internal components and cabling. therefore these panels need to be replaced.

Figure 43: Corroded local isolator

Figure 44: Corroded electrical distribution panel

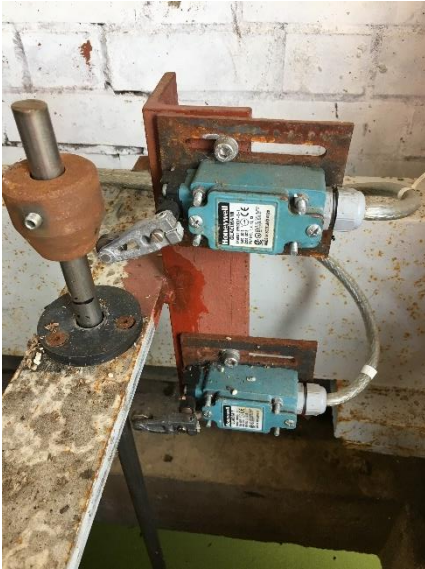
Additionally, the bracket which supports the sluice gate number one limit switches are heavily corroded, as can be seen from Figure 45, and needs to be replaced to ensure secure support of the switches in the future.

Figure 45: Corroded Limit switch bracket

- Frequent inspection schedules to be set in place for the installation inspection in terms of good cable insulation, security and integrity.
- Replacement of heavily rusted limit switch brackets.

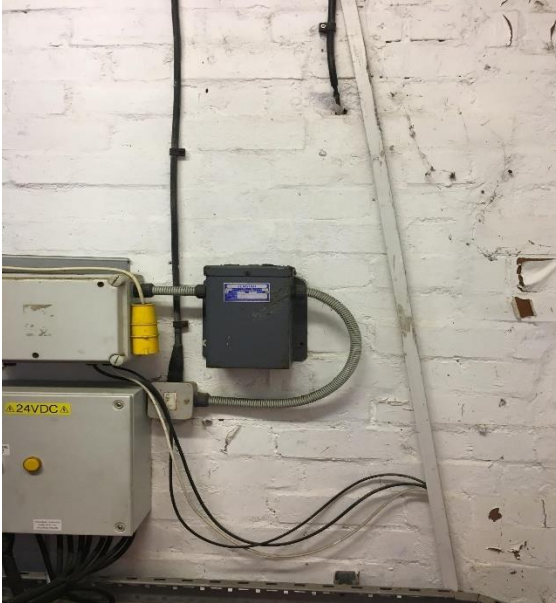
Examples of unsupported cables can be seen in Figure 47 where the cables of the limit switches are not securely fixed on the wallside via cable trunking. All unsupported cable installations should be rectified utilising appropriate cable trunking to provide cable protection.

Figure 47: Unsupported cables

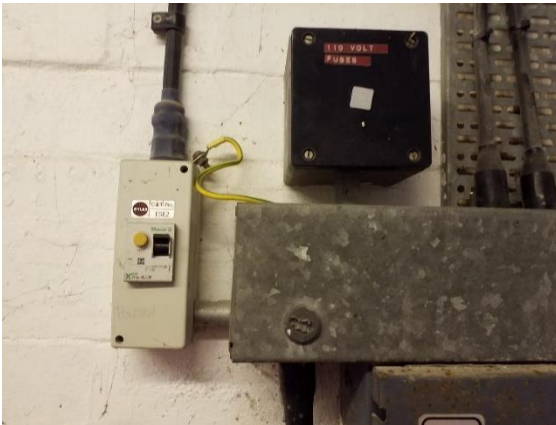
Figure 49 shows a free earthing lug not fixed in place. It is not confirmed where the earthing lug was connected to; however, a free earthing lug could compromise the installation bonding and personnel safety. Therefore, it shall be checked whether it forms parts of an active circuit and reconnected back in place as required.

Figure 49: Broken earthing lug

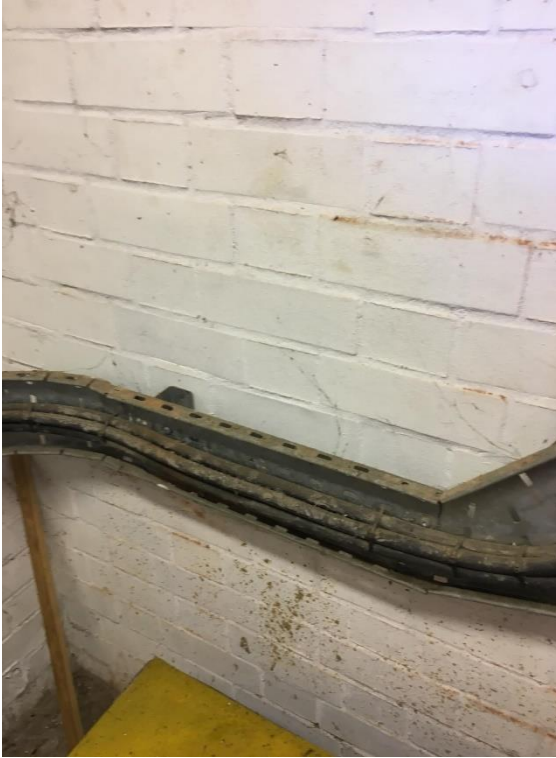
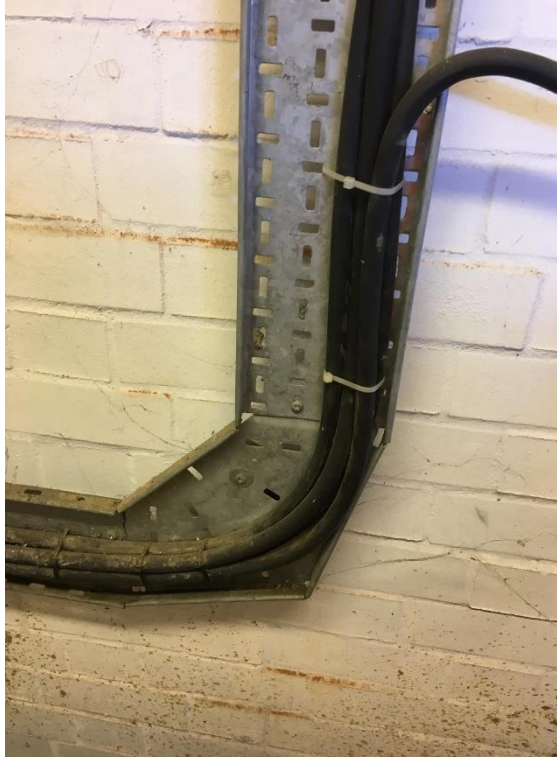
On several sections of cable tray, shown in figures Figure 50 and Figure 51 it appears that there is no earth bonding conductors between the cable tray sections. Additional bonding may be required to provide an equipotential bonding system. This shall be further investigated and any

installation required to be by a competent electrical subcontractor. Installation and the continuity tests shall be in accordance to the BS7671 wiring regulations.
