# Bristol Beacon

## Technical Report

30 November 2022

# Post DoV Impact of Delays on Construction Programme

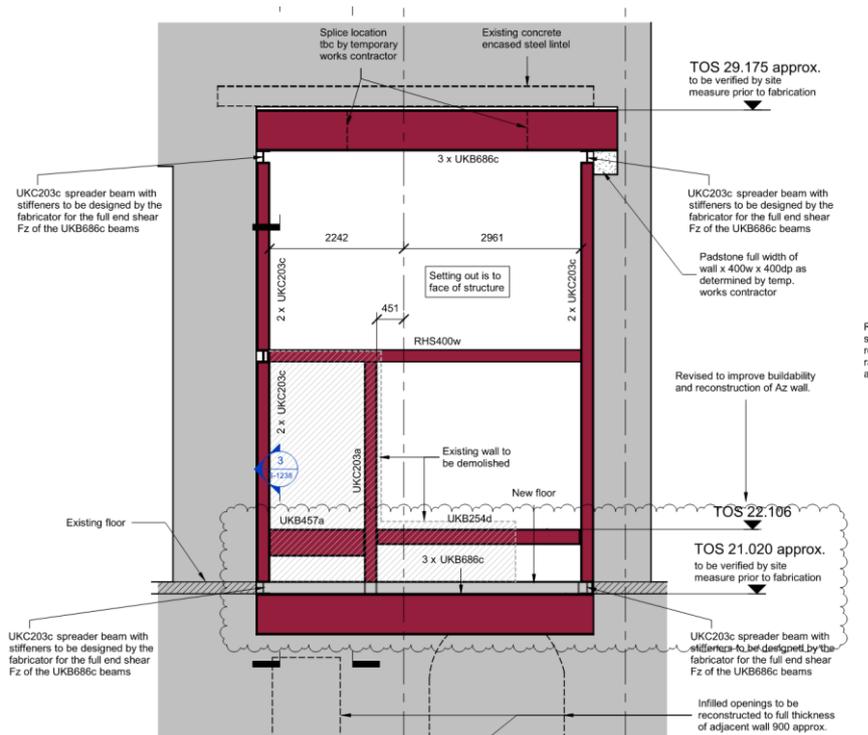
Extract from DR-S-1238

The new Wing Wall steelwork frames support a significant load of masonry above and also supports the new roof trusses over the stage. The existing openings had to be enlarged, both horizontally and vertically. The main construction issues were related to the complex temporary works (as explained in the next section).

During cutting back of the masonry to install the steelwork, the Contractor identified what it considered was a weaker band of random stone masonry below stage level on the Colston St side. The Contractor had concerns about this rubbly masonry as it was located directly underneath a highly loaded pier. Whilst ultimately remedial works to this rubbly material were not required, checks had to be made.

On the Trenchard St side, the cutting of the masonry arches to form the opening for the stage lift revealed the bottom of a previously unknown flue. In particular, the vertical route of the flue was not known but it was considered likely to pass underneath a highly stressed, masonry pier of the Wing Wall. It was therefore considered important to trace the flue and grout it up to ensure the support to the existing pier was sound and adequate. Tracing the flue proved difficult due the presence of a large cobble blocking the tracing rods at a bend. Attempts to dislodge the cobble were unsuccessful. Horizontal cores to locate the flue/dislodge cobble were drilled but were unsuccessful. A series of vertical small pilot holes were drilled around the base of the masonry pier and water was poured down each one. One pilot hole was found to connect with the flue. This allowed the flue to be pressure grouted so as to ensure all voids under the masonry pier were fully filled.

An additional splice connection in the steelwork was also introduced to facilitate installation of the steelwork.

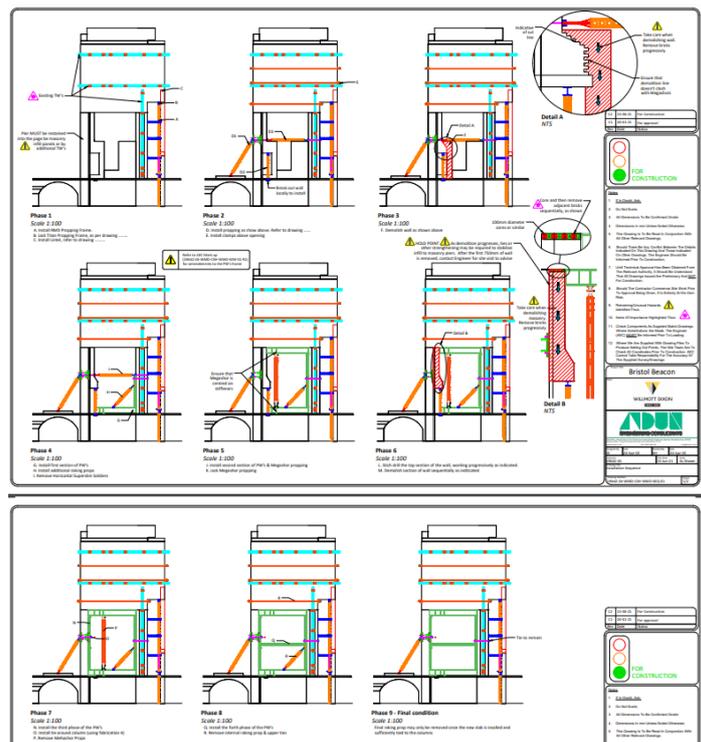
The initial proposal was to incorporate two columns per side within the required aperture, meaning that, when the loads were applied, each column had to withstand a factored axial loading of 1200kN x 2 (240 Tons). This was a significant design challenge and for it to be successful the sequence of works was paramount.

Due to the slender nature of the columns and incoming steelwork the points of connection required significant strengthening and this was achieved with heavy wrap around plated bracketry placed at three levels per side.

In order to avoid collapse whilst carrying out these works a strict methodology had to be followed. However, when the works began on the Trenchard St side, the chimney flue was discovered. Works could not continue until the investigation and subsequent remediation works to the flue were carried out.

The drawing below illustrates the complexity of the Contractor's construction sequence for the revised wing wall steelwork installation (including temporary works).

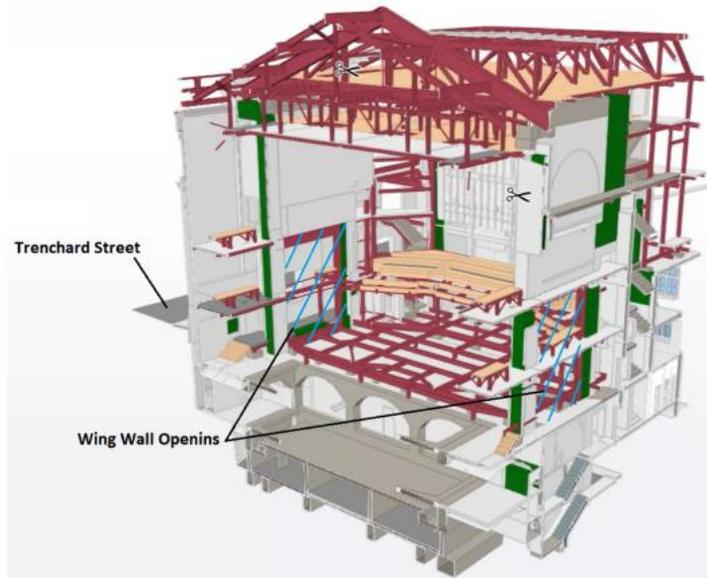
On the Trenchard St side, access had been difficult due to the extensive temporary works and rebuilding of the masonry around Stair 7. Once access was afforded in July 2021, it was observed that the lintels supporting a spandrel panel of masonry between the wing wall pier and the external walls were corroded. Access also allowed the Contractor to review its methodology and sequence and it was observed that the masonry panel obstructed the cutting of the masonry back to the correct line. The spandrel panel tied the masonry pier to the external wall and its removal required temporary works to replace the restraint which would be lost when the panel was removed.

To accord with the Architect's design intent, two openings through the spandrel were required to pass from the side balconies to back of house. The associated demolition cut was required directly to the rear of the Masonry Columns referred to above.

With the intricacy of adjacent Wing Wall works and the safety issues surrounding anything directly attached thereto, a normal demolition could not be considered.

To achieve the end goal, a revised design required steelwork to be wall mounted within an existing aperture below and to provide lateral restraint to the rear of the Wing Wall Column, before the required opening was formed.

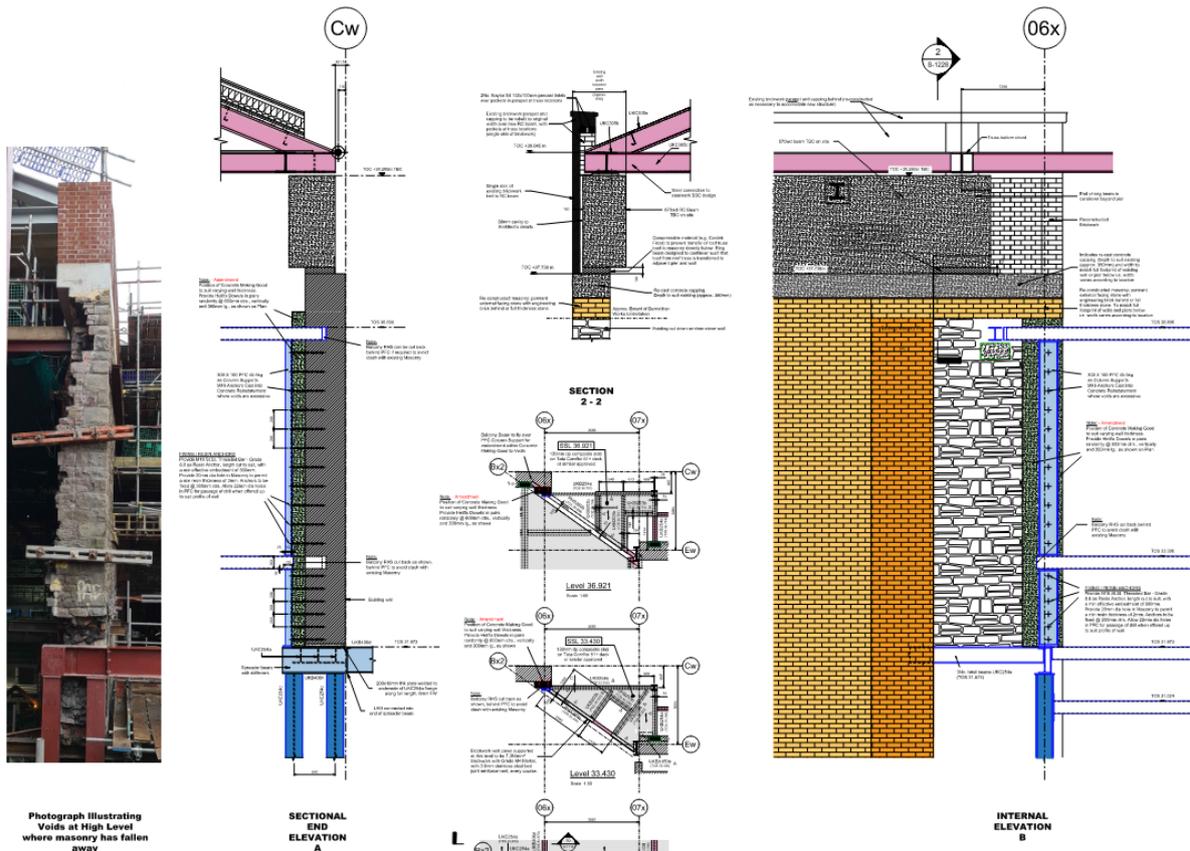
Photograph Illustrating Voids at High Level where masonry has fallen away

The main alterations to Stair 7 are associated with an Early Warning Notice, issued on 04/03/22, which stated *“While attempting to form the padstone at GL Aw/06x on level 6, it became apparent that the existing stone, rubble infilled wall, was unstable. To avoid collapse we immediately removed the unstable elements. Following completion of the padstone and concrete of steel this element will require rebuilding by specialist due to the conservation element of this façade”*.

A visit to site concluded that the wall required stabilising by the addition of steelwork, bolted into the face of the masonry. Works to this area were stopped and temporary measures were put in place to ensure the temporary stability of the wall until the permanent steelwork strengthening details were issued, fabricated and installed.

The review of the Contractor’s structural engineer’s structural proposals issued on 15/03/22, was subsequently re-badged and issued to the PMO on 16/03/22 as the structural designer’s drawing S-1641C01. S-1641C02 was issued on 13/05/22 and included minor amendments – including concrete making good to the inside face of the wall.

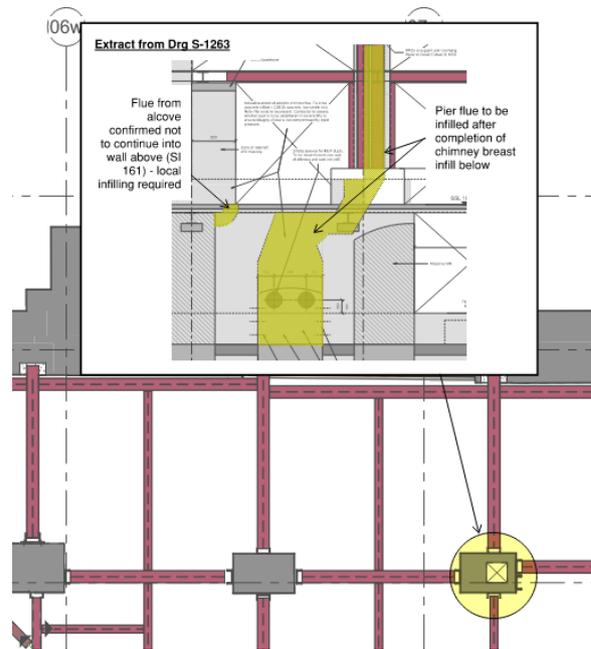
Extract from Sk-S-2044

- Defects in the existing structure, hidden behind finishes, continued to be discovered as the finishes were removed and/or as access was provided, including various cracks and defects in existing masonry walls. Also, Hall 2 roof rot was only discovered when a subcontractor started undertaking plaster repairs. The discovery of soft plaster led to investigation/opening up which identified further timber rot even though none had previously been observed.
- Defects in the existing structure only became visible when new works were undertaken, such as when walls were cut back to form new openings or padstones were formed, revealing defects

and flues, e.g., Various flue infills: Sk-S-2044 (Hall 2, 16/04/22), Sk-S-2045 (Lantern, 16/04/22), Sk-S-2160 (Restaurant Pier, 02/11/21), SK-S-2176 (toilet block, 18/05/22).

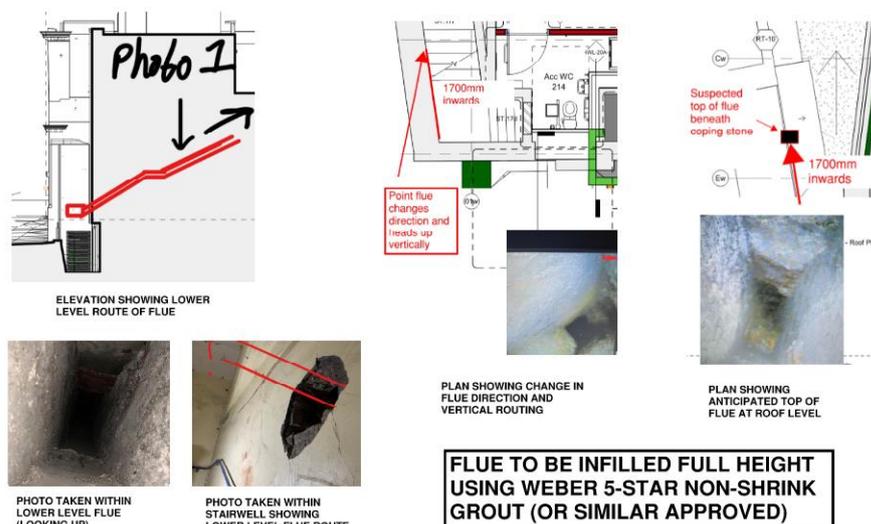
Extract from Sk-S-2176

The existing horizontal chimney flue structure was not as expected and this impacted on the new structure, requiring further checks and/or design changes, e.g., an almost horizontal flue in the toilet block was discovered that required grouting up to stabilise the wall. SK-S-2176, issued 18/05/22.

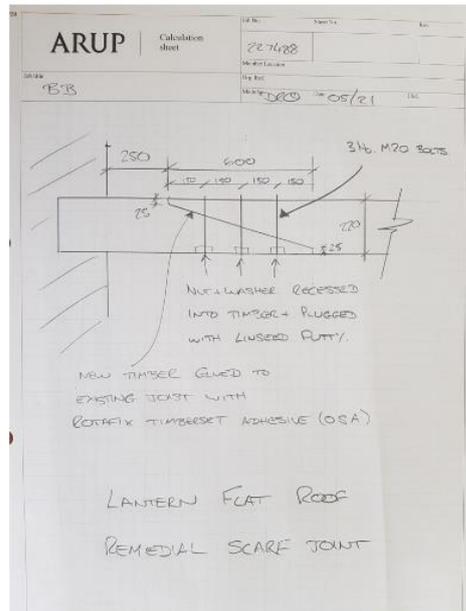
Extract from Sk-S-2139

In some areas the originally intended construction sequence was very specific. When defects were discovered, like for like replacement was not feasible as other surrounding structures prevented access. This necessitated more complicated remedial works (e.g., replacing flat roof timbers either side of Lantern where both ends were built into walls). SK-S2139 issued 16/06/21

CROSS SECTION OF SCARF DETAIL TO REPLACE ROTTEN JOIST ENDS

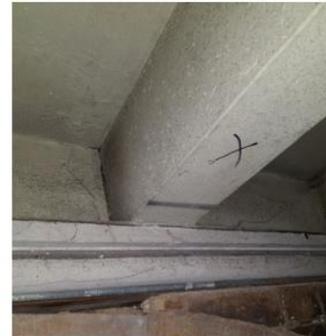
PHOTO OF TYPICAL - 120 x 220 JOIST END TO BE REMEDIATED

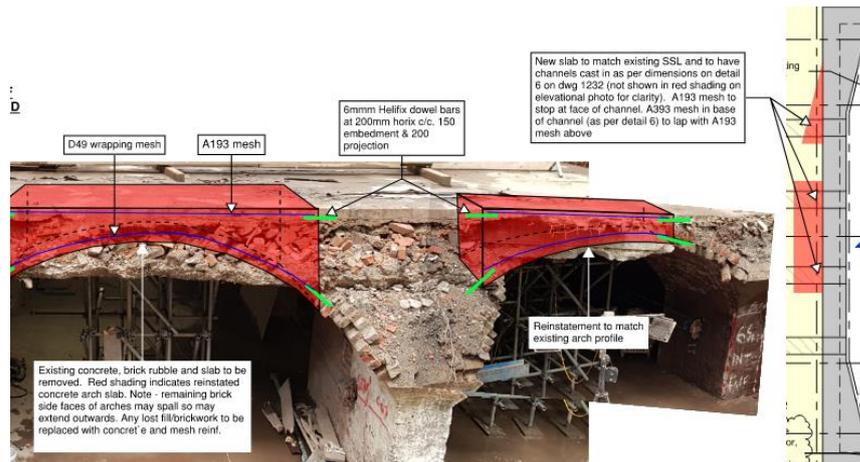
Extract from Sk-S-2131

Historic 'covered up and poorly executed' repairs or alterations continued to be found, e.g., Hall 1 Stage level where the cutting of masonry vaults to create a void for the lift revealed poor fill around concrete openings and under existing slabs. SK-S-2131 issued 14/05/21.

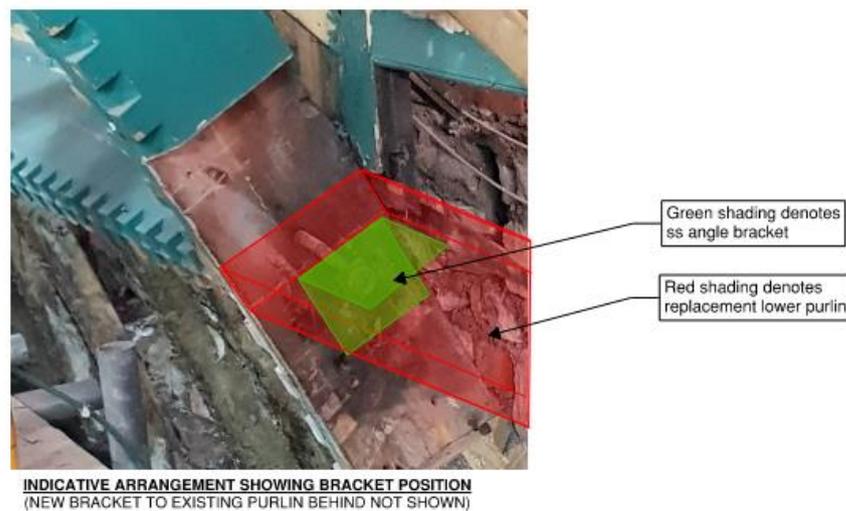
Extract from Sk-S-2128

Some defects have been found in highly stressed structural elements with the result that investigations to determine the extent, severity and repairs had to be carried out slowly and carefully to avoid undermining/damaging remaining existing structure. This often required temporary propping and frequent adaptation of existing scaffolding and or access towers e.g., wing walls (See below) and ongoing complexity of Lantern roof repairs SK-S-2128 issued 26/04/21.

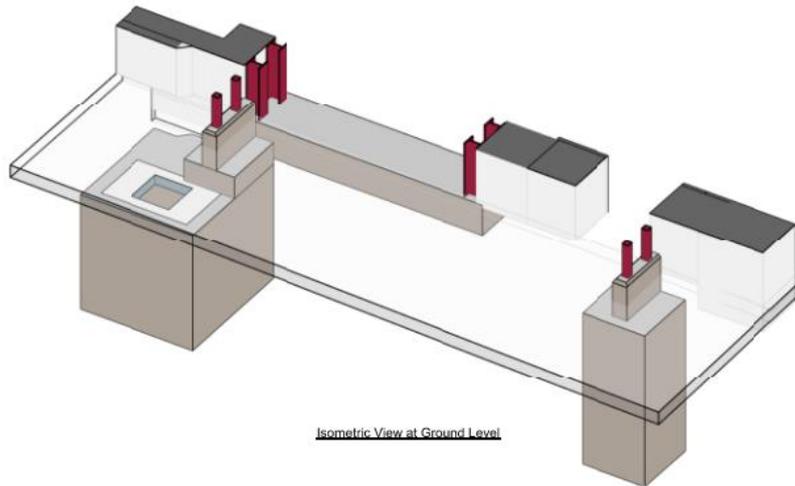
Extract from DR-S-1277

The profile/level of the quartzitic sandstone (a hard and competent rock which the foundations 'sit' on) is very erratic, resulting in areas of competent material at shallow depth which then suddenly and unexpectedly become areas of poor (soft) ground (consisting of silts and clays). This makes ground conditions in any one area extremely difficult to predict. For example:

- Piling required for the restaurant entrance portal foundation to the Colston St side. Quartzitic sandstone was found nearby at shallow depth but excavation directly under the portal column failed to find it approximately 3.5m below ground level. Further excavation risked undermining Hall 2 foundations. See DR-S-1277 and 1278 issued 25/11/21.

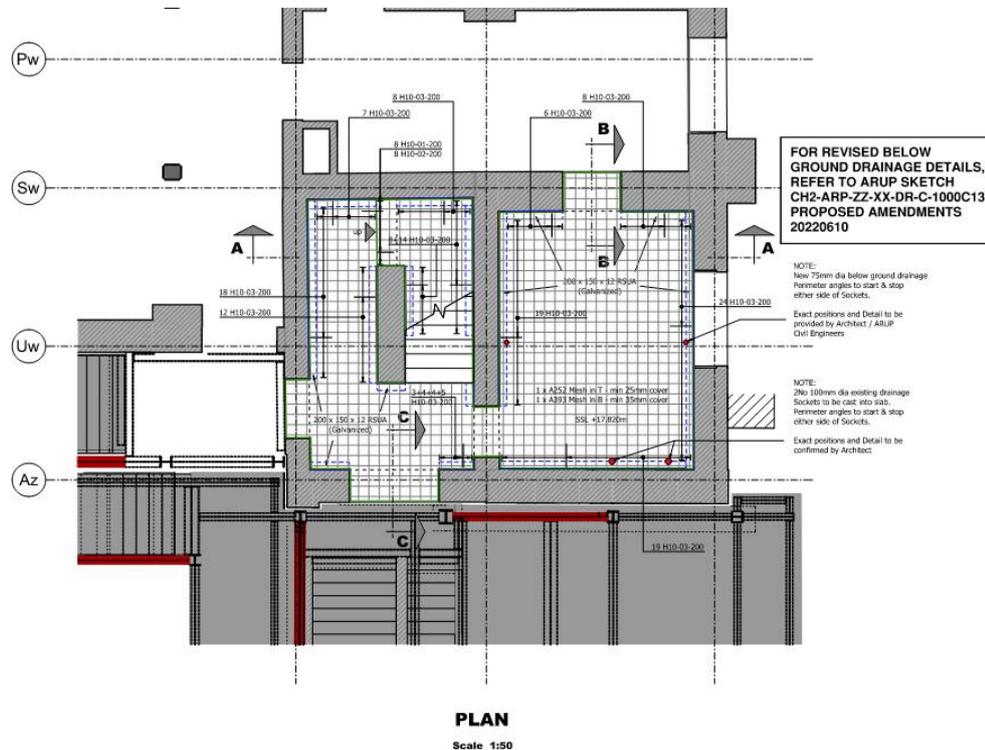
Extract from Sk-S-2178

- Replacing a ground bearing slab which had significant voids underneath it, involved installing a suspended slab on new shelf angles. See Sk-S-2178 issued 13/06/22
