Appendix A1

Examples of Condition photographs of structural elements of on Cumberland Basin

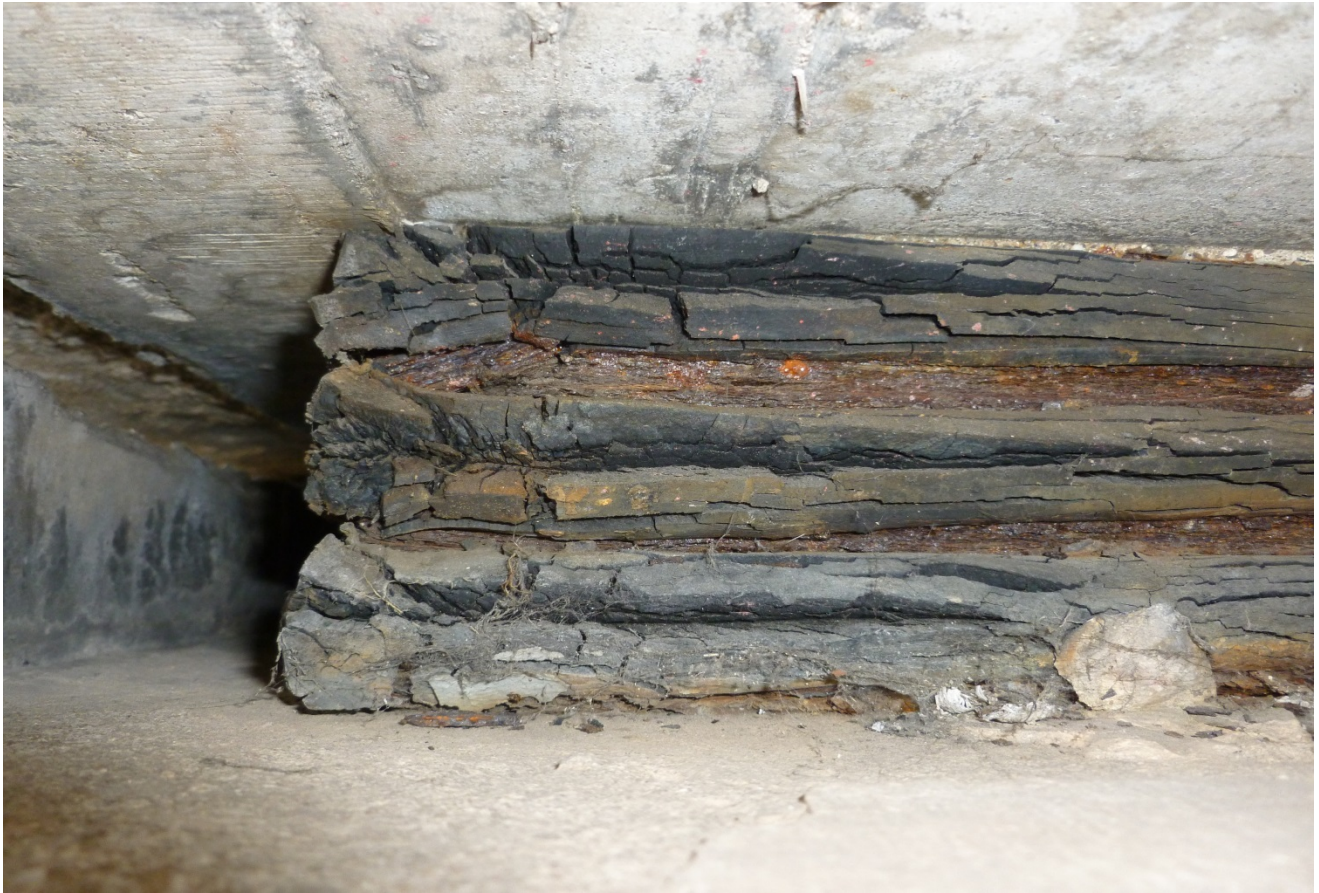
Figure 1a - Typical Example of Condition of an Elastomeric Bearing on elevated sections.

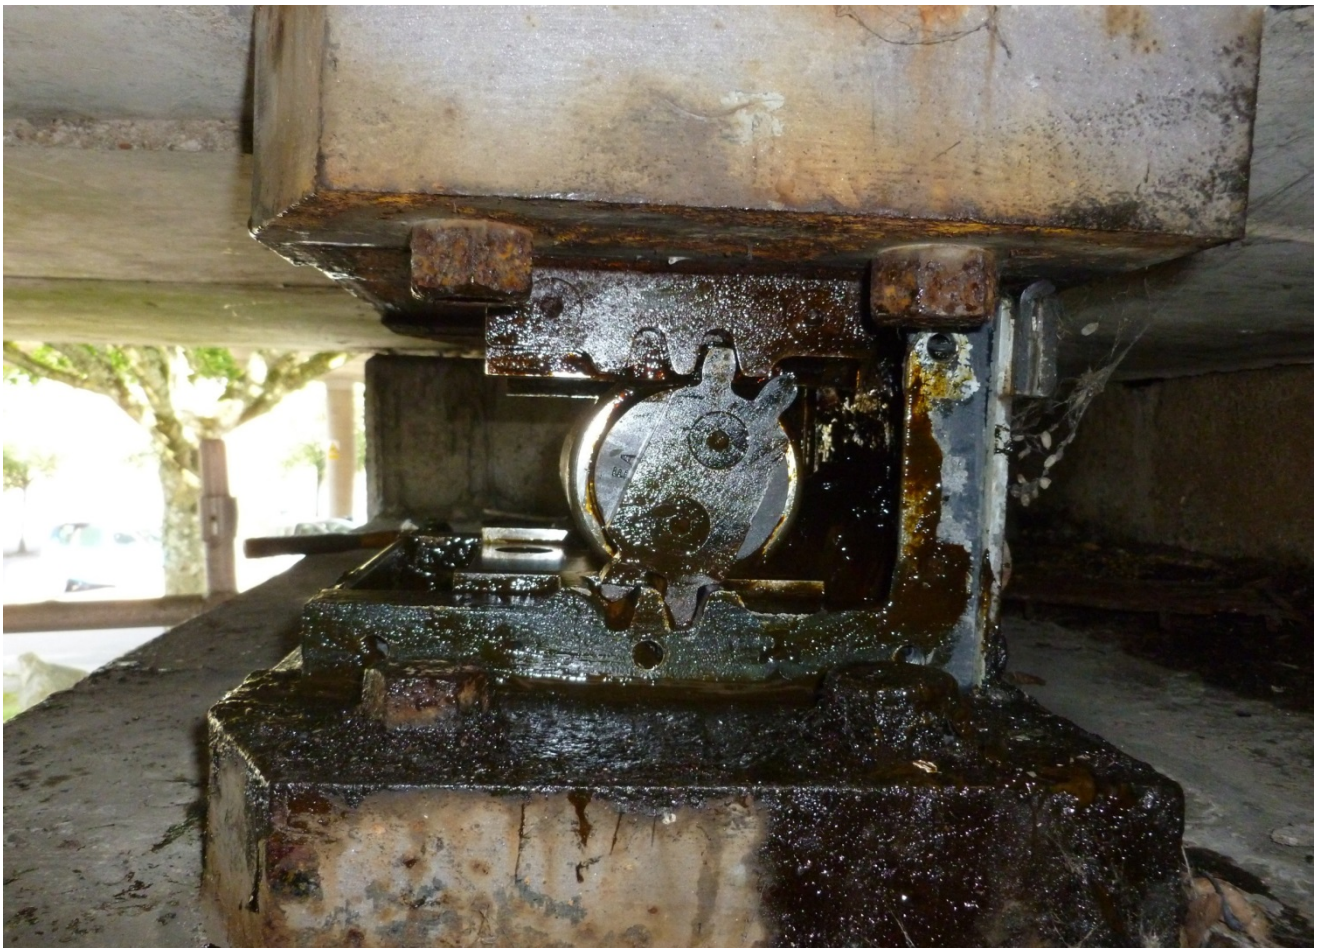
Figure 1b - Typical Example of a misaligned Roller Bearing on elevated sections.

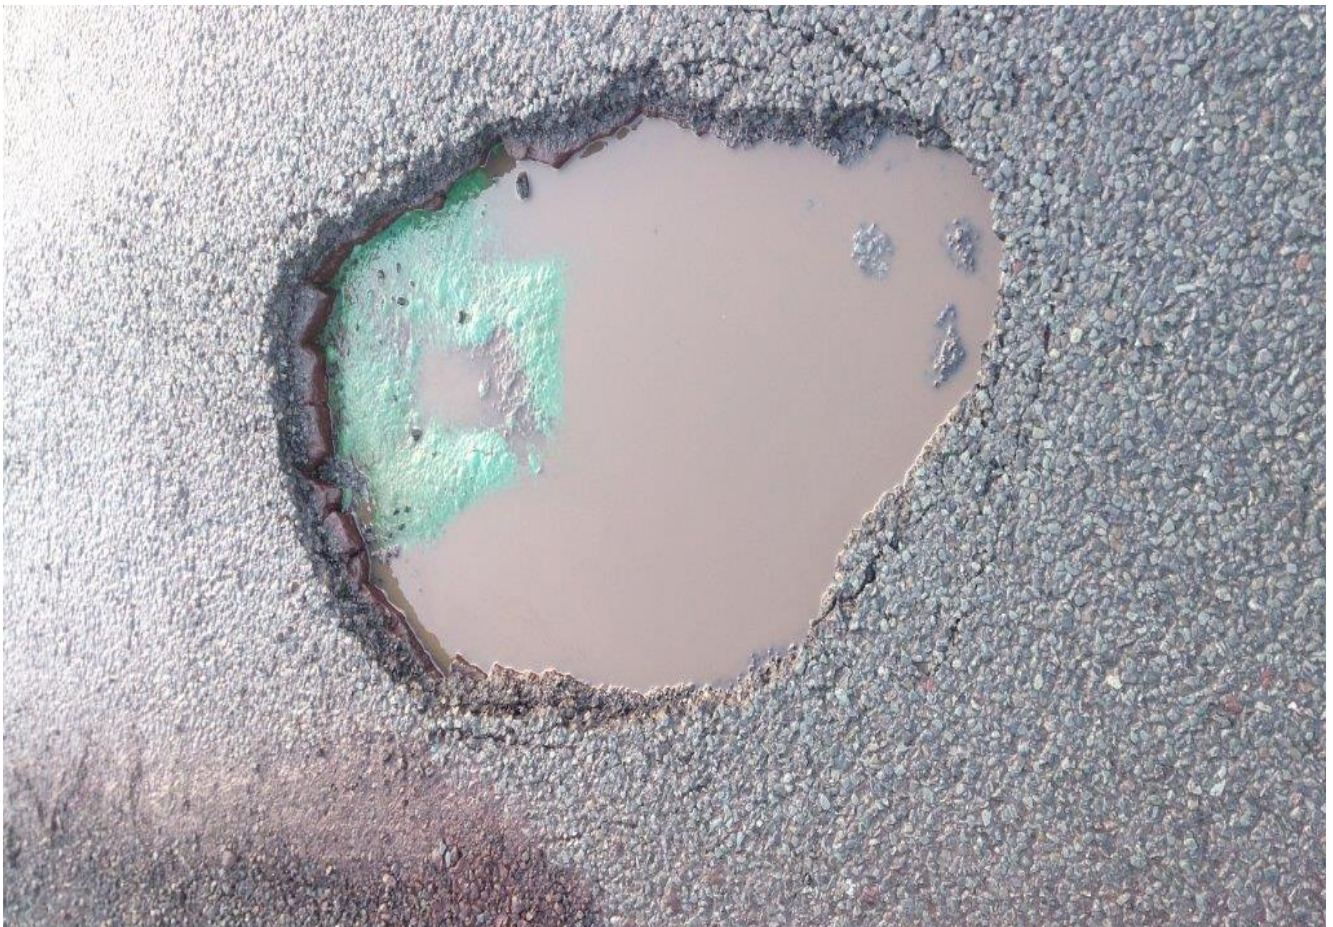
Figure 2a – Typical example of debonded waterproofing layer (in green) creating pot hole formation

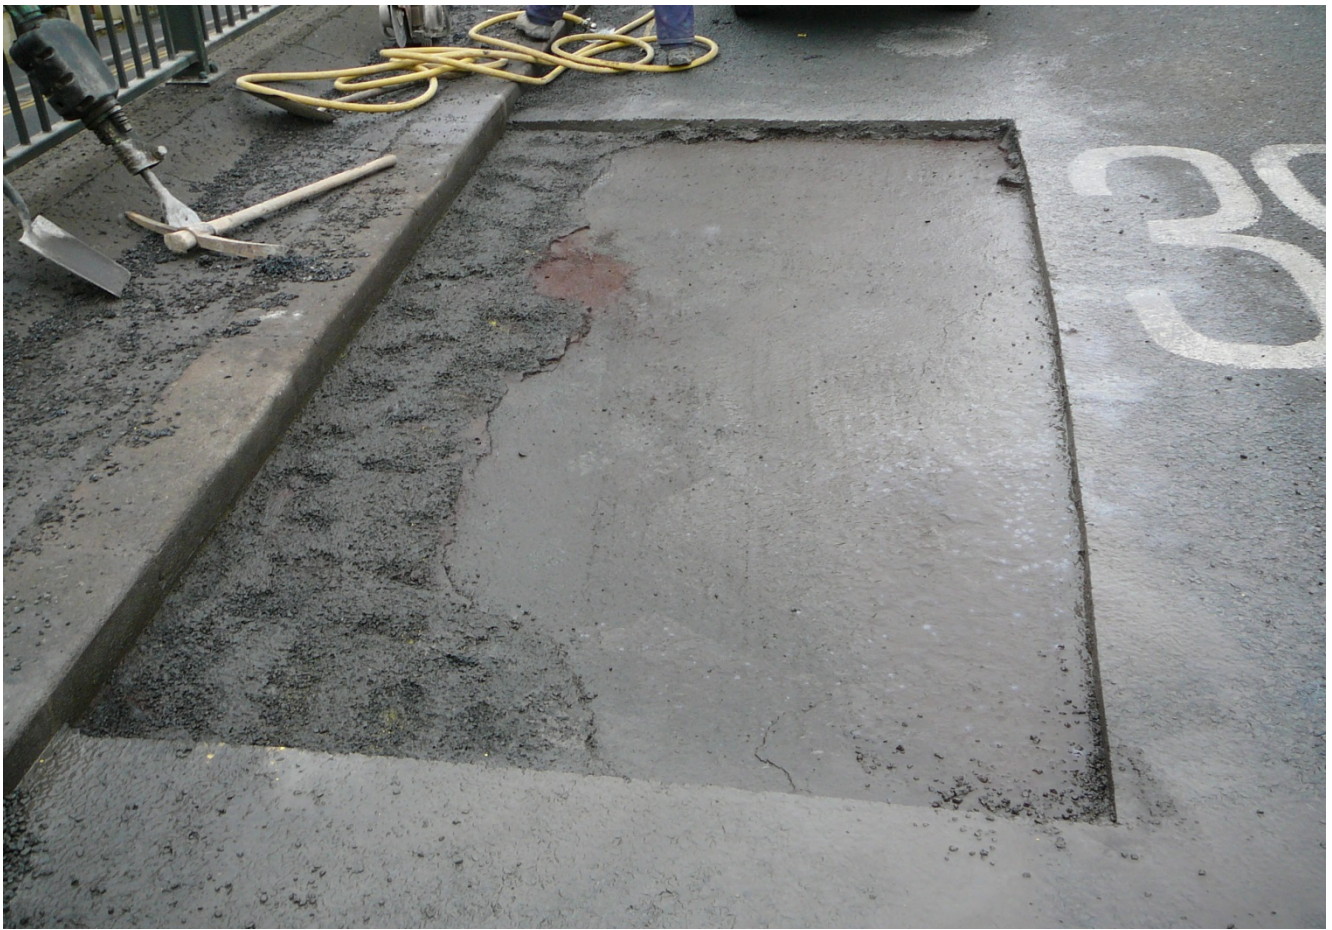
Figure 2b – Resultant pot hole repairs - Exposure of Concrete bridge decking, showing partially debonded remains of waterproofing layer being removed, prior to reinstatement of wearing course.

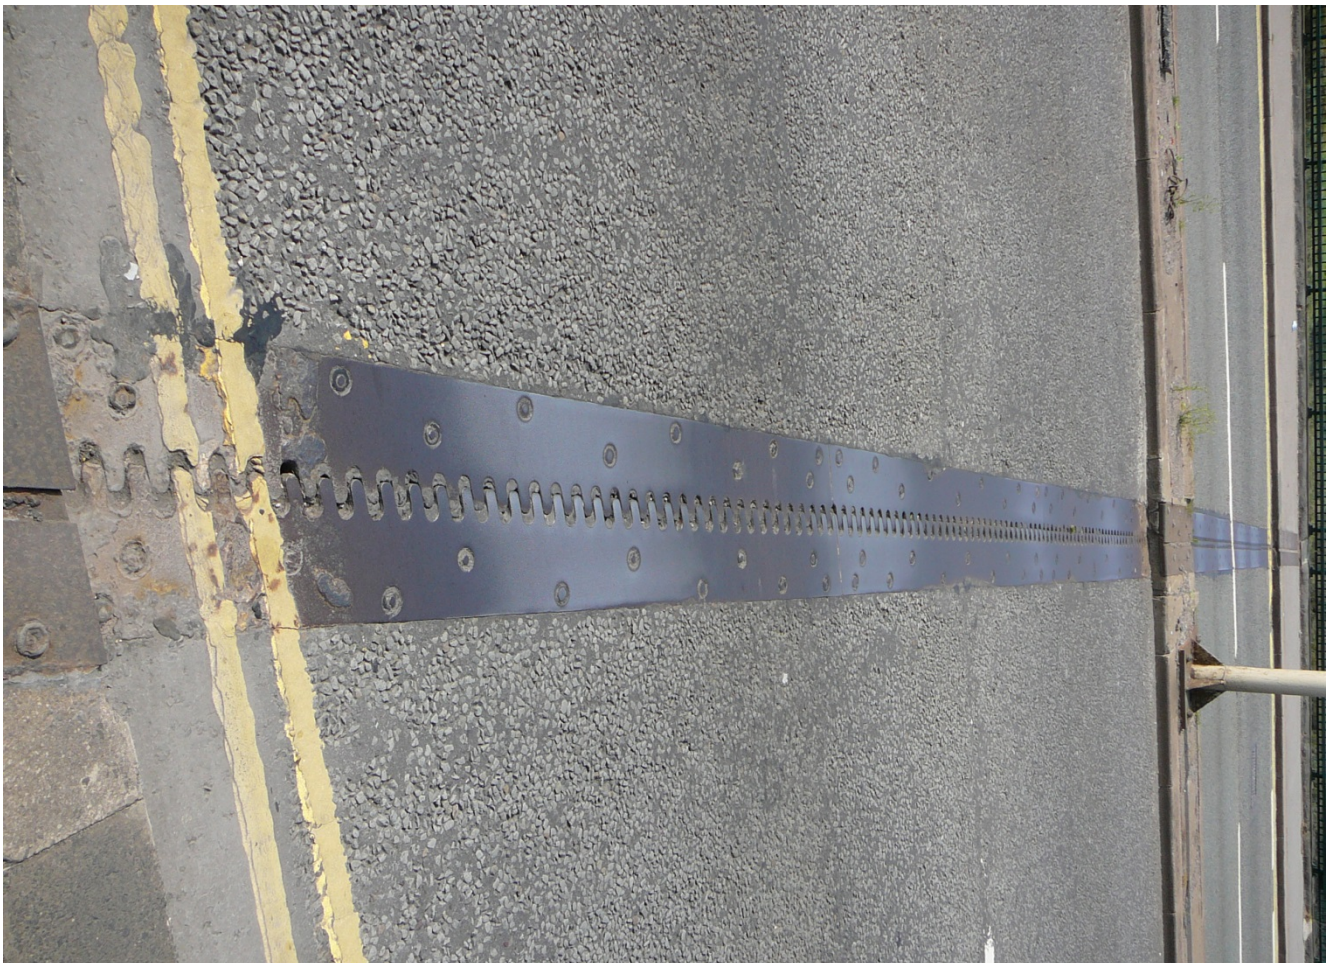
Figure 3a – Original Mechanical “ Comb Joint” Expansion Joint now fused into position resulting in no movement/expansion ability of this joint. This joint will be replaced.

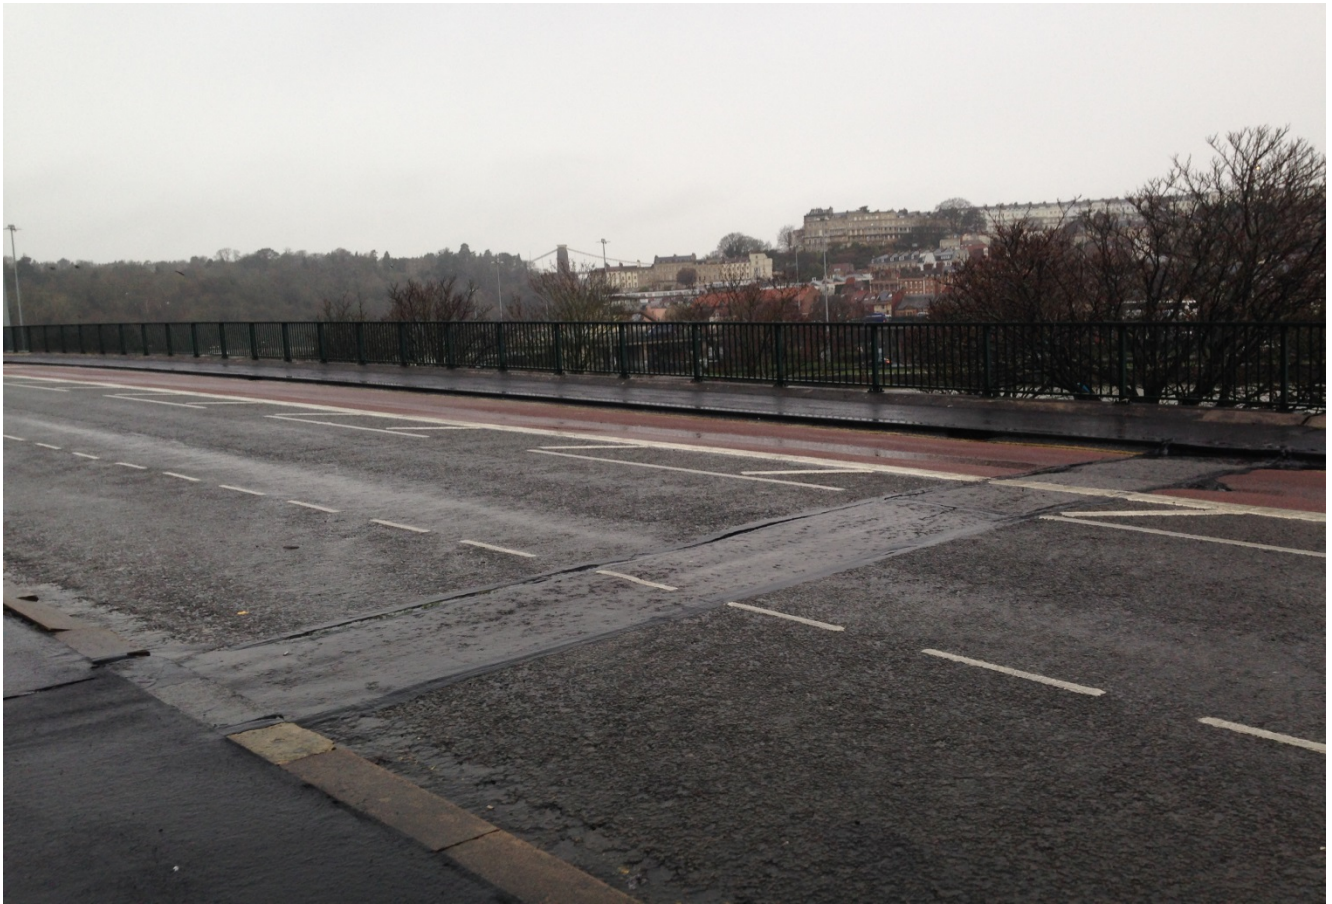
Figure 3b – Previously replaced and now defective, Asphaltic Plug Joint requiring full renewal

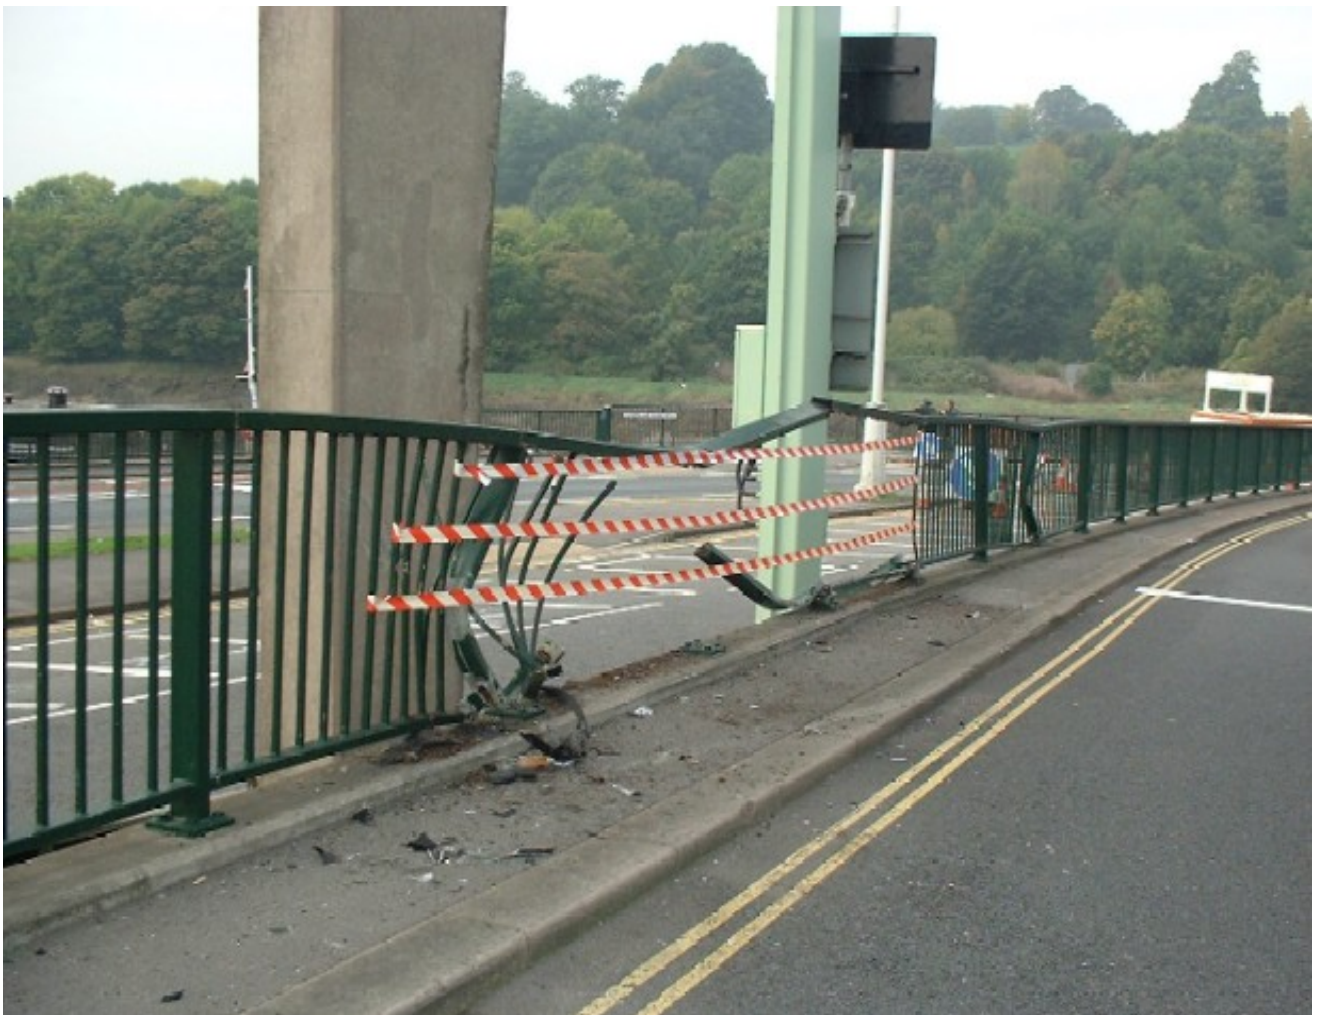
Fig 4a – Typical example of a RTC Parapet Repair along the Cumberland Basin Complex

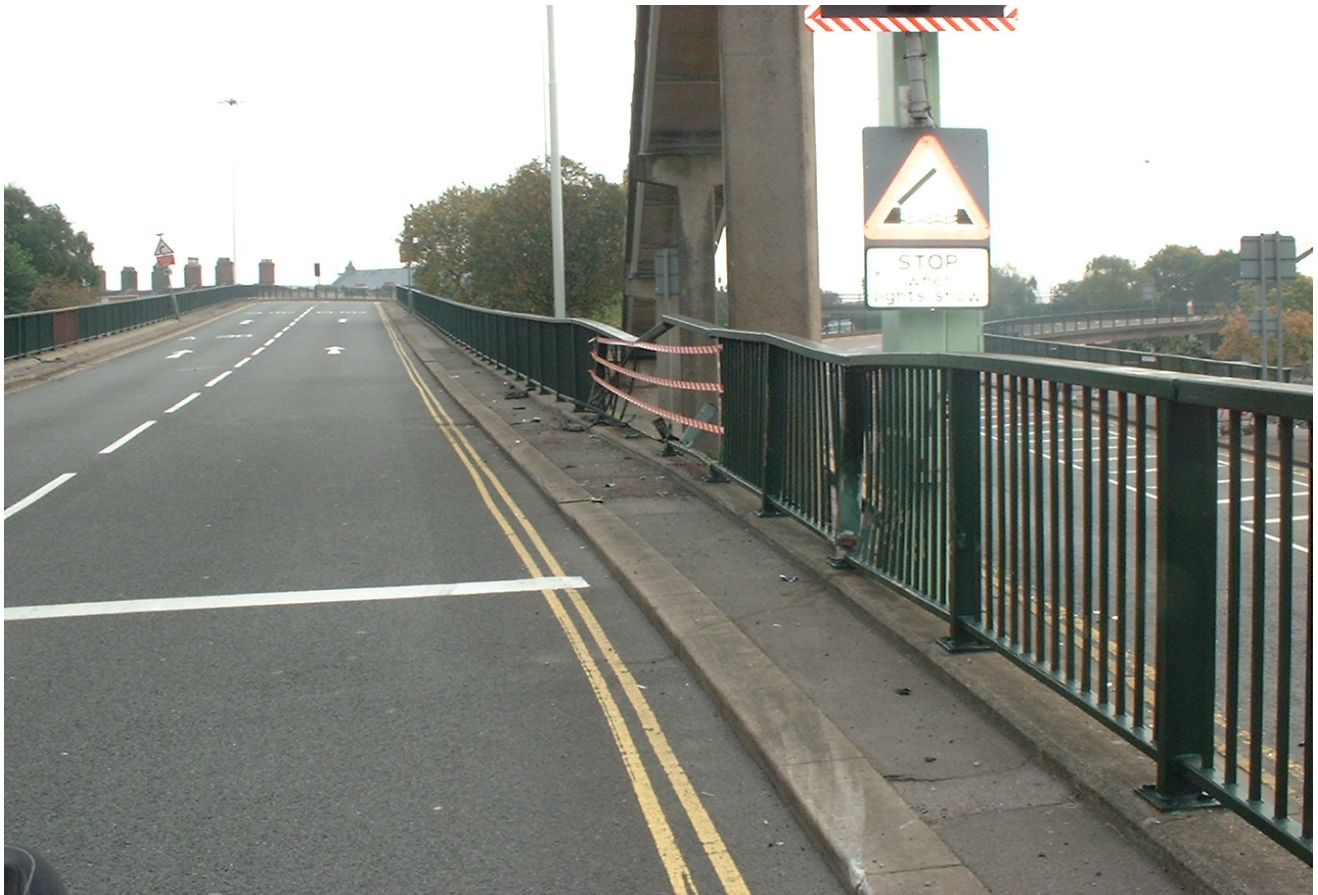
Figure 4b – Typical example of an RTC repair along the Cumberland Basin Complex

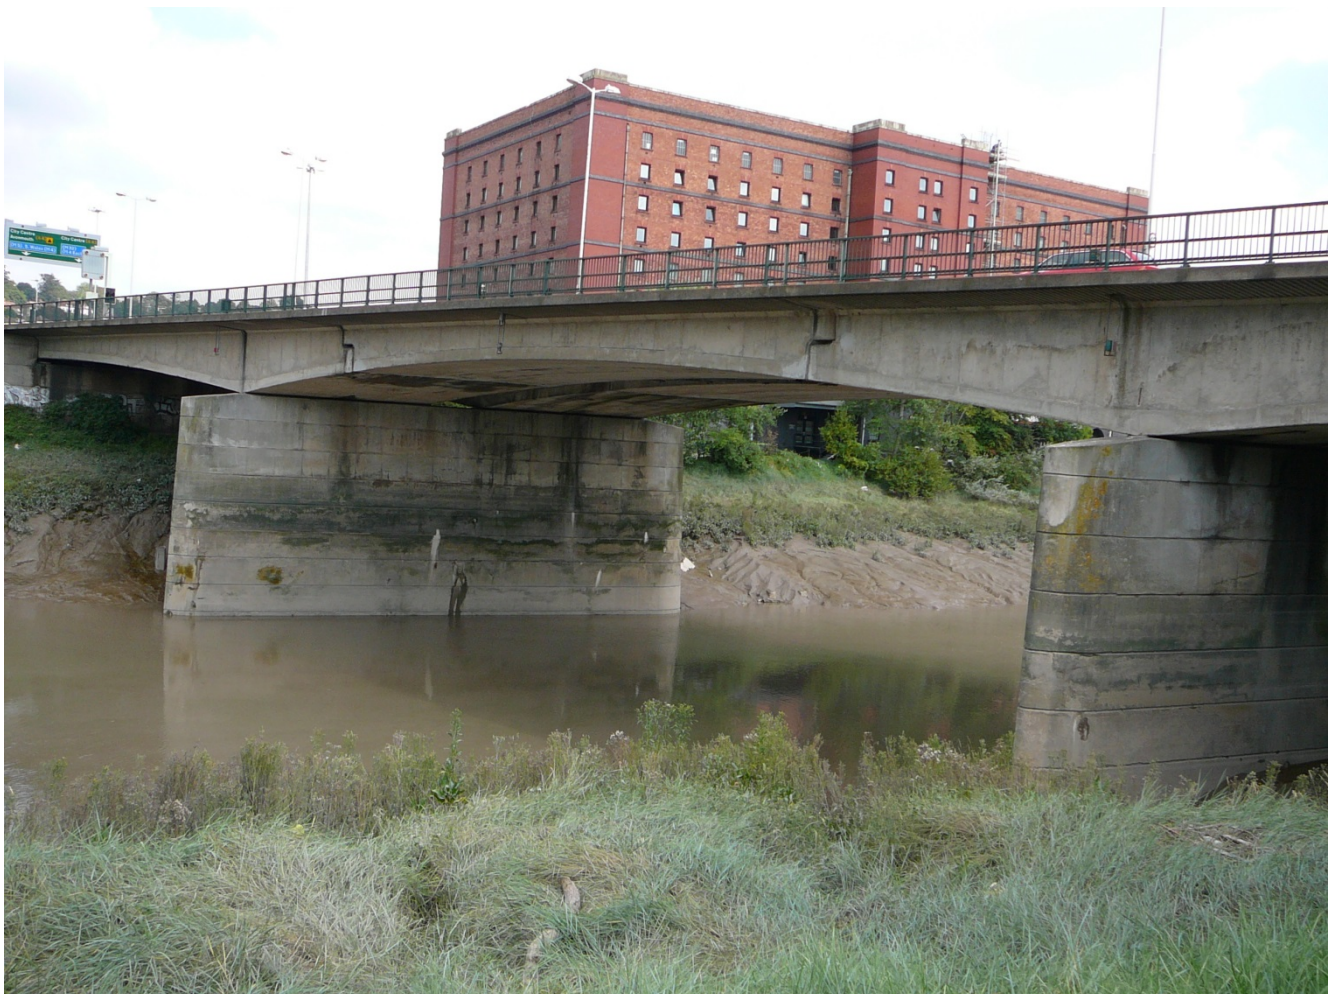
Figure 5a General view of Avon fixed bridge showing “Half Joint” Construction and previous repairs

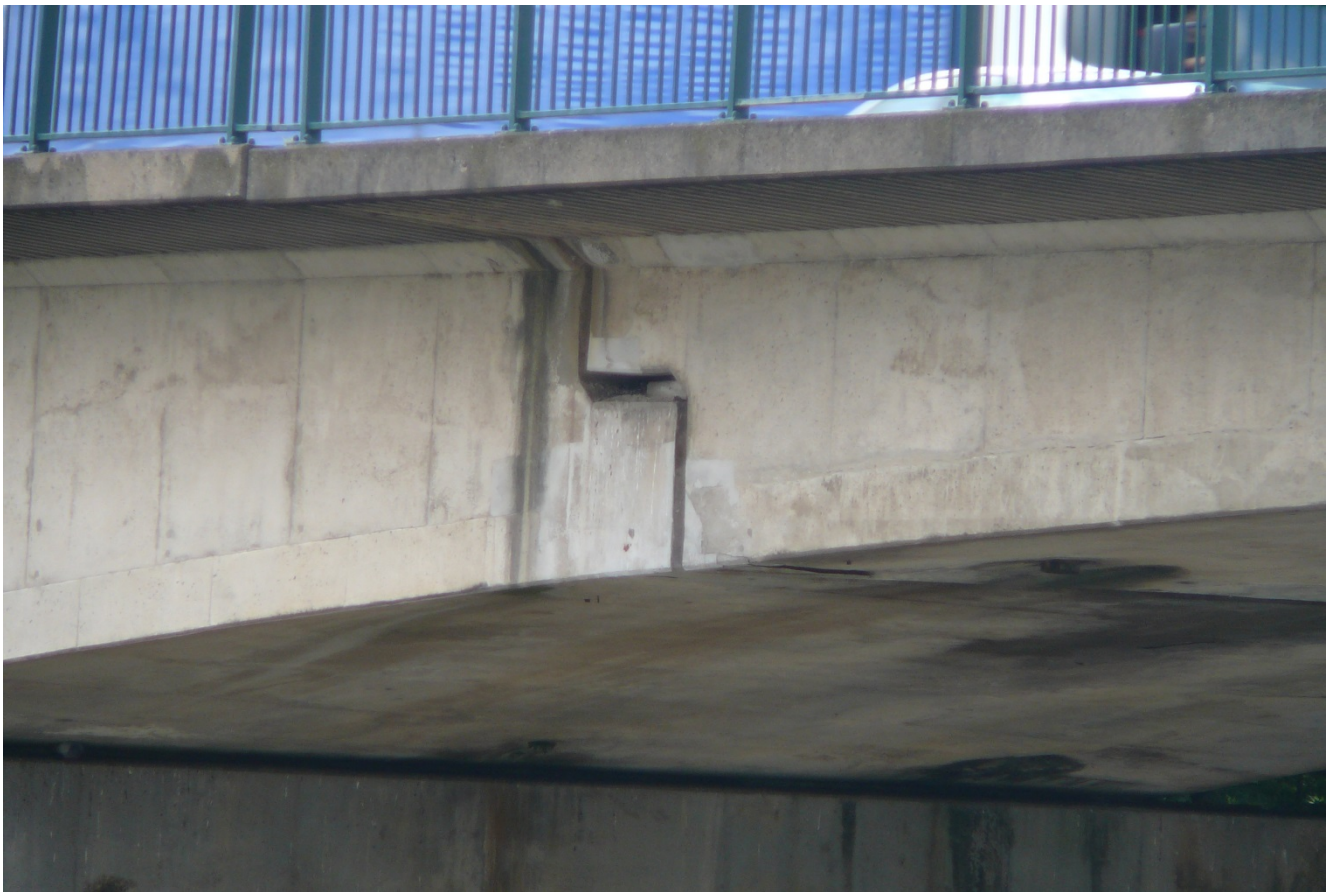
Figure 5b – Close up view of “Half Joint” showing failed previous half joint concrete repairs.

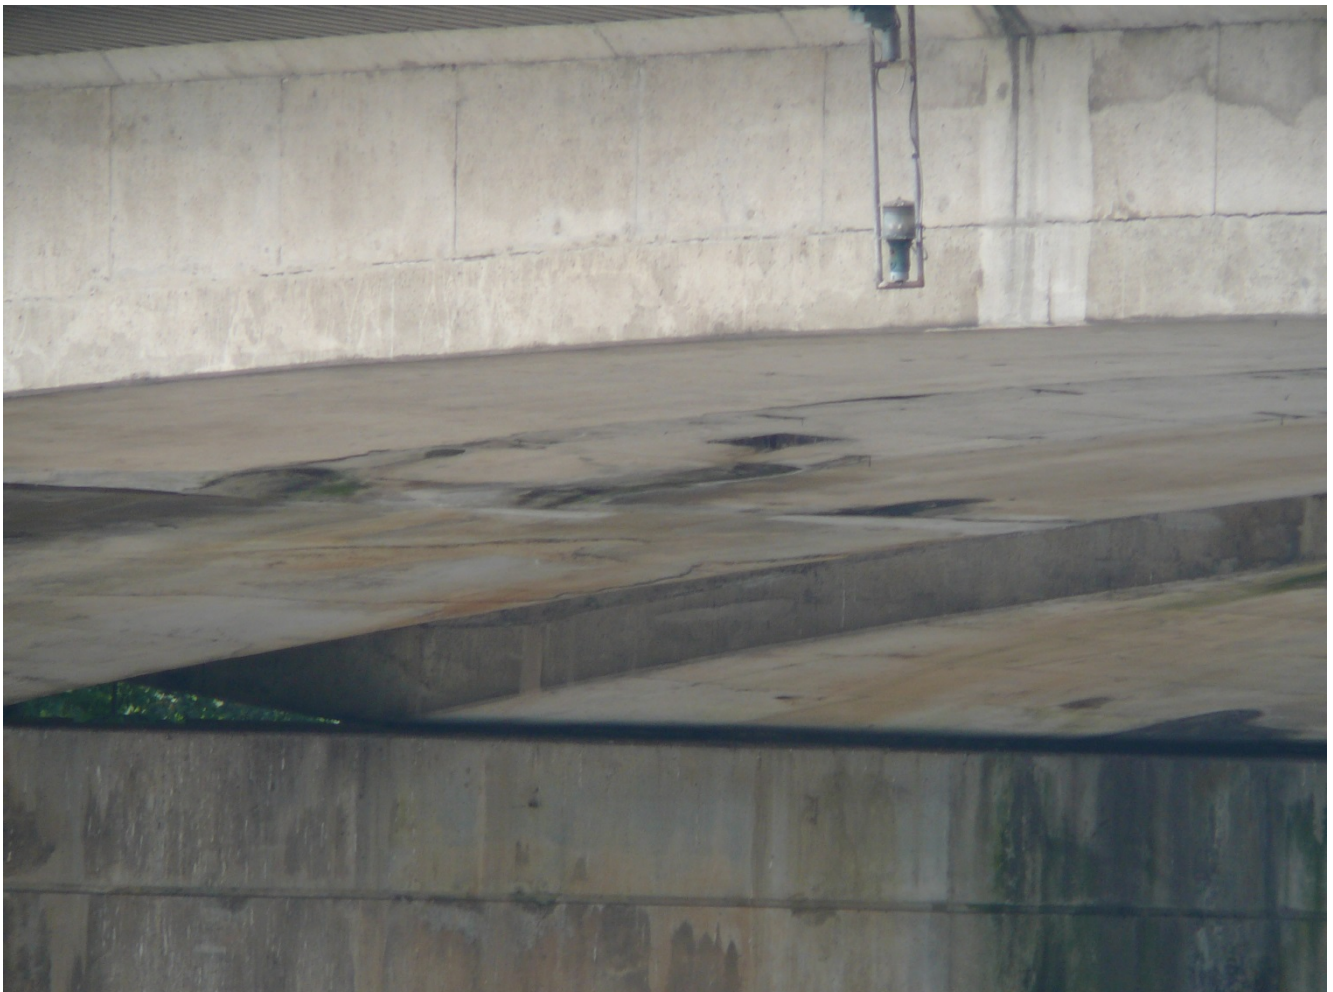
Figure 5c Close up view of previously failed bridge span soffit concrete repairs of Avon Fixed Bridge

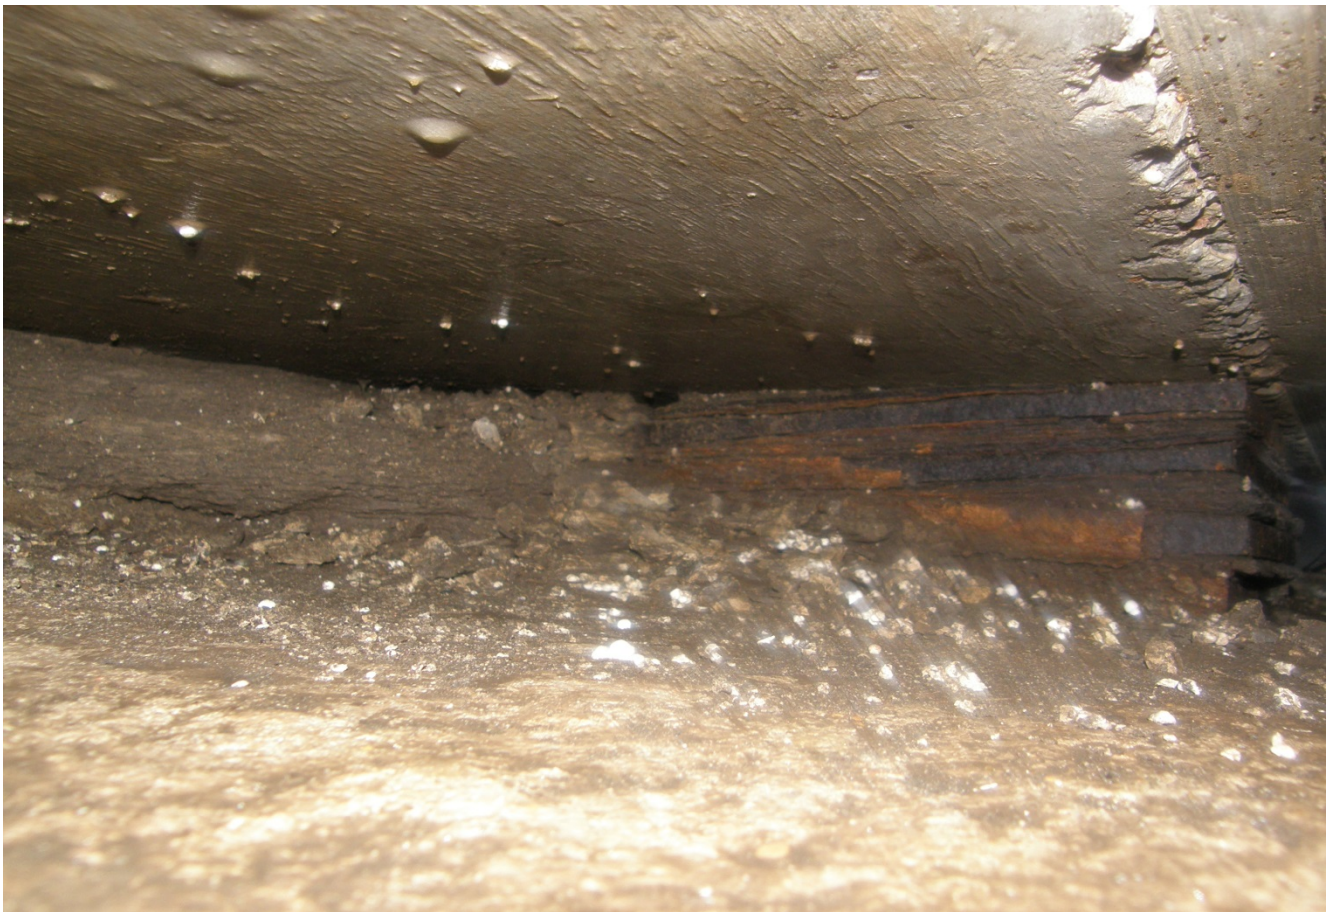
Figure 5d – Close up view of seized bearing plate within voided bridge span of Avon Fixed Bridge
