# **SPI - Asset Investigations and Repairs Project ID 052**

Critical Asset Overview Report

June 2023

**Document reference:** | 100105143-MMD-00-XX-RP-CV-003 | A01 |

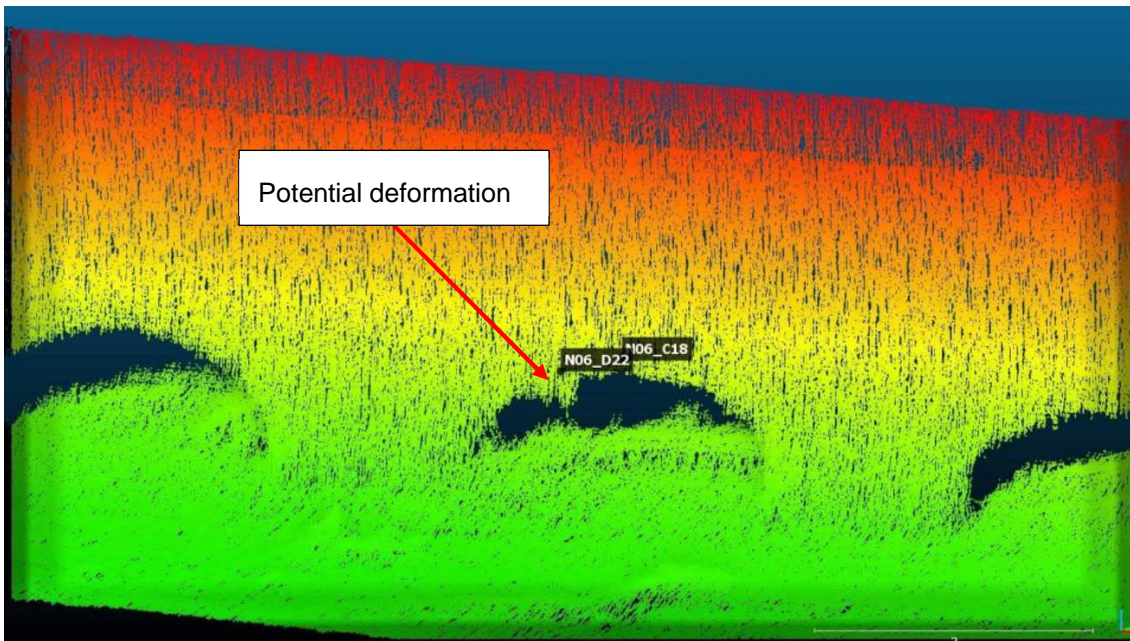
**Figure 4.2: N06 Potential arch deformation of barrel (underwater)**

During the initial inspections, undertaken in 2019, potential deformations were detected in four separate arch barrels, Figure 4.2 shows an example of this. The potential deformations were all approximately 0.6m wide and drop 0.3m below the arch barrel. However, these defects were not identified during the dive survey (see section 4.1.8) and are now assumed to be anomalous readings in the sonar scan.

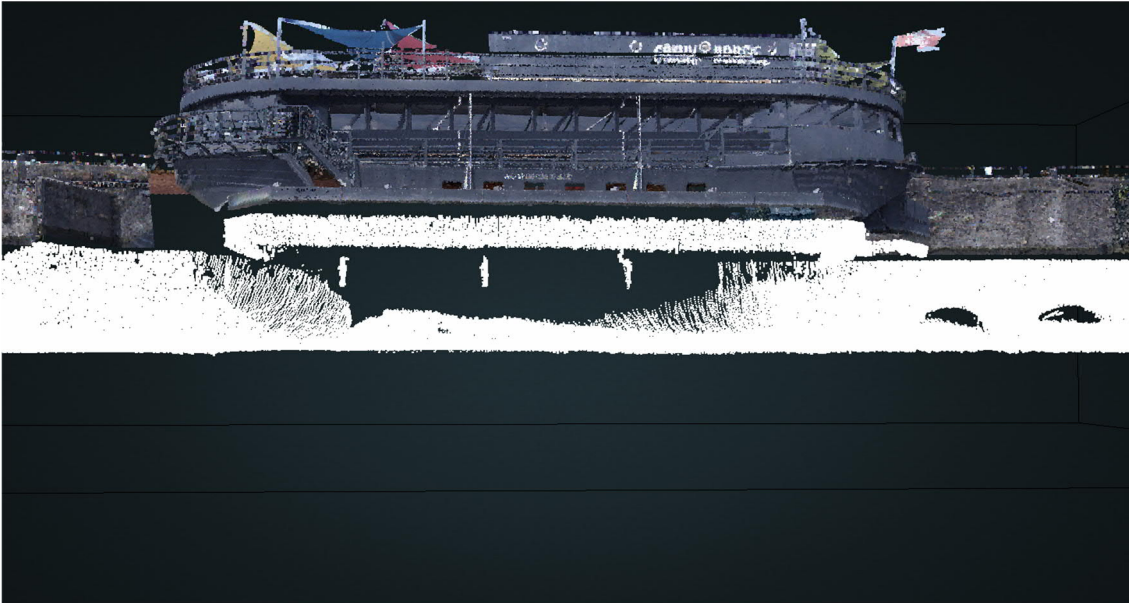
**Figure 4.3: N06 Data blackspot caused by Grain Barge**

The Grain Barge blocks line of sight to a length of wall, and consequently this area could not be captured using Multi Beam Echo Sonar (MBES) scanning, as seen in Figure 4.3. An on-site inspection was undertaken for this area and a void in the harbour wall was detected below the waterline. An underwater video was subsequently taken using a camera on a long reach pole which confirm the presence of a void in this area, see Figure 4.3. The void is approximately 1.5m wide and of unknown height and depth.

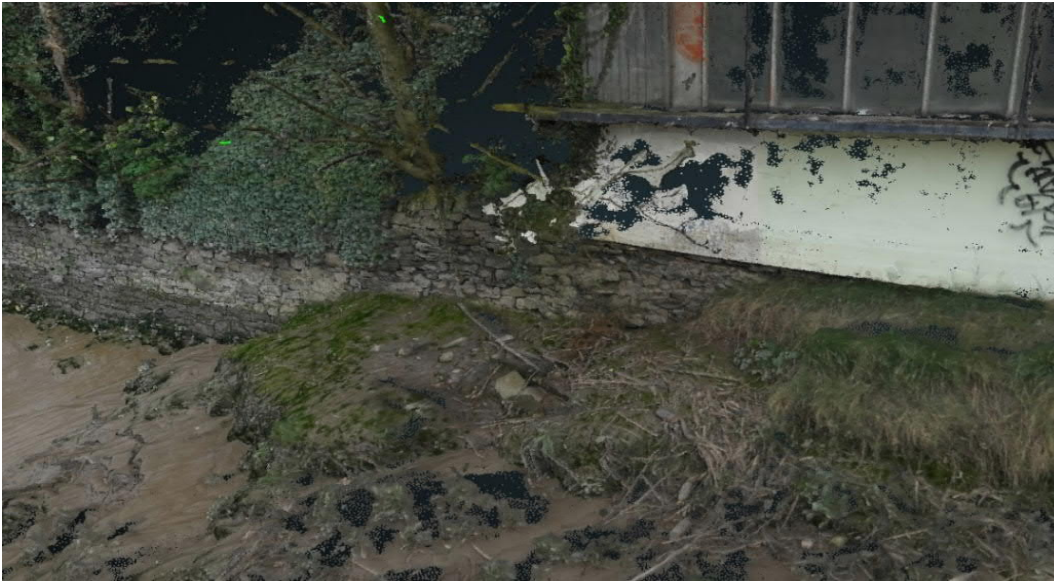
**Figure 6.5: NSC06 Building part of Bristol Metal Spraying & Protective Coatings site**

To the western end of the asset a building, part of the Bristol Metal Spraying & Protective Coatings site, is located above the wall. This is shown in Figure 6.5. This building is located approximately 8m from the wall deformation shown in Figure 6.4. It is unknown whether the wall is providing any support to the building but it is possible that the wall is retaining the material around the building's foundations. In addition, there are several buildings located at the top of the slope.

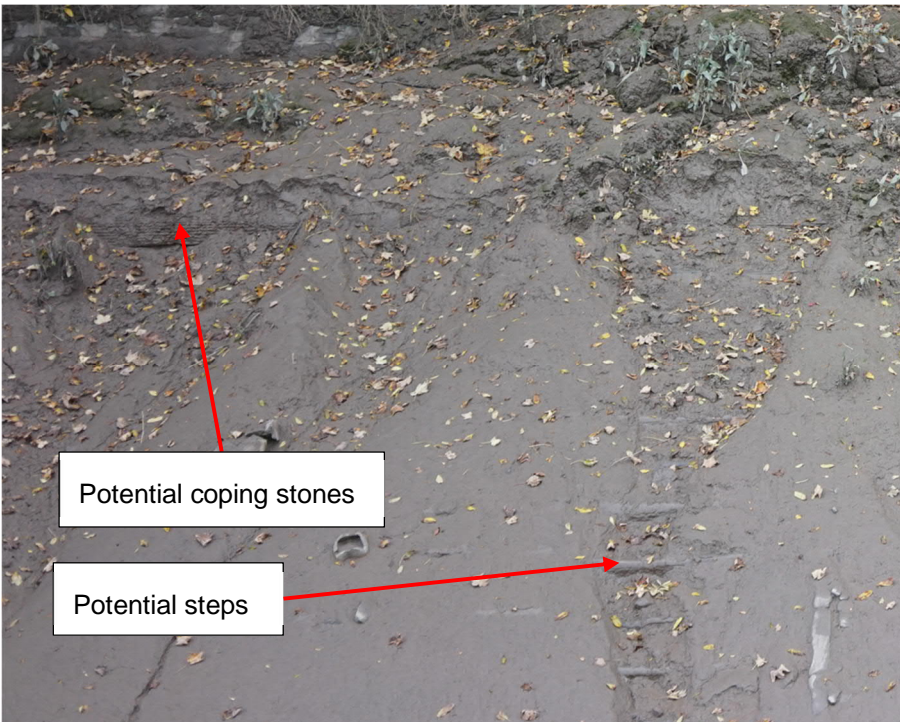
**Figure 6.10: NCS06 Buried structure 2022**

The drone survey has revealed further evidence that there is a buried structure as highlighted in Figure 6.2. This is shown in Figure 6.10, where it appears that there may potentially be buried steps.

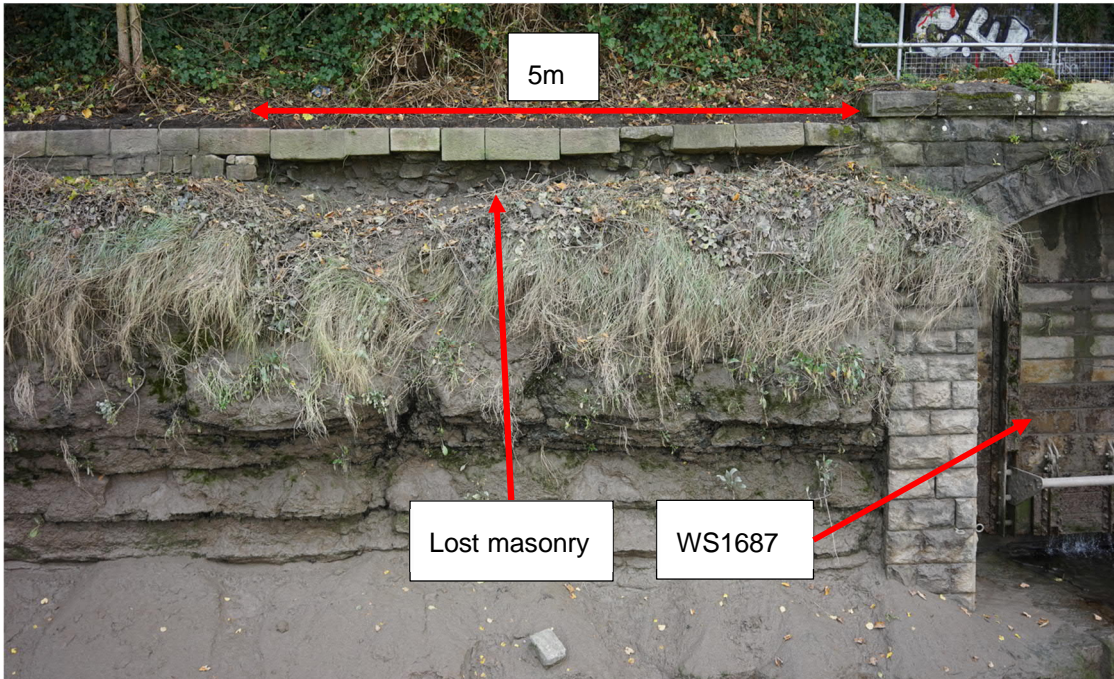
**Figure 7.5: NCS13 Missing masonry by Sheene Road Culvert**

The gated outlet for Sheene Road Culvert (WS1687) is located along the asset's length. The outlet is owned by Wessex Water and is not part of this scope, but it appears to be in a fair condition. However, adjacent to the outlet, an approximate 5m length of wall is exhibiting lost masonry. This is shown in Figure 7.5.

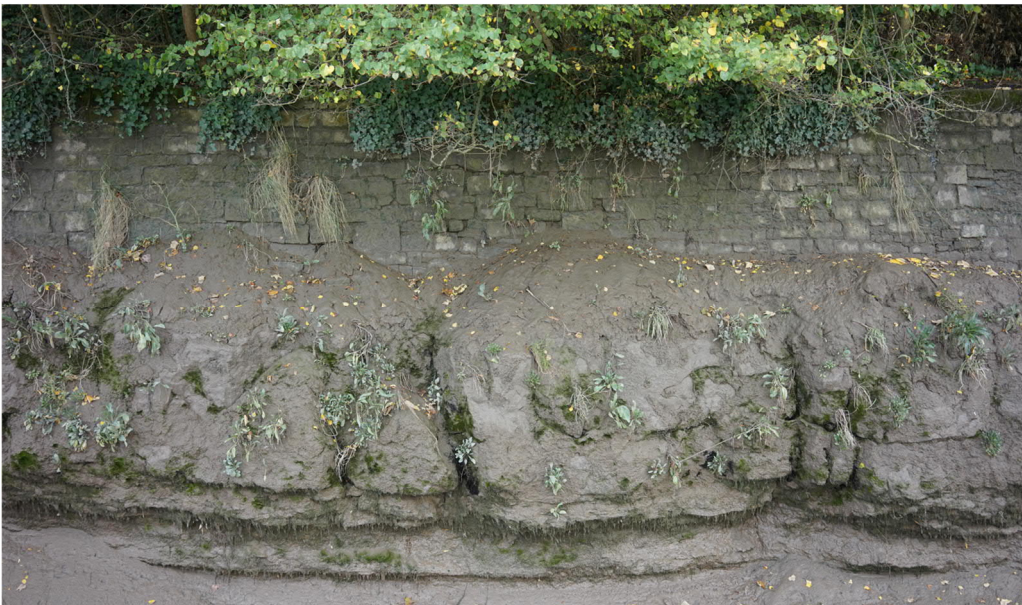
**Figure 7.6: NCS13 Scour**

There is potentially scour happening to the bedrock that the wall has been constructed upon. The appearance of the rock is similar to other locations up and down the New Cut. This is shown in Figure 7.6. This is not considered a short-term concern.

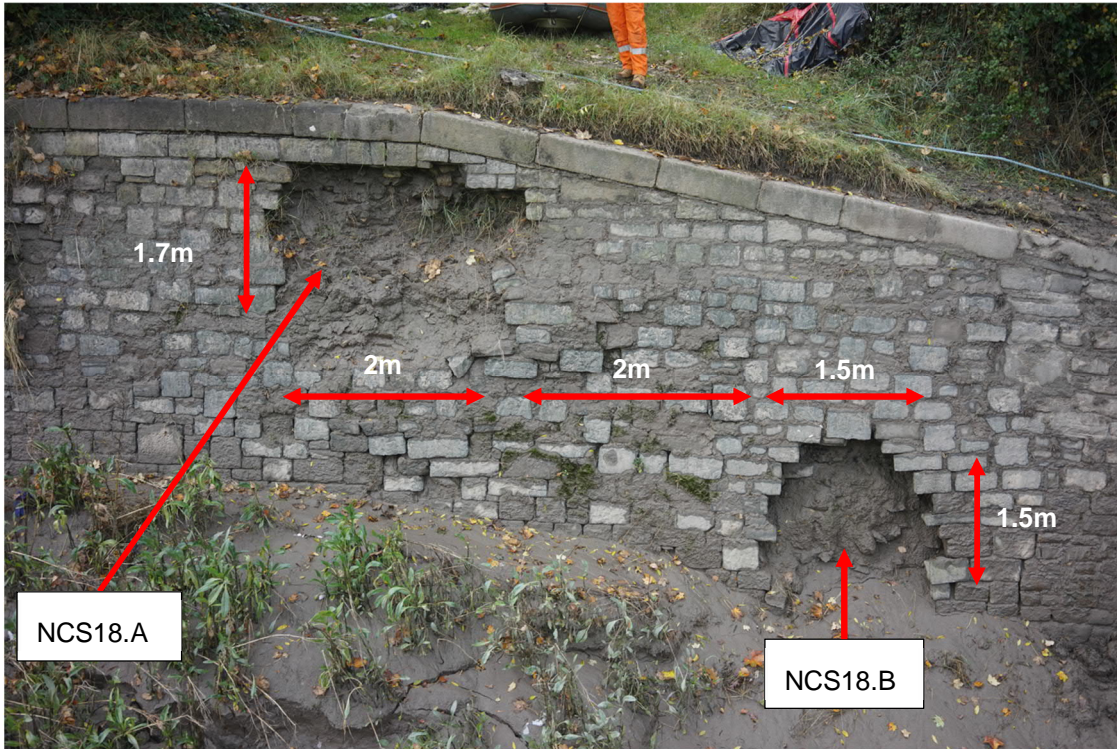
**Figure 8.3: NCS18 Collapsed sections (Slipway)**

There are several collapsed sections of the wall and areas of deformation. The defects have been treated as two different sections depending on their location, slipway and slope wall.
