## Appendix Aii – Original BCC Structural Recommendations

**Asset No. 1 - N06 – Harbour Wall, Masonry Arches deformed below waterline**

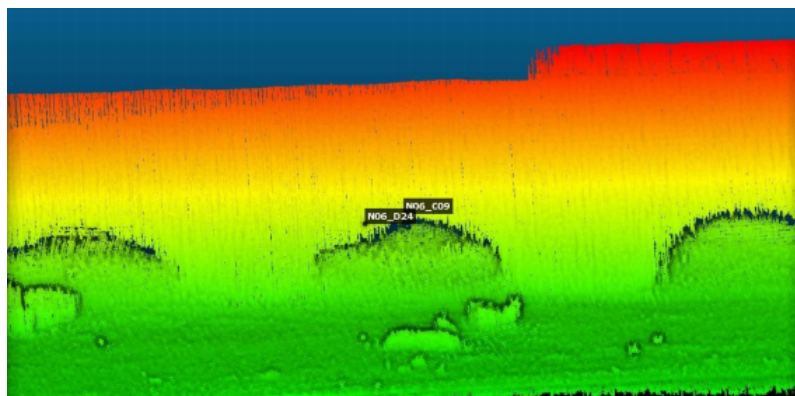
Deformation of underwater arches and areas of lost masonry, see image below showing deformation of arches.

If the wall were to collapse, there is a risk that Hotwell Road will also be affected by a loss of support and lane closures would be necessary. There are boats moored along the asset in the vicinity of the critical defects and there is the potential for them to be damaged by falling masonry

- Install and monitor survey points
- Dive inspection of affected arches

- Undertake full diving inspection and stabilise Arch and install scour protection measures
- Estimated Cost = **£500,000.00**

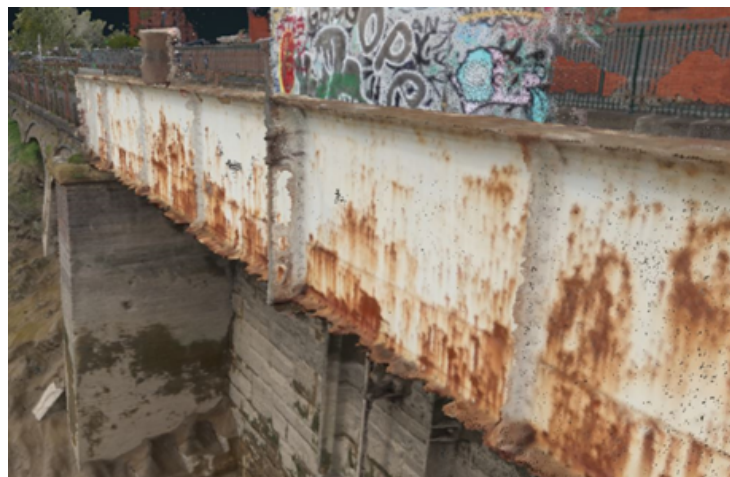
Severe corrosion of steel beam footbridge as shown in image below

Collapse of the structure poses serious risk to life, reputational risk, financial risk and loss of function of Underfall sluice gates. Loss of the sluice gates would result in a loss of the ability to control the water level in the harbour with far reaching consequences. Flooding and damage to property.

- Cordon off bridge to prevent pedestrian access (actioned)
- Investigation to determine the capacity of the girder and place load restrictions on the bridge. Action subsequent recommendations accordingly

- Replace whole Structure. Estimated Cost = **£1,000,000.00**

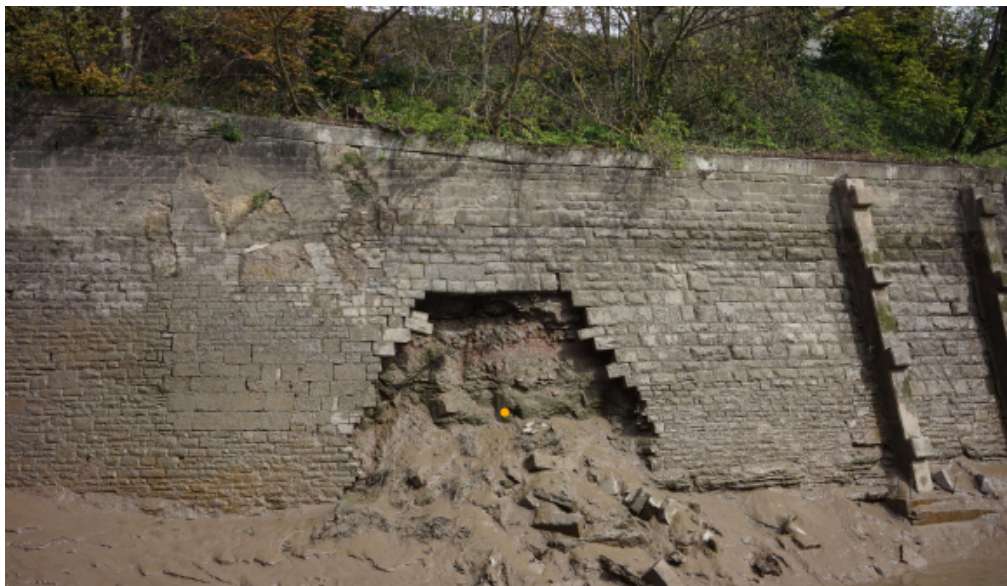
The critical section of the asset is an area of lost masonry measuring 6m x 4.5m

The failure of NCN16 could cause a failure in NCN17 resulting in a collapse of the footpath and partial collapse of Cumberland Road. There is a risk of major travel disruption.

- Install and monitor survey points
- Undertake repairs of the critical section

- Undertake full masonry reconstruction/masonry Repairs and underpinning at base  
Estimate = **£1.550,000.00**

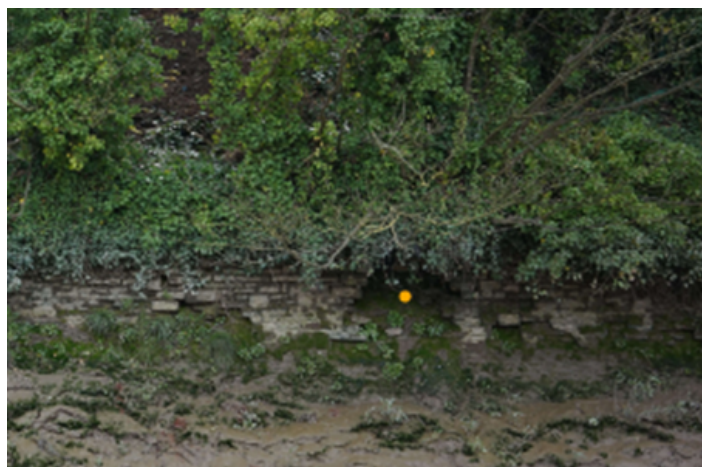
Several areas of collapsed wall along the length of the asset and the remaining masonry is generally in a poor condition as shown the image below.

Potential for a loss of support to building foundations and the building could collapse, presenting risk to life.

- Conduct investigation to gauge whether the asset is providing direct support to the building at the western end and to confirm the depth of foundations of the building behind.

- Masonry Repair and rebuild along with some foundation underpinning  
Estimated Cost = **£550,000.00**

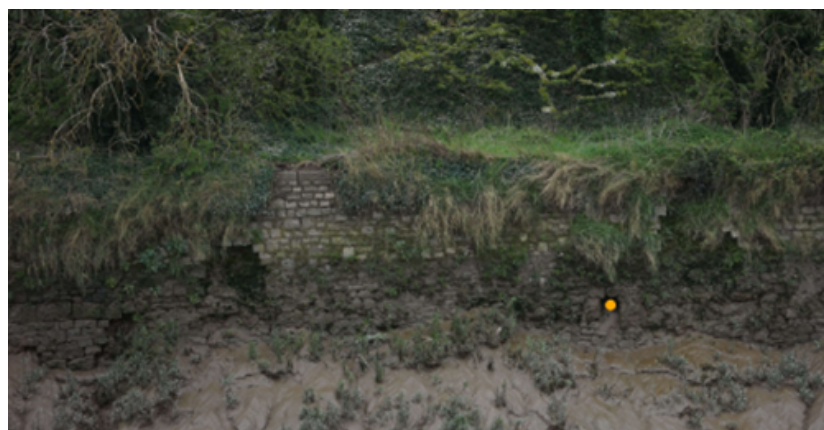
Numerous collapsed sections along the full length of the asset and the masonry is in a poor condition with deformations noted. Scour is affecting the rock outcrops which the asset is constructed on.

If there was a loss of support to the embankment, Coronation Road may be affected. There is a risk of major disruption to travel.

- Install and monitor survey points
- Repairs to eastern section of the asset where the embankment is directly supported by the wall.

- Masonry Rebuilds and repair along with some underpinning and rock anchoring at base.  
Structural Estimate = **£850,000.00**

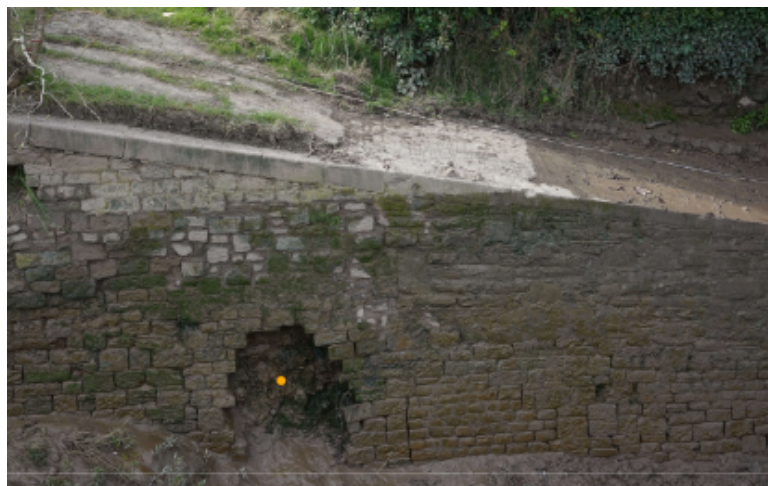
Several collapsed sections and areas of deformation along the length of the asset including slipway

Coronation Road may be affected by a loss of support and failure. There is a risk of major travel disruption.

- Install and monitor survey points
- Repairs to the areas of deformation and collapsed sections where the wall directly supports the embankment.

- Masonry Rebuilds and repair along with some underpinning and rock anchoring at base.  
Structural Estimate = **£1,600,000.00**

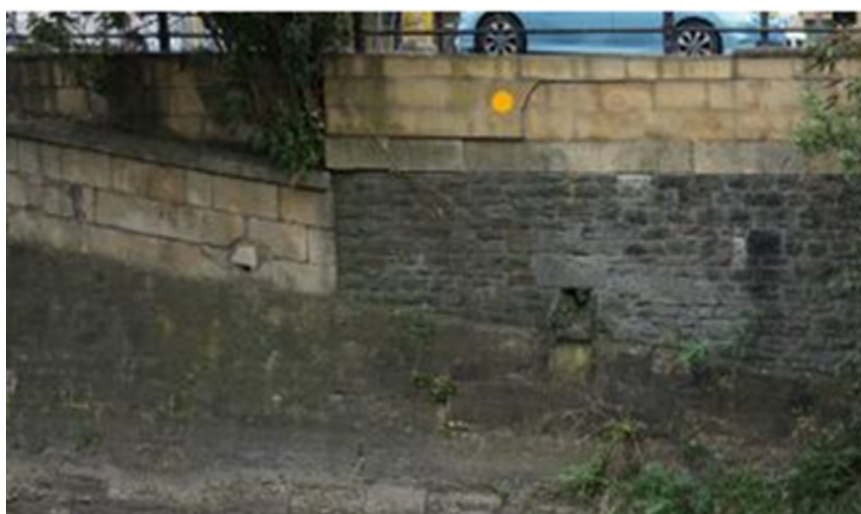
Significant deformed area situated at the eastern end of the asset

Loss of support/collapse of the footpath is likely in the event of a failure. Load restrictions and a partial closure would be necessary. There is a risk of major travel disruption.

- Protect rear of the footpath with barrier
- Undertake vegetation removal at critical location and repairs to the area of deformation.

- Remove upper Blockwork Wall and Railings and stabilise and then reconstruct.  
Structural Estimate = **£300,000.00**

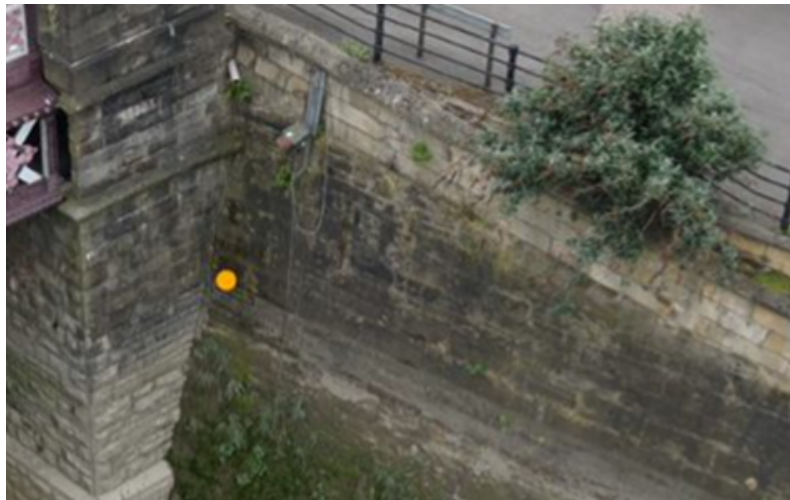
Area of deformation at the crest of the wall adjacent to Bedminster Bridge roundabout

Loss of support/collapse of the footpath is likely in the event of a failure. Load restrictions and a partial closure would be necessary. There is a risk of major travel disruption.

- Protect rear of the footpath with barrier
- Vegetation removal at critical location
- Repairs to the area of deformation

Stabilise lower level wall with rock anchors and repair masonry facing. Structural Estimate = **£400,000.00**

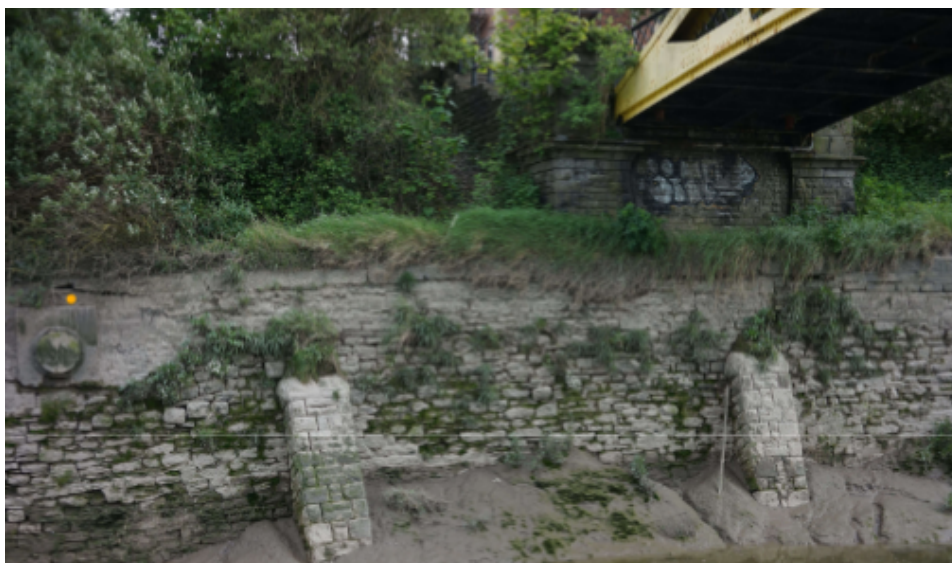
There are several areas of significant masonry loss and extensive deformed sections, particularly in the vicinity of Langton Street footbridge. The asset is generally in a poor condition along the entire length

Immediate loss of support to York Road and to Abutments of Langton Court Road footbridge

- Confirm the depth of foundations for Langton Street footbridge
- Installation of survey points on the asset and bridge

- Installation of survey pegs on the fill behind the asset

Undertake full structural assessment and based on findings. Stabilise full extent of retaining wall  
Structural estimate = **£2,750,000.00.**

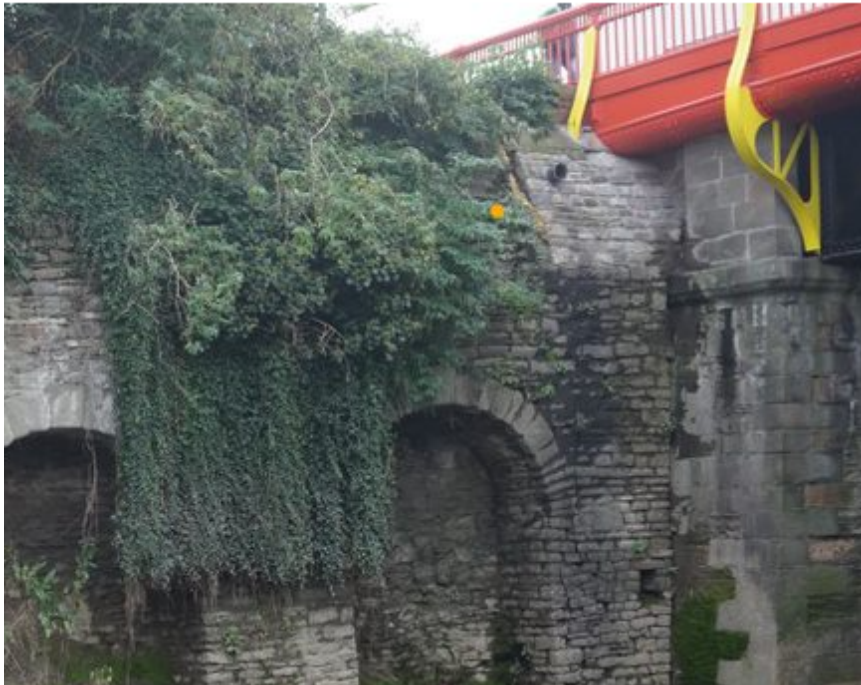
The arch adjacent to Bath Bridge Roundabout has failed from its springing point and the masonry is bulging significantly. There are also areas of collapsed masonry above this arch

Collapse of the arch will cause a loss of support to the retained material leading to a collapse of Network Rail land, exposing the edge of the bridge abutment and is likely to affect the stability of Bath Road

- Install barrier to prevent pedestrian access
- Installation of props or ties to restrain the bulging area and carry out repairs / reconstruction

Undertake full assessment of deformed arches and take appropriate stabilisation measures and stabilise full masonry wall. Structural Estimate = **£300,000.00**

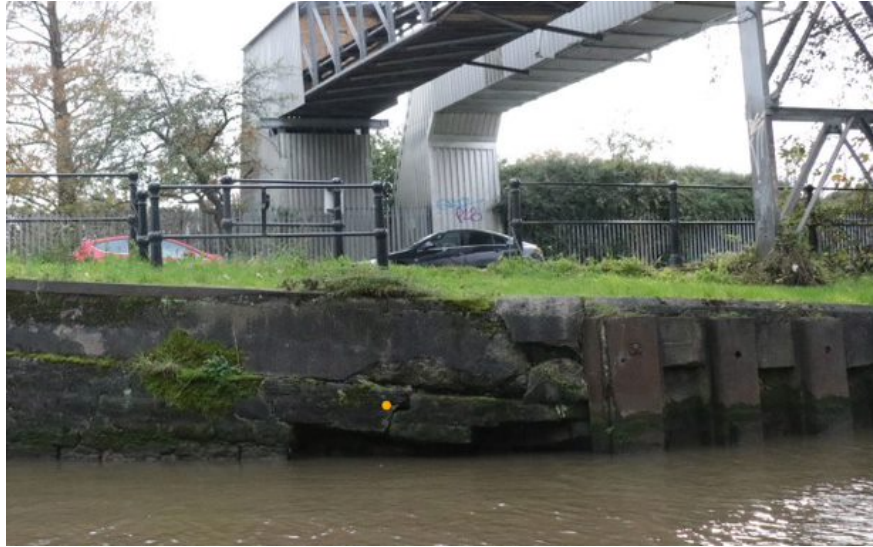
There are large areas of lost masonry underwater at the western end and numerous capping beam failures along the length. There is an extensive amount of vegetation growth from gaps between the concrete planks. There are several large areas of deformation visible on the capping beam

Loss of support to the retained material would result in a collapse of the footpath and potentially a partial collapse of Feeder Road. Risk of minor travel disruption

- Install survey points to monitor the asset for movement

Underpin base of wall and stabilise retaining wall/ capping beam. Structural estimate = **£450,00.00**
