# Barton House

January2024

Barton House Structure

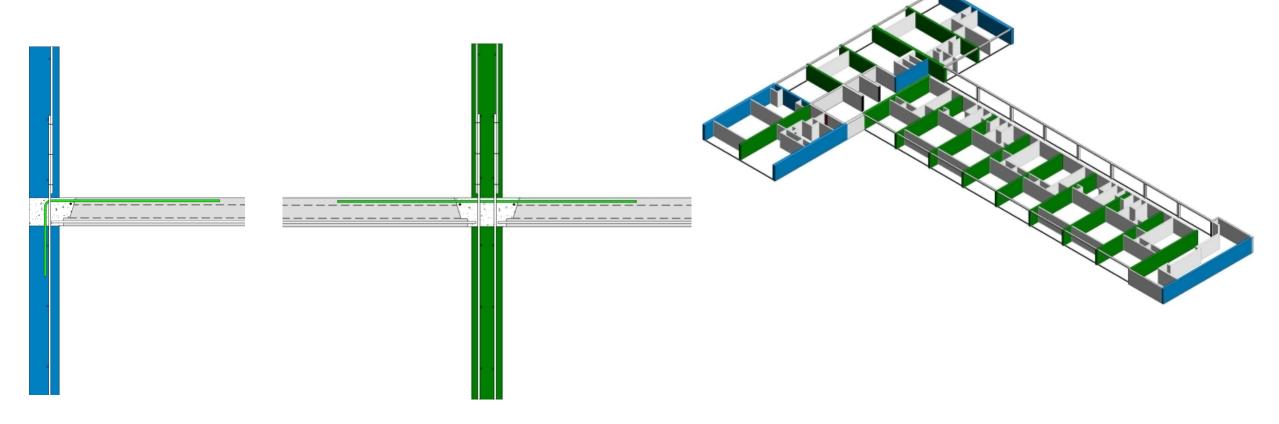
#### **Details**

Flank wall and slabs
Approx 85% effective

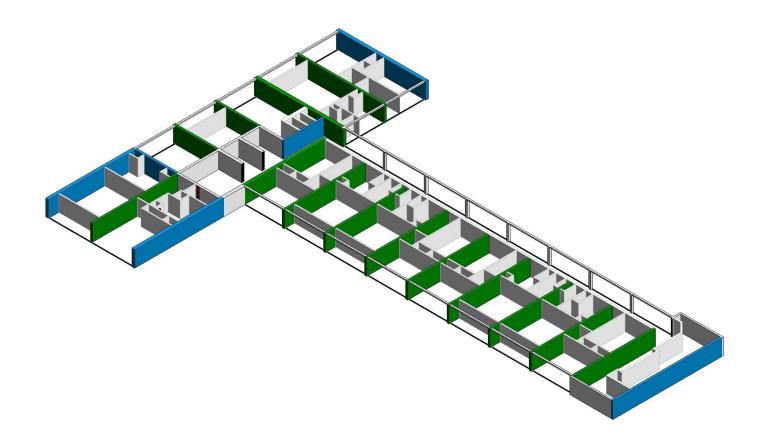
#### **External wall condition**

Original construction needs additional support to be OK in the event of a fire.
