**DOWNS COMMITTEE
9th September 2013**

Title: Downs Rangers Report

Appendix 1 – Tree Officer's report

Ash tree adjacent to ladies mile

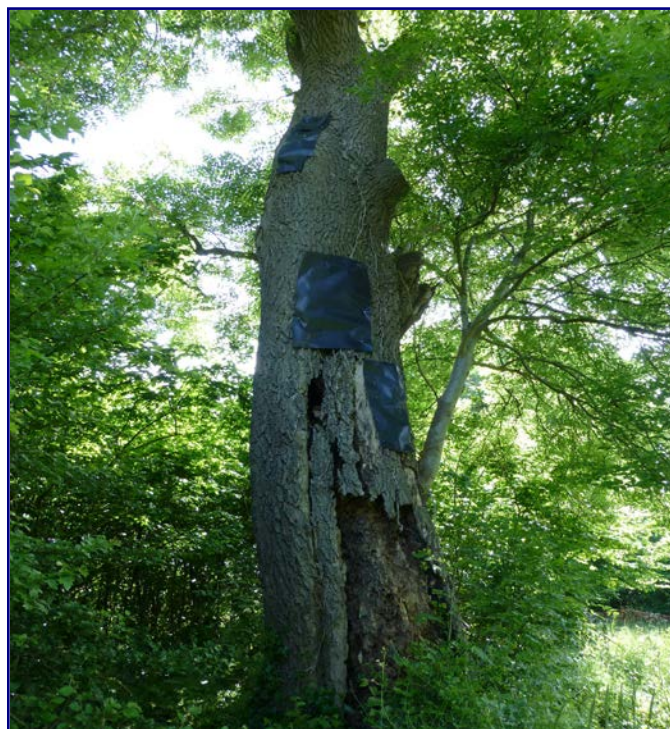
The mature status of the ash tree is obvious upon initial inspection. It is classified as a veteran due to the presence of several veteran characteristics: a hollow stem, cavities in the branches, rot holes, delaminated bark and partially decayed wood. Management of this tree should therefore consider its current and potential habitat value. The Ash tree has become prematurely aged in advance of the other specimen in close proximity due to the loss of a large limb on the east side at 4 metres this has a direct correlation to the main column of

The tree has an open column of decay on the south west side from ground level to 4.6 m, and further cavities associated with historic branch removal join this column to over 6 m. At ground

level, the cavity extends to at least two thirds of the stem diameter and tapers as it rises into the main stem. At the junction of the main stem to the second order crown limbs there appears to be an area of limited decay. The second and third order crown limbs show significant colonisation by *Inonotus hispidus*. Old brackets were observed on the ground, the main stems, and *Inonotus* bark canker is present at old bracket locations. *I. hispidus* is a wood decaying fungus that causes a white rot in the upper portions of the trunk and main structural limbs. The fungus simultaneously degrades lignin and cellulose, causing a loss of strength and branch failure.

Although it could cause the failure of the large structural branches, *Inonotus hispidus* is a secondary consideration due to the extent of decay within the main stem.

Without intervention, this will certainly happen within the foreseeable future as the main stem continues to decay and the crown continues to grow. The failure point would be between ground level and 4m.

- Due to the complex nature of this tree and location no one option can be employed to make the tree safe whilst retaining the habitat value. The most appropriate form of management would be to prune the tree within acceptable limits of safety and establish a more compact safety zone so as not to occupy a large area of the Downs.
- The recommended option is to prune the tree via MEWP to reduce the main second order limbs to within a metre of the main stem. The final cuts can be carved to create pseudo-natural failure points.
- Natural barrier planting to a radius of 15m surrounding the tree, will dissuade the public from entering the zone. This area will require fencing in the short term in order to allow the planting to establish.
