# Kings Weston Footbridge Design and Access Statement

## Planning and Listed Building Application

## Introduction

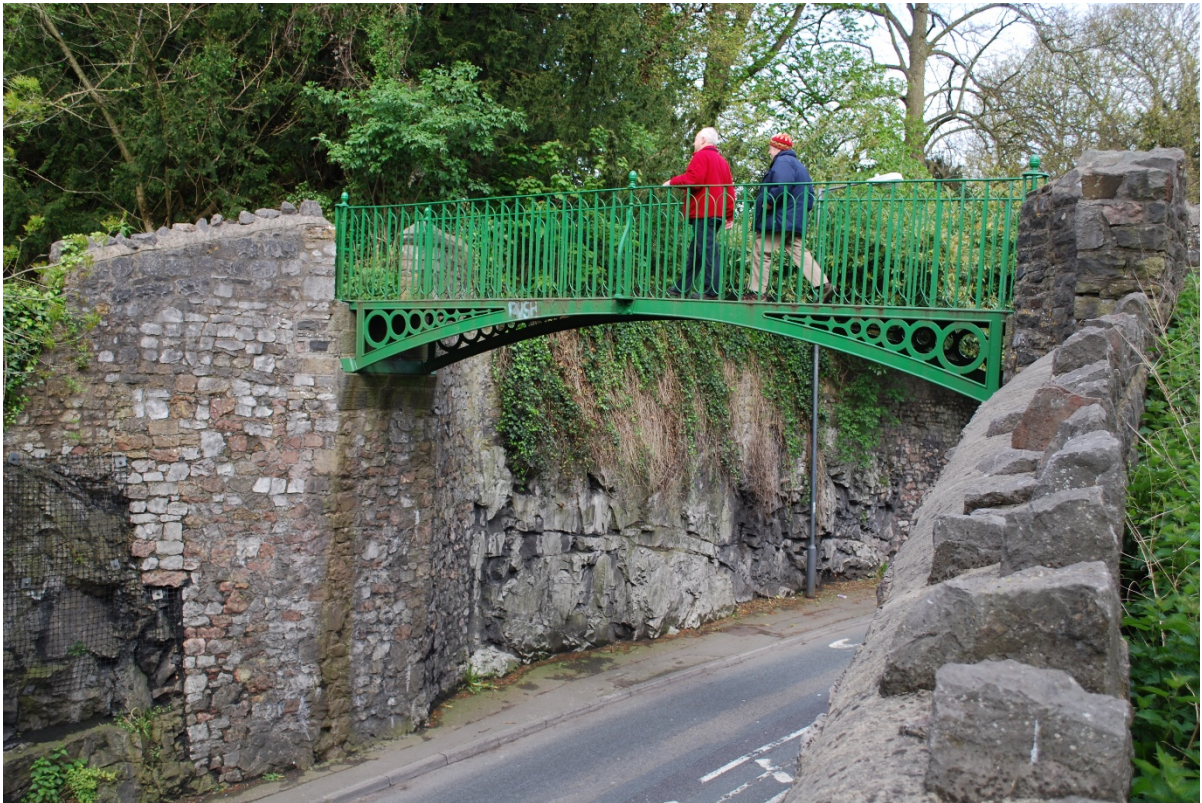
Above: View of existing bridge prior to safety scaffolding

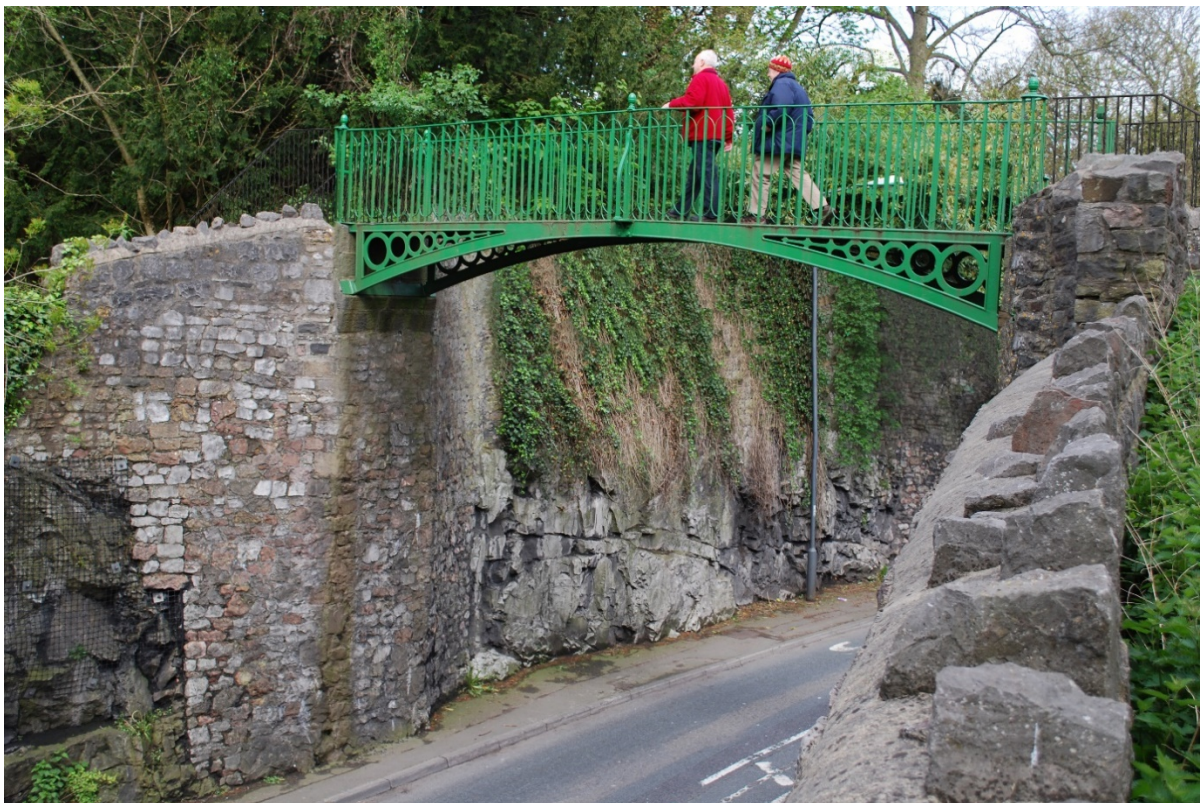
Above: Photomontage view of bridge raised by 1m with new guard railings (dark grey) and steps at eastern and western ends.

The damaged bridge will be dismantled, in accordance with the provisional method statement, to enable repair off-site. Following conservation repairs the bridge will be reassembled on site, in the same location, but raised at a height of 1m above its current elevation.

New additions will include stone steps constructed on both sides of the bridge to provide pedestrian access. These will be faced in coursed pennant stone matching the adjacent parapet walls, with pennant stone treads. New high-quality handrail railings will be mounted at each side for safety. These will be painted a dark grey colour to appear distinct and secondary to the green coloured iron bridge as the principal historic asset.

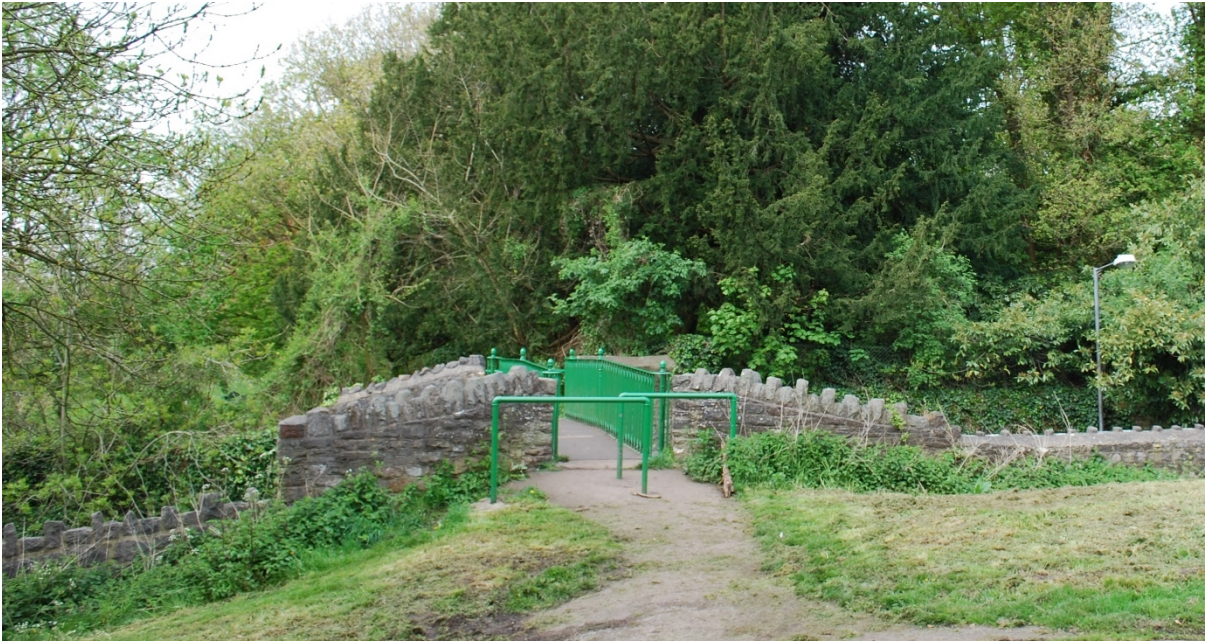
Above: View of existing bridge prior to safety scaffolding

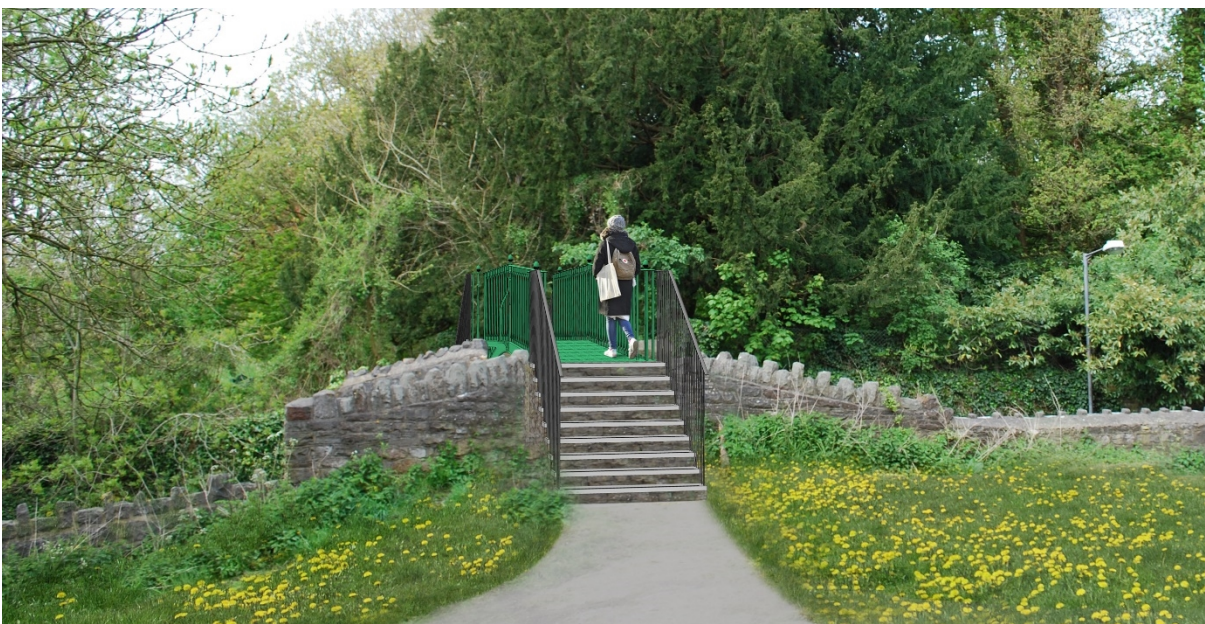
Above: Photomontage view west towards the raised bridge showing the proposed steps and railings.

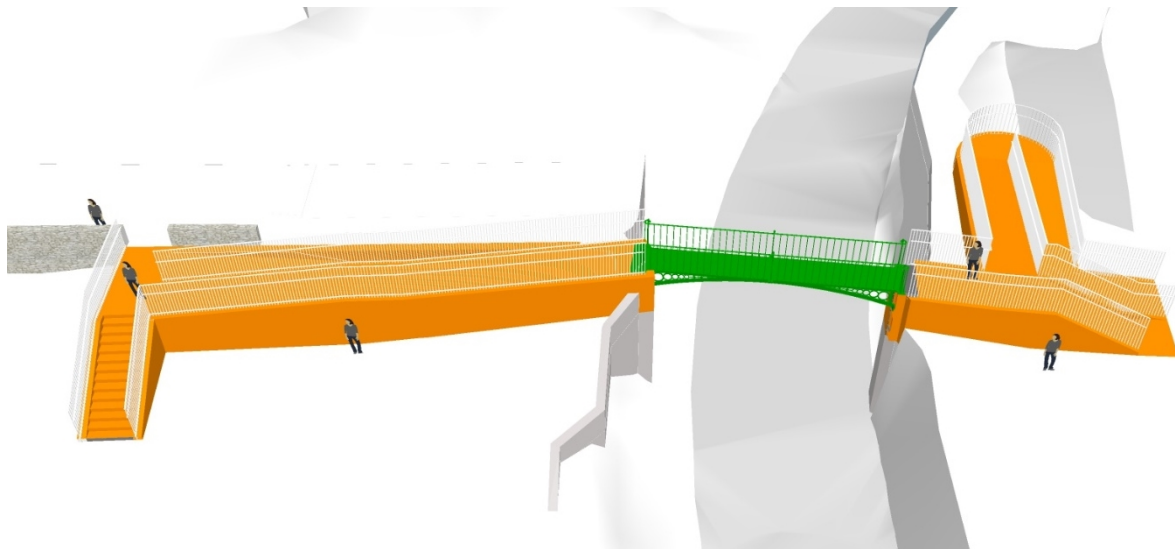
Above: Schematic aerial image showing bridge with extent of ramp structures required to facilitate level access

During stakeholder consultation with Bristol Physical Access Chain, the designers were encouraged to look at the feasibility of constructing access ramps at either end of the bridge. Due to the falling ground levels leading away from the bridge, any ramps at minimum acceptable gradients of 1:12 would require a substantial ramp structure some 30m in length on the western side.
