Appendix A iii

Summary of the Identified workstreams & associated Current Investigation/Design Work Estimated Costs (From the £2.5m Capital funding)

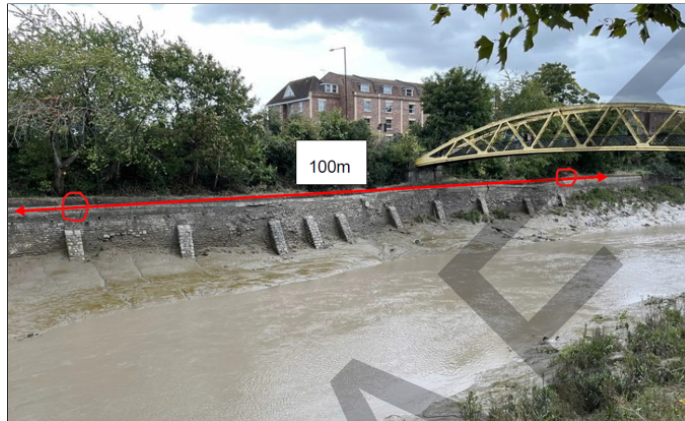
1. NCN28 Langton Street Bridge/Banana Bridge River Retaining Wall

This river retaining wall asset is showing substantial stability movement and condition depreciation of the south retaining wall over a distance of 100m, centred about the Langton Street Footbridge (Banana Bridge), but retaining the adjacent York Road. Whilst the failure of this river wall asset is unlikely to impact the footbridge or surrounding infrastructure, that potential of partial failure does immediately exist, so it does require immediate structural stabilisation attention, and would certainly require a partial closure of the adjacent Highway (York Road), in the event of any further displacement or observed movement. It is also worthy of note that the cost of mitigation will be substantially increased, should a full or partial collapse actually occur. This would be evidenced by the failure of Cumberland Road River Wall and the 12-million-pound stabilisation out turn cost, post failure.

With regard to NCN-28 and NCN-16, Both of these projects are potentially highly complicated, as until we have completed Stages 1 & 2 of the D&B designs (Including the Ground Investigation) the extent of the works remains unknown, although the budget costs discussed to-date are based on a piled solution, such being the most obvious approach.

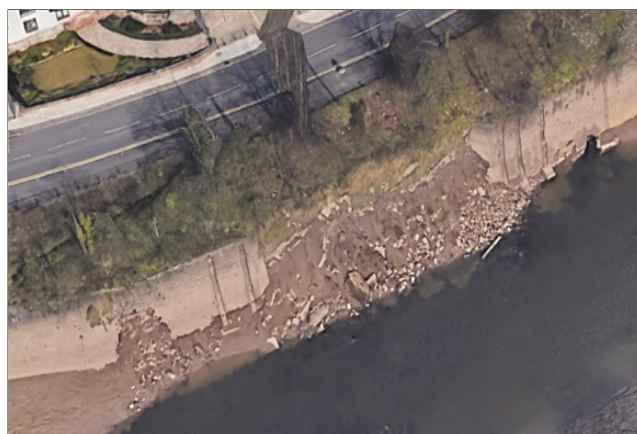
2. NCN16 The Gateway/Slipway (Adjacent to Gaol Ferry Entrance Gate)

Whilst the (SP) Critical Asset Overview Report focused on the localised masonry defect to the West of this structural failure, this river wall will require full structural repair, the remaining 30m length of river wall collapse to the East is of a much more and far higher critical priority but has not been addressed fully in the (SP) Report. This 30m failure has exposed the existing sedimentary rock face on the river bank, so the structural reinstatement of the lower river retaining wall and the ultimate scour protection restatement, will ultimately support for the higher level secondary walls on Cumberland Road and thus is a very critical high priority.

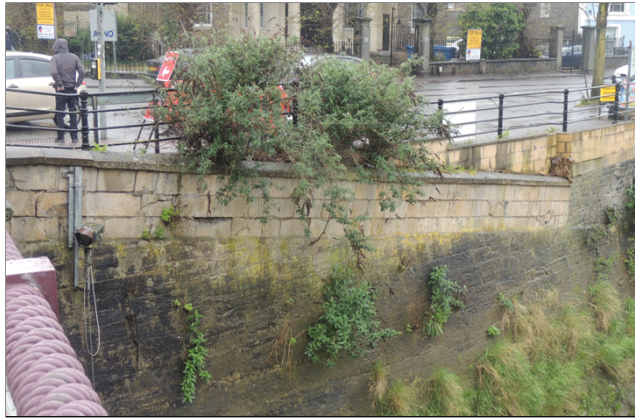
3. **NCN21/23 Bedminster Bridge wingwall (Adjacent to Bedminster Old Bridge)**

This is purely masonry displacement (rotational hinging) in the adjacent bridge wingwall though vegetation growth and overburden, which is easily rectified via traditional masonry reconstruction methods. The remedial works are deemed to be high priority, as the failure to address this structural issue, could lead to a partial collapse, which could endanger the footpath and adjacent Bus Shelter users, and would make the repair costs substantially much higher, although the risk of such a collapse is considered medium to low at the present time.

This facilitates the Principal Contractor (AGCL), to officially appoint the Principal Designer (Hydrock Consultants) who have noted a two-month design time, so the programme is showing a site commencement date in early 2024, with a revised budget estimate in the region of £150k + Prelims and added 40% Contingency.
