River Wall and Chocolate Path – Section B

BD79/13 Management Report

Document No. R002 | A

Client: Bristol City Council

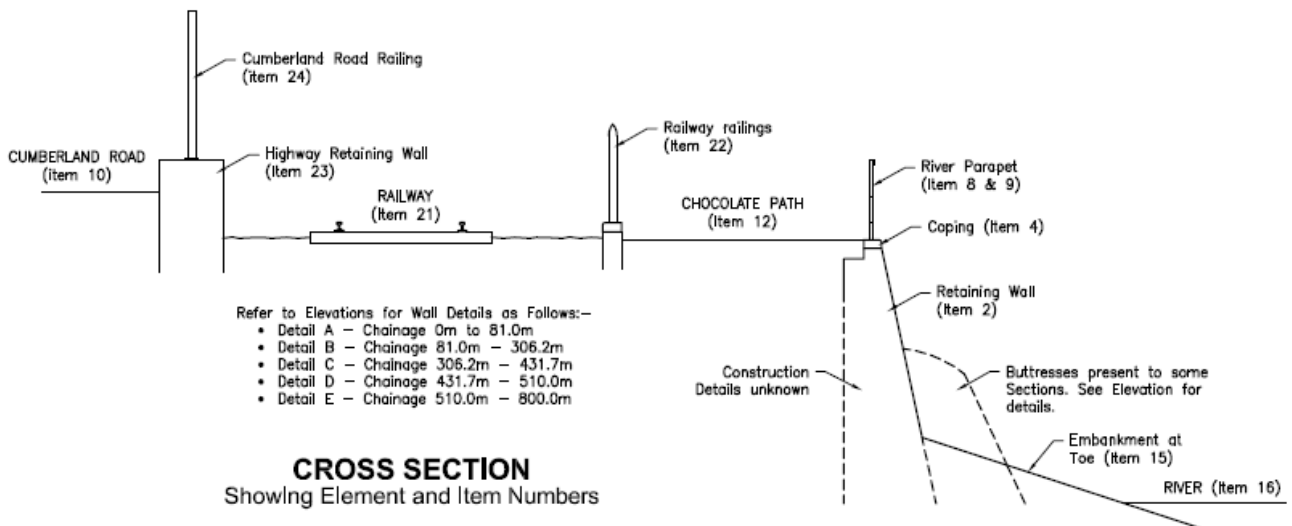
Defect Sketches:

Set	No	Element Description	S	Ex	Def	W	P	Cost	Comments/Remarks
Wall Elements	1	Foundations	4	C	6.6	K	TBC	TBC	1) Settlement and rotation of structure due to assumed slip circle failure. 2) & 4) Poor condition. The retaining wall has undergone significant settlement and rotation between 140m – 210m due to assumed slip circle failure. Multiple defects.
	2	Retaining Wall	4	C	M	K	TBC	TBC	
	3		Secondary						
	4	Parapet Beam/Plinth						Item 2	
Durability Elements	5	Drainage	2	D	8.1	Z	C	£5000	5) Condition unknown – assume some blockages. 6) None present 8) The paint coatings to the river parapet (5D) and railway railings (5E) have failed resulting in surface corrosion throughout.
	6	Movement/Expansion Joints							
	7	Surface finishes: wall							
	8	Surface finishes: handrail/parapet	5	E	4.1	K	C	Item 9	
Safety Elements	9	Handrails/parapets/safety fences	4	C	M	K	C	£43000	9) Corroded fixing to rails. Major deformation due to slip circle. Severe corrosion to several posts. Surface corrosion throughout. 10) Recently resurfaced. Good condition with no apparent defects. 12) Major settlement and undulations between Ch140 – 170m.

Foundations: Settlement and rotation of structure due to assumed slip circle failure.
