REPORT

Temple Gate MSCP Life Care Plan

Bristol City Council

April 2018

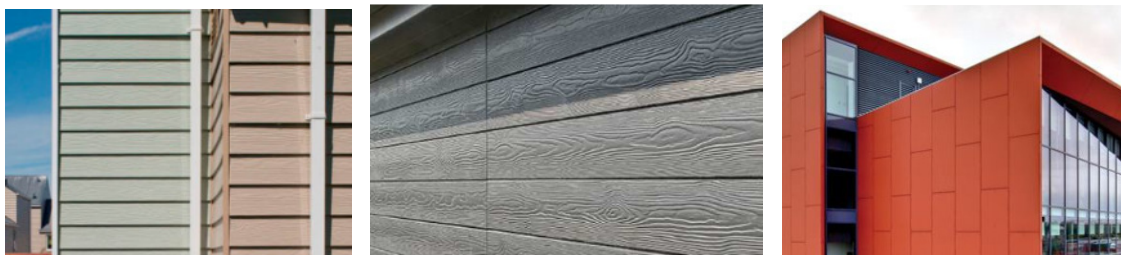
Figure 5-3 Cladding
Examples of maintenance-free cladding systems on the market to replace the deteriorating infill walls to the South Elevation

There is also concern that falling masonry might occur at any time. In light of this, we recommend urgent inspection, using a scaffolding tower, to properly examine the walls for defect and stability. It will also aid the preparation of the specification for remedial works required.

If the walls are found to require replacement, this could present an opportunity to re-clad the elevation with a maintenance-free cladding system such as those shown in Figure 5-3. These would of course incorporate suitable framework to provide the shear resistance required, but with an improved and relatively maintenance-free external appearance.

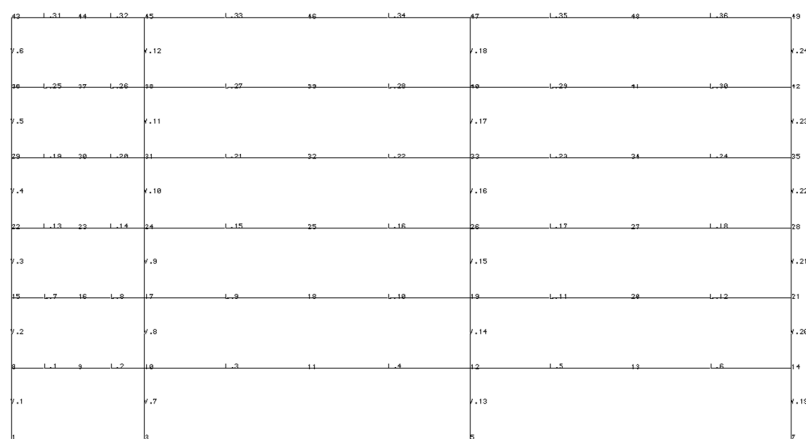
Figure 7-1

At the car park ends, the two semi decks are aligned vertically (Figure 7-1) while at mid length the decks are out of phase by half a storey height (Figure 7-2). The vertical height is 2.718m per storey.

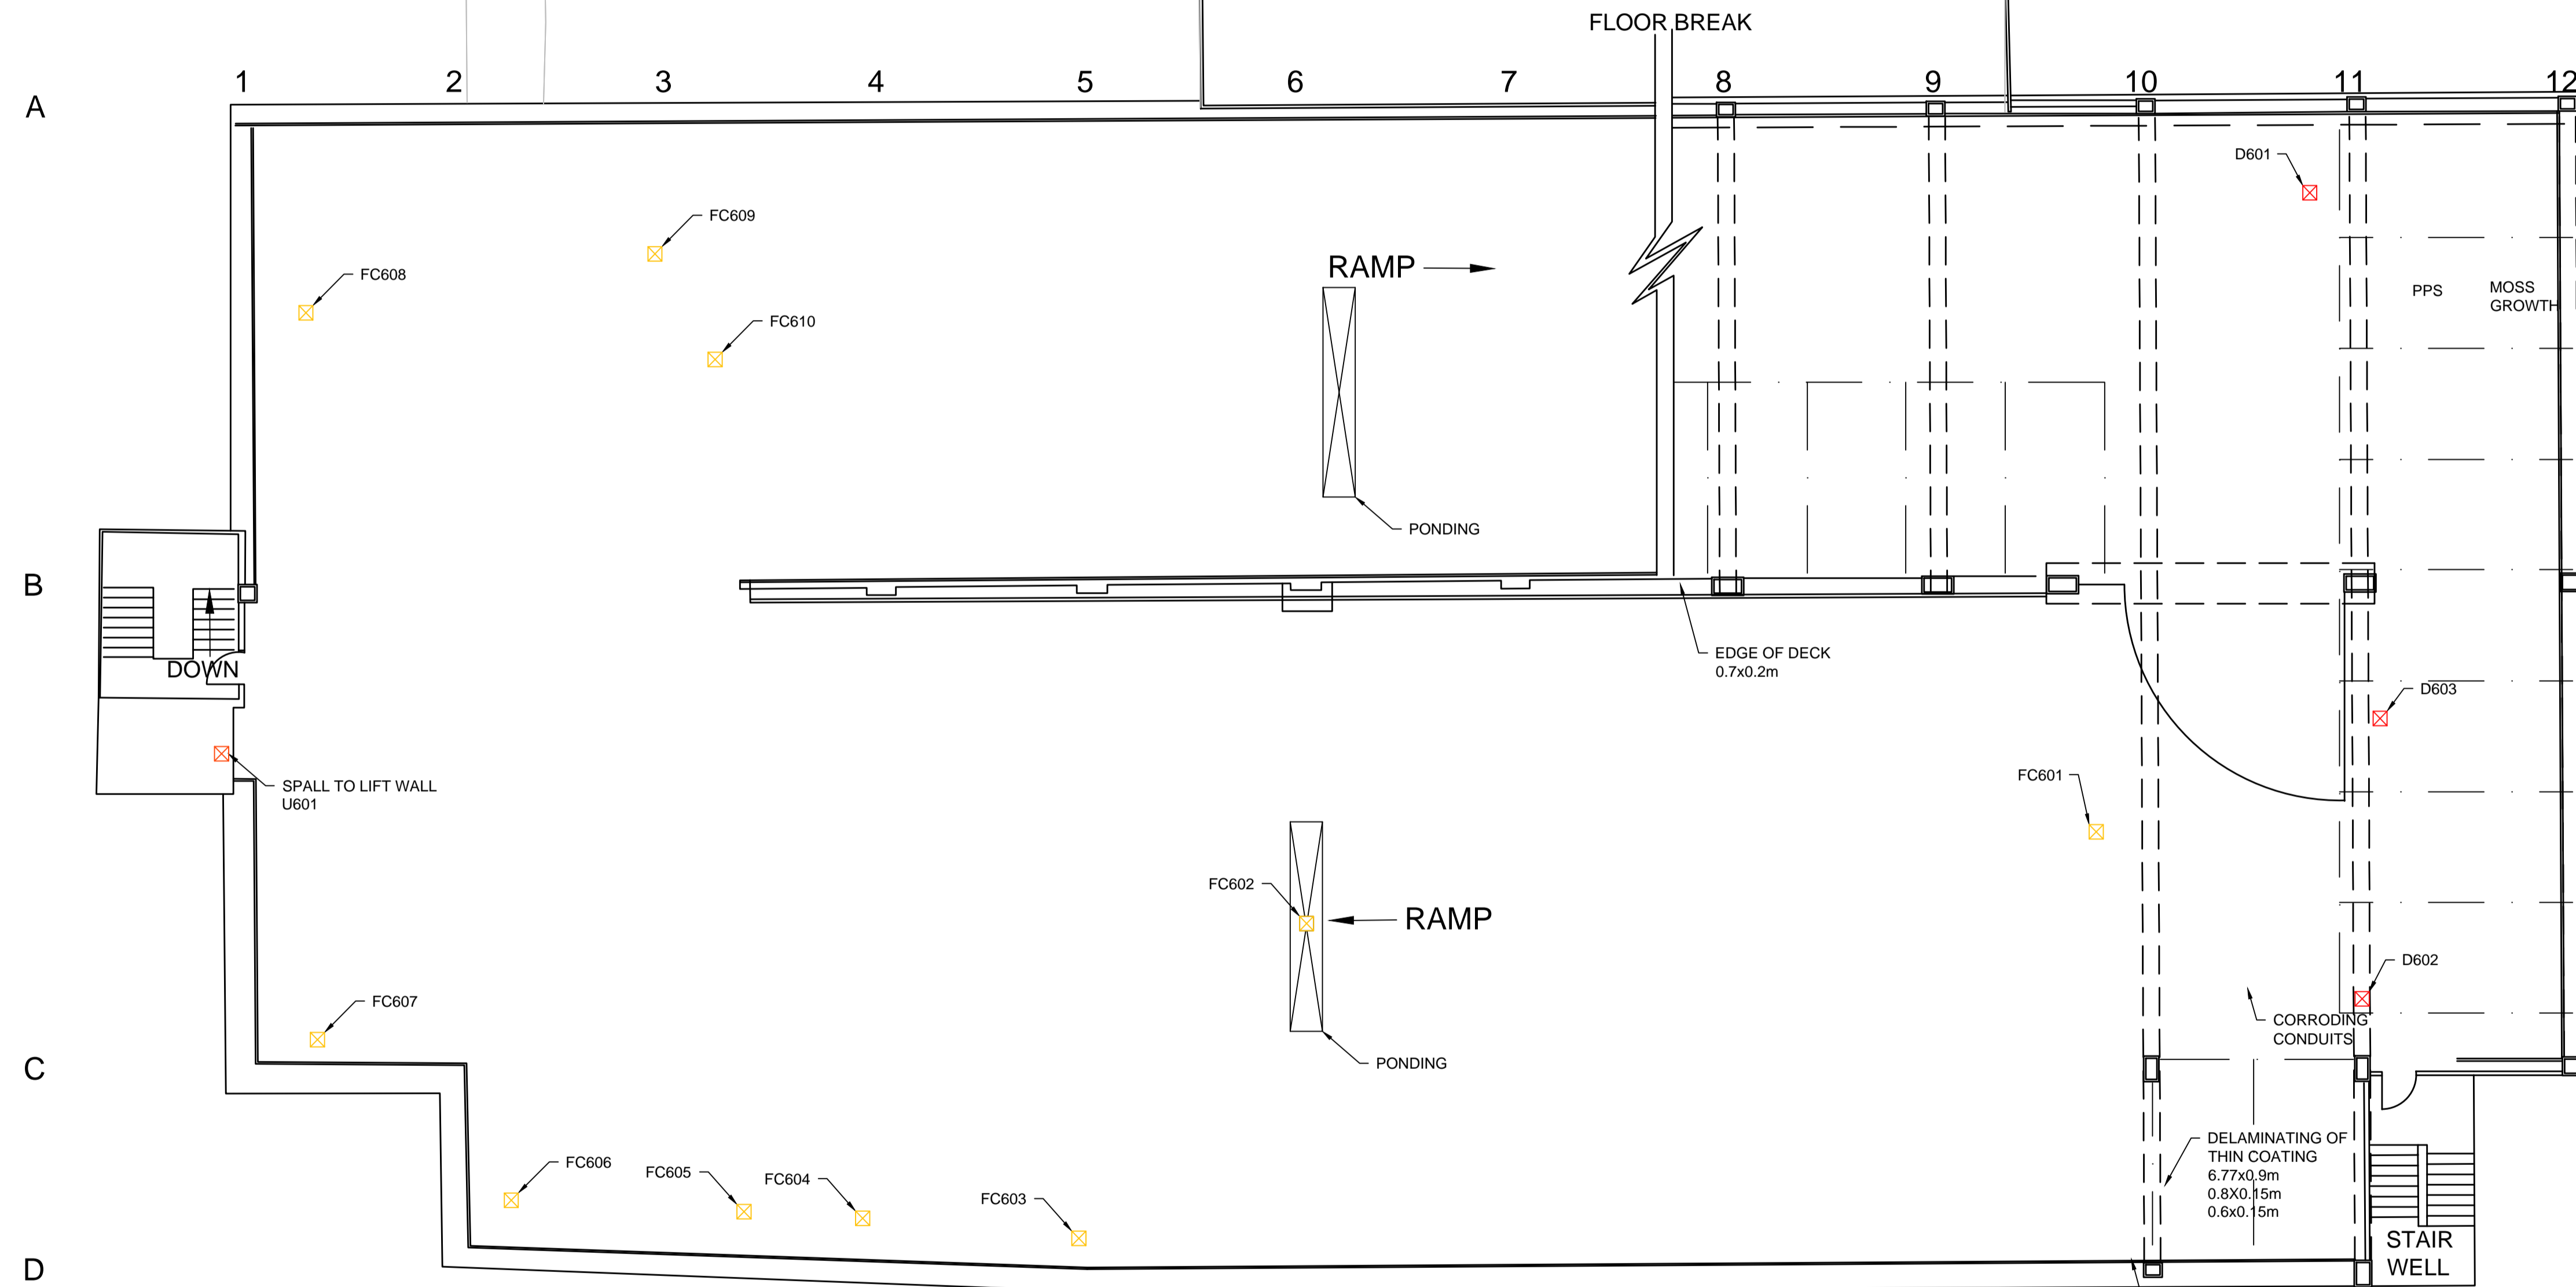
LEVEL 6 FLOOR PLAN
NOT TO SCALE

☒ DECK DEFECT

☒ FAILED SURFACING

CONCRETE REPAIR SCHEDULE - DECK		
REPAIR REFERENCE	LENGTH (mm)	WIDTH (mm)
D515	100	100
D516	100	150
D601	150	100
D602	500	200
D603	100	100

FAILED SURFACING SCHEDULE		
REPAIR REFERENCE	LENGTH (mm)	WIDTH (mm)
FC601.1	3400	400
FC601.2	1000	350
FC601.3	400	250
FC601.4	600	650
FC602	7250	1550
FC603	2600	650
FC604.1	350	100
FC604.2	250	100
FC605	100	100
FC606	550	750
FC607.1	400	250
FC607.2	850	100
FC607.3	100	100
FC608	250	100
FC609.1	400	200
FC609.2	100	200
FC610	2500	600

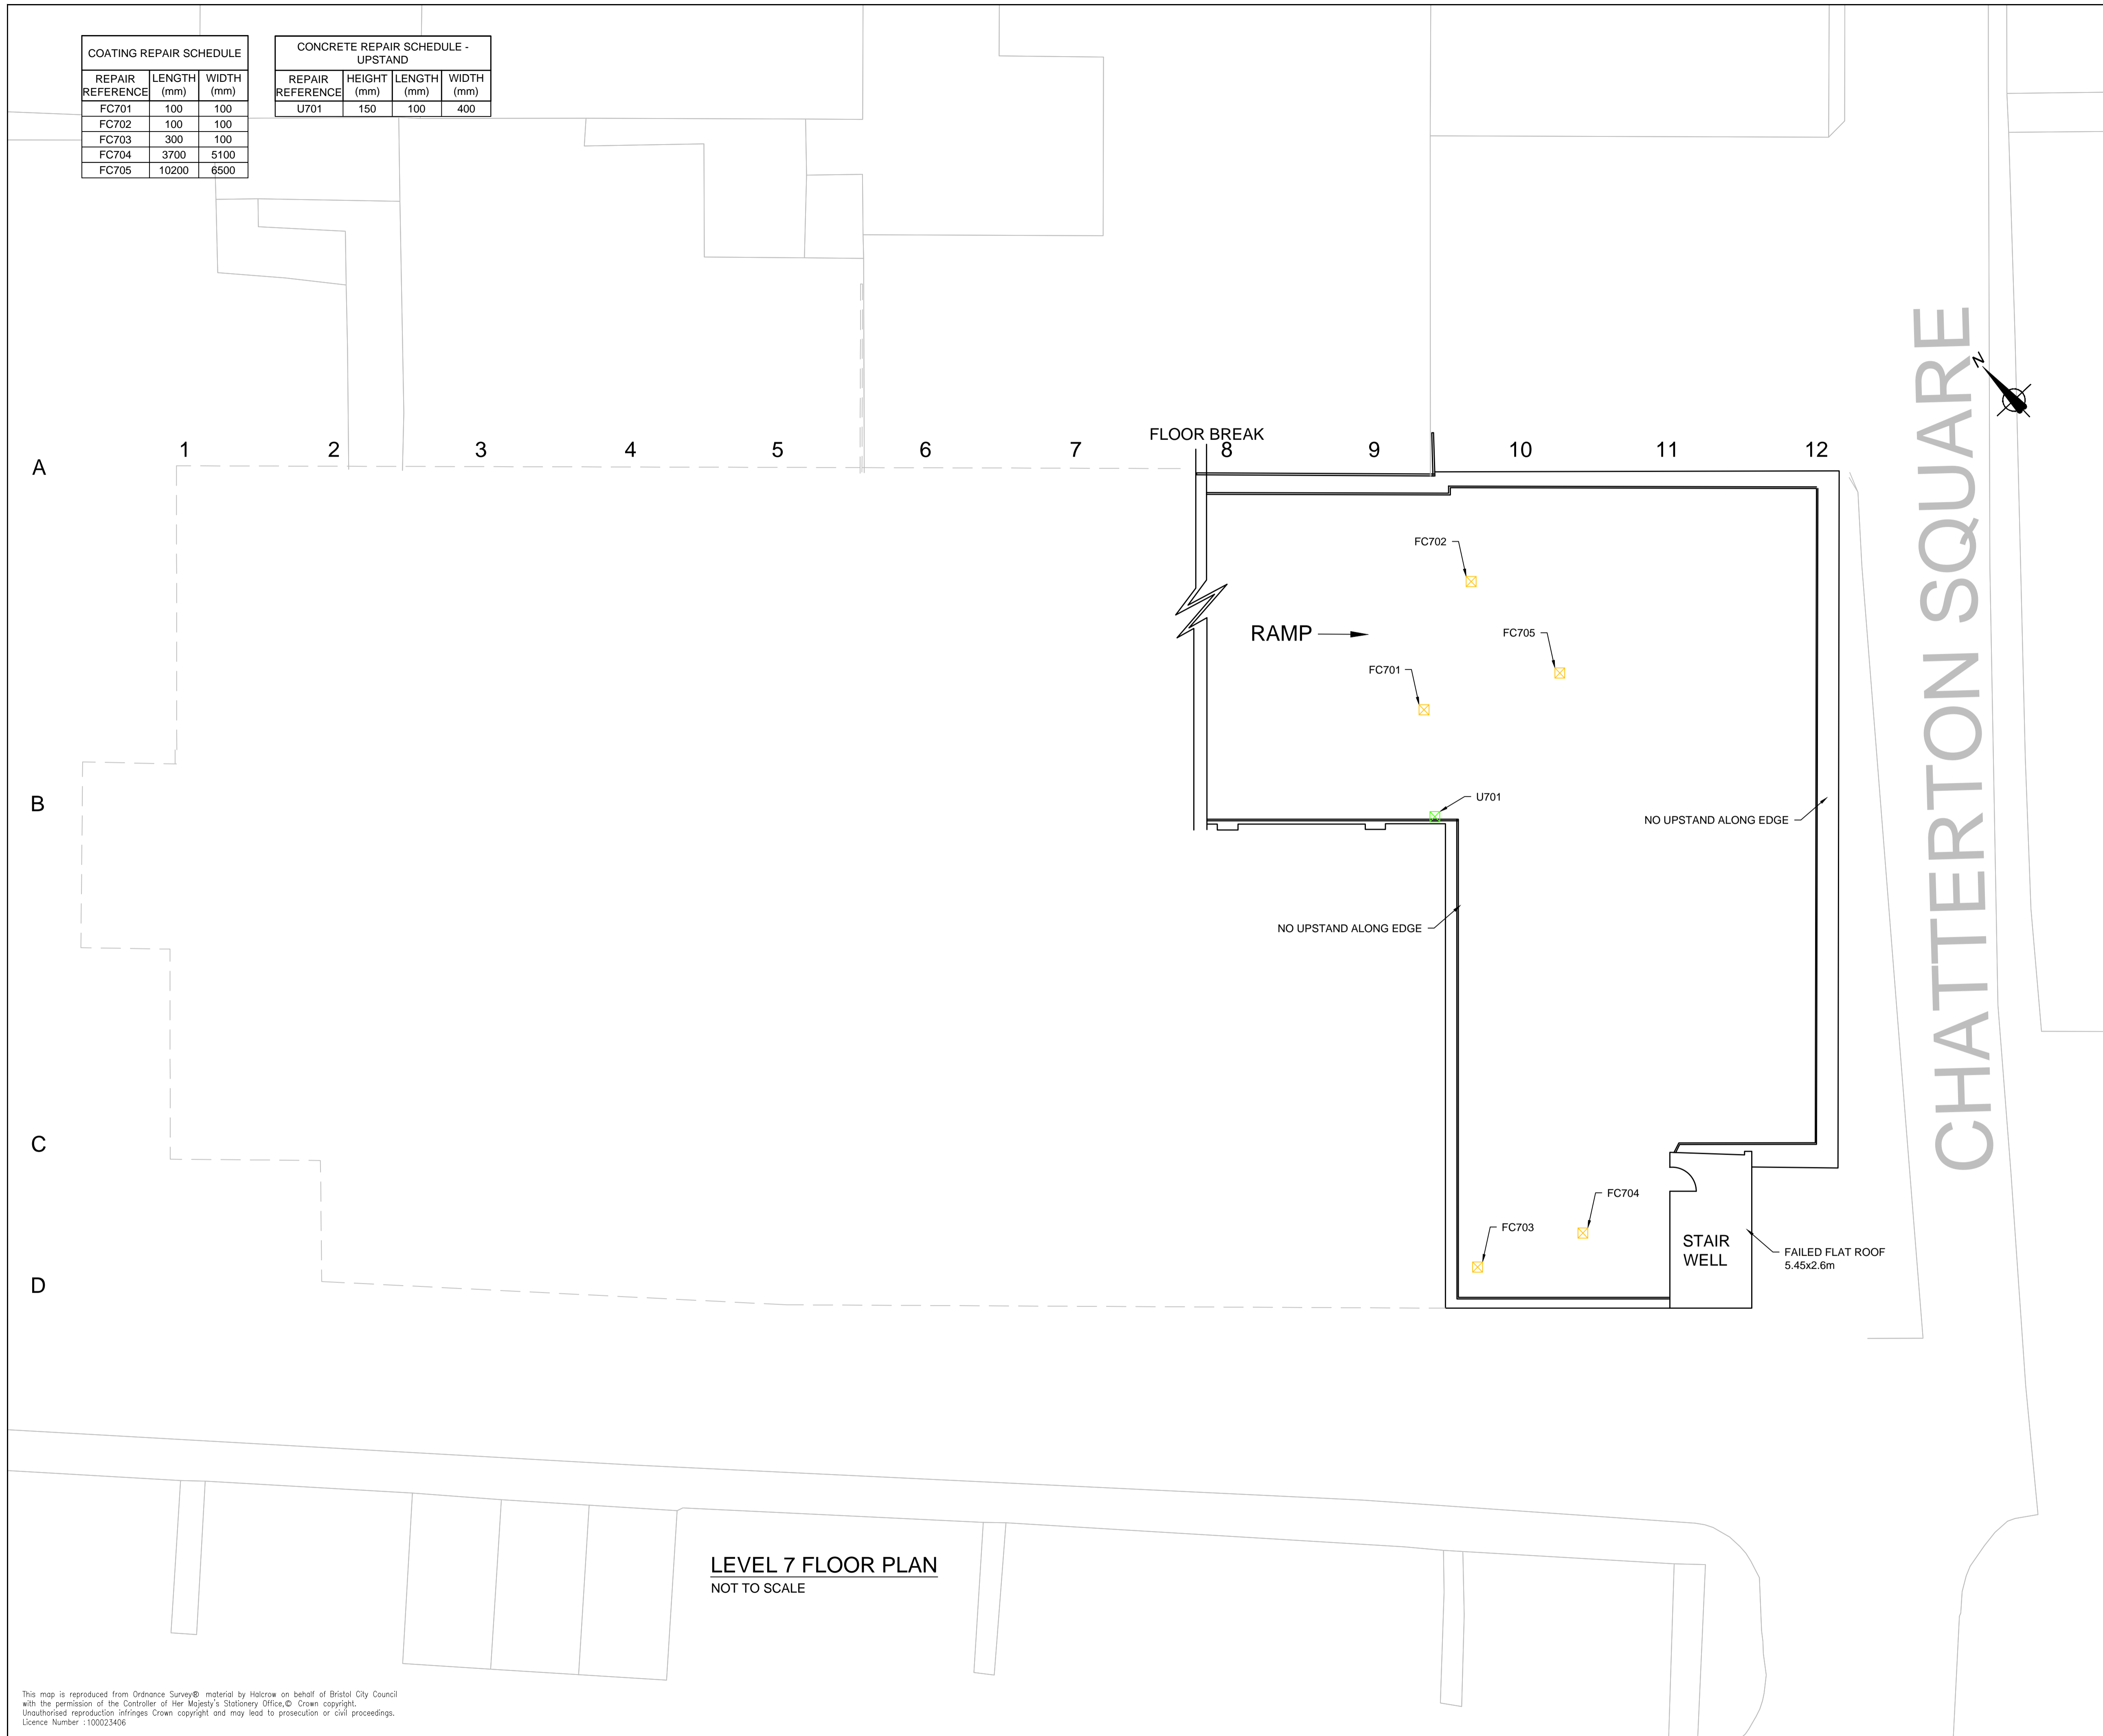
LEVEL 7 FLOOR PLAN
NOT TO SCALE

☒ UPSTAND DEFECT

☒ FAILED SURFACING

REPAIR REFERENCE	LENGTH (mm)	WIDTH (mm)
FC701	100	100
FC702	100	100
FC703	300	100
FC704	3700	5100
FC705	10200	6500

REPAIR REFERENCE	HEIGHT (mm)	LENGTH (mm)	WIDTH (mm)
U701	150	100	400

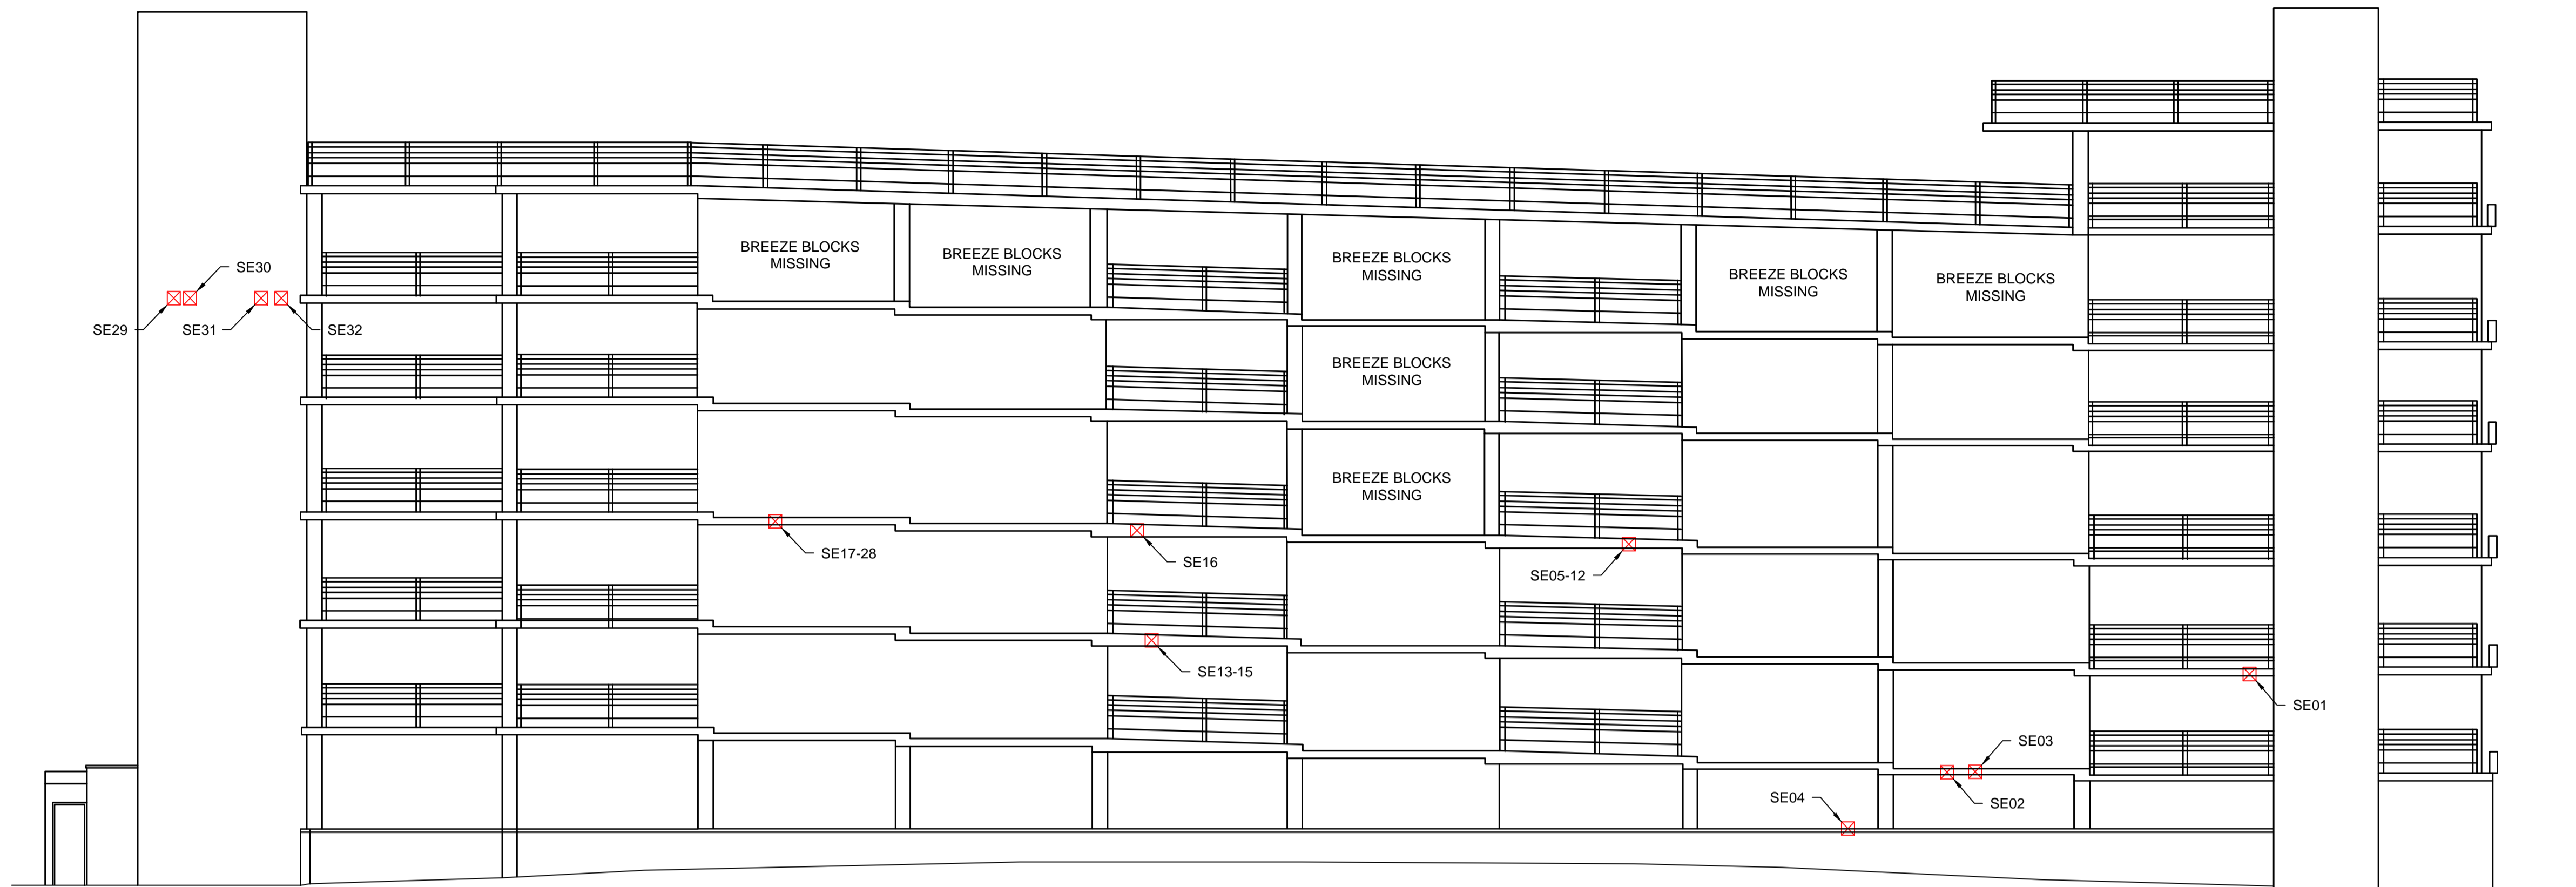
SOUTH ELEVATION
NOT TO SCALE

☒ ELEVATION DEFECT

CONCRETE REPAIR SCHEDULE - SOUTH ELEVATION

REPAIR REFERENCE	LENGTH (mm)	WIDTH (mm)
SE01	100	100
SE02	100	100
SE03	100	100
SE04	50	350
SE05	100	100
SE06	100	100
SE07	100	100
SE08	100	100
SE09	100	100
SE10	100	100
SE11	100	100
SE12	100	100
SE13	100	100
SE14	100	100
SE15	100	100
SE16	500	300
SE17	100	100
SE18	100	100
SE19	100	100
SE20	100	100
SE21	100	100
SE22	100	100
SE23	100	100
SE24	100	100
SE25	100	100
SE26	100	100
SE27	100	100
SE28	100	100
SE29	100	100
SE30	100	100
SE31	100	100
SE32	200	200

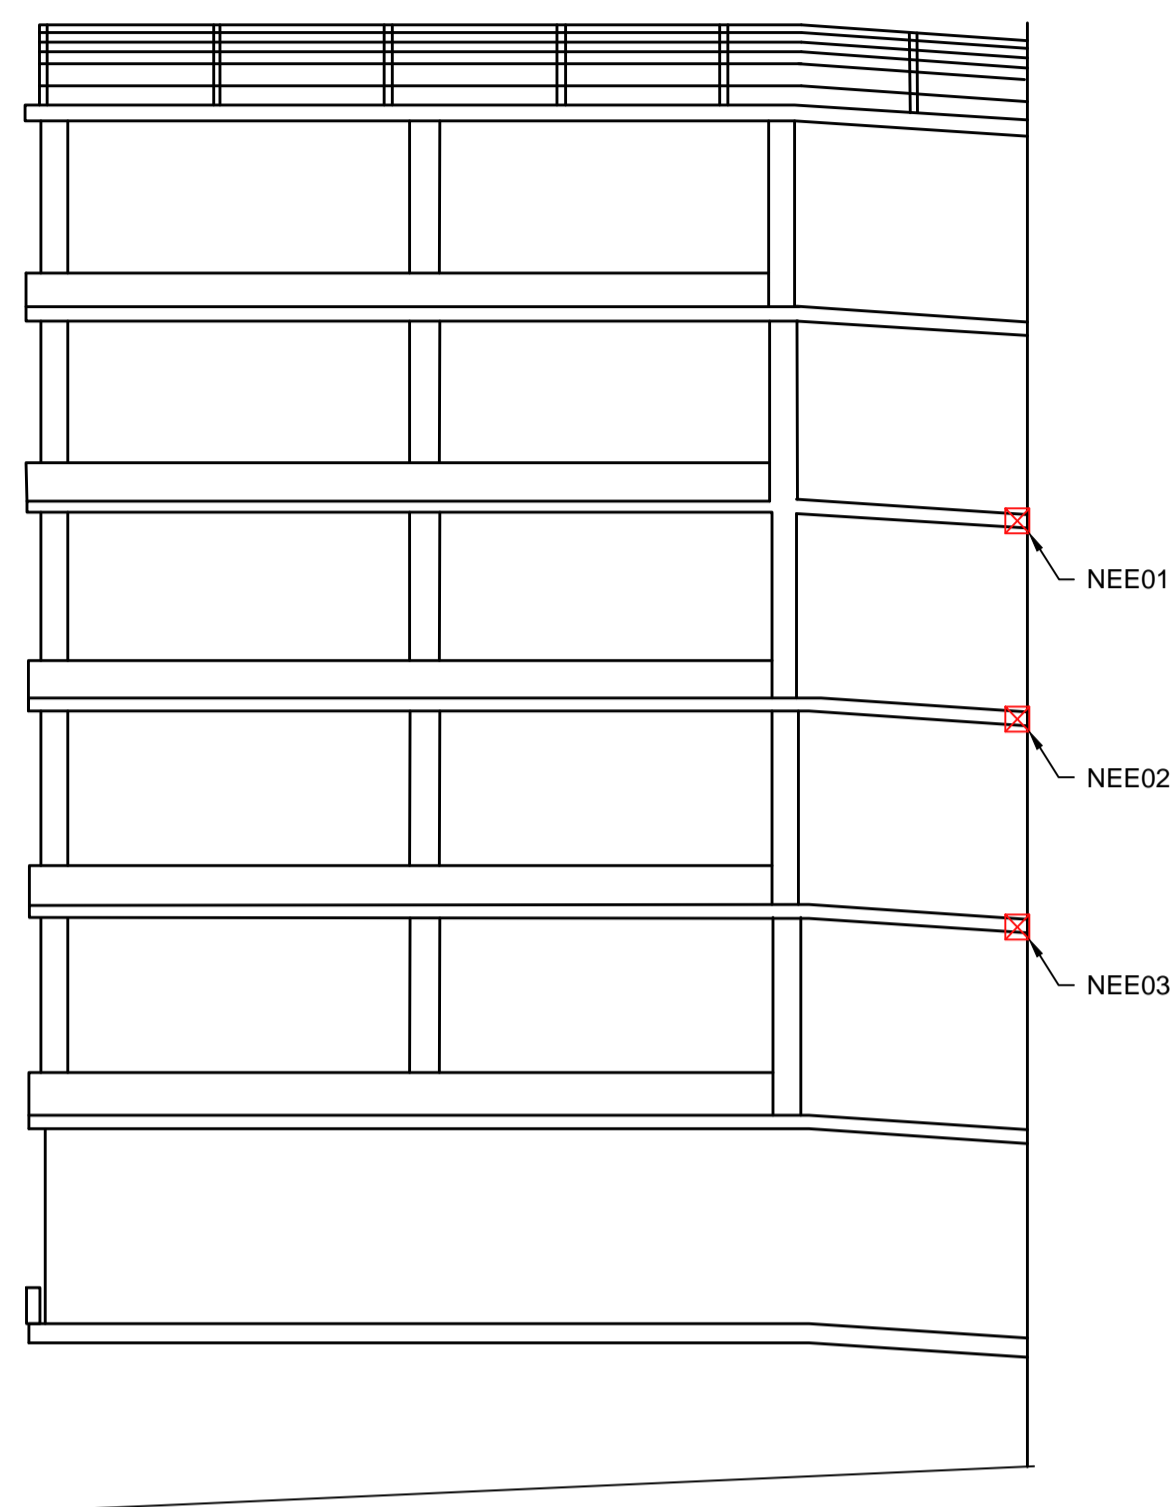
NORTH EAST ELEVATION
NOT TO SCALE

☒ ELEVATION DEFECT

CONCRETE REPAIR SCHEDULE - NORTH EAST ELEVATION

REPAIR REFERENCE	LENGTH (mm)	WIDTH (mm)	DEPTH (mm)
NEE01	500	175	150
NEE02	750	175	150
NEE03	1000	175	150
