REPORT

West End MSCP Life Care Plan

Bristol City Council

May 2018

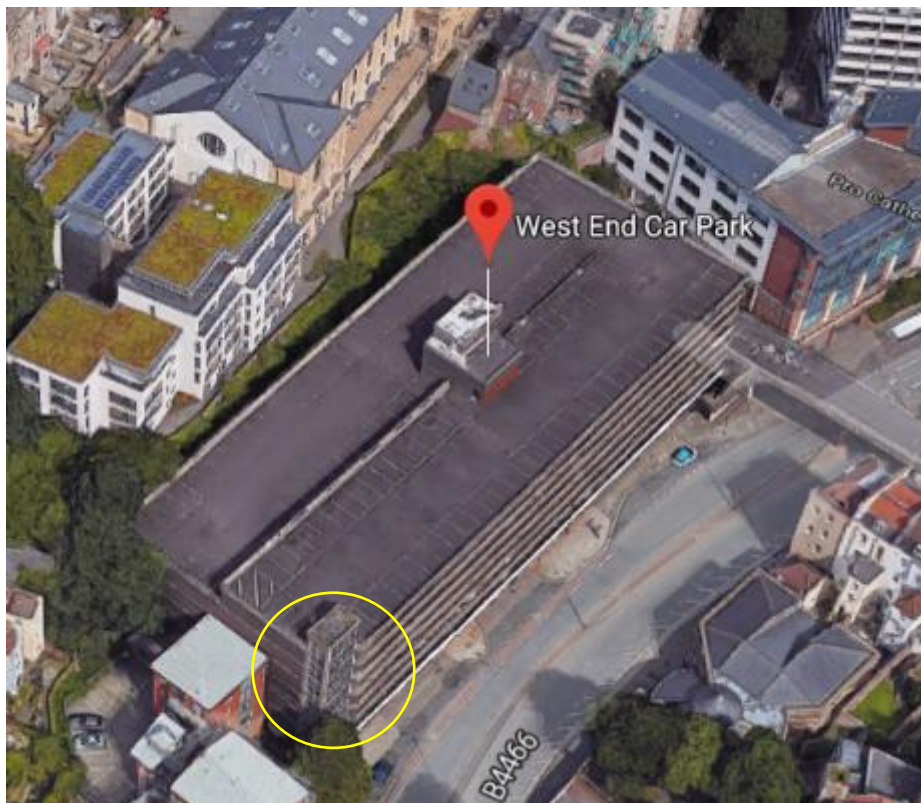
Figure 5-13 Location of south stairwell (ringed)

The full-height staircase, to the southeast corner of the car park (Figure 5-13), comprises of pre-cast concrete stairs and integral landings (215mm thick), resting on the car park framework at each floor level. They incorporate yellow paint applied non-slip nosings.

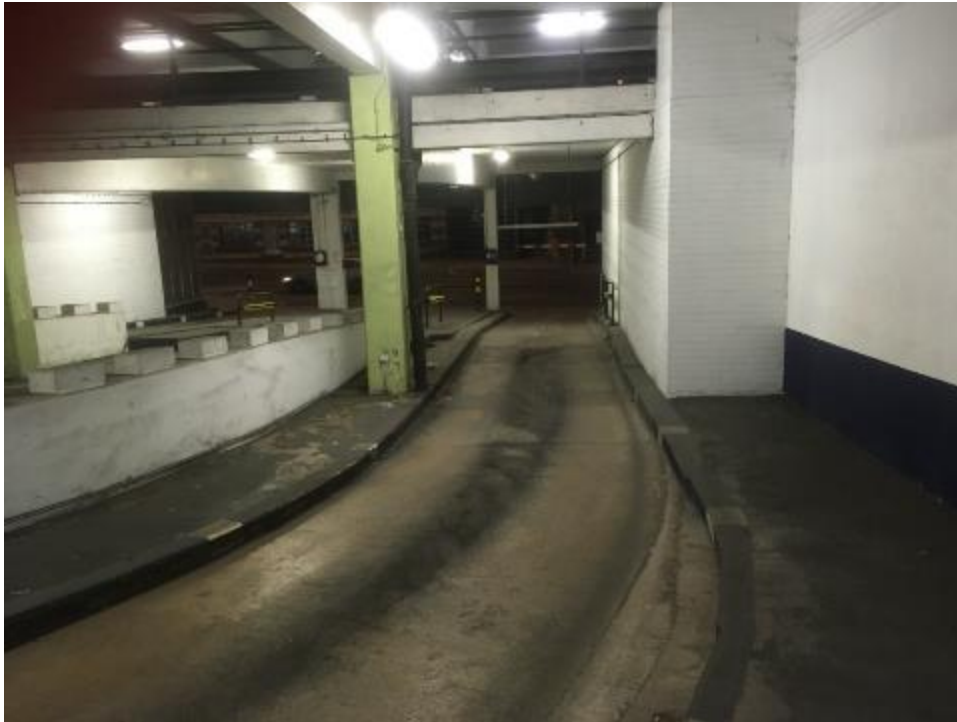
Figure 5-18 Entrance ramp

The ground-level access from Jacob's Wells Road is constrained by the layout of the superstructure (i.e. the columns and beams supporting the decks above) and walls (see Figure 5-18).

Illustrating the bottleneck formed by the retaining wall, column, down pipe, kerbs and masonry wall

CH2M have reviewed the ground floor entry/exit layout and determined that the only viable option is to move the existing kerb back. BCC have moved the kerb before and the benefits gained would be limited as the width of only one lane can be improved. The proposed arrangement is shown in CH2M Drawing 673846-WE-XX1-Rev A, an extract of which is included in Figure 5-19.

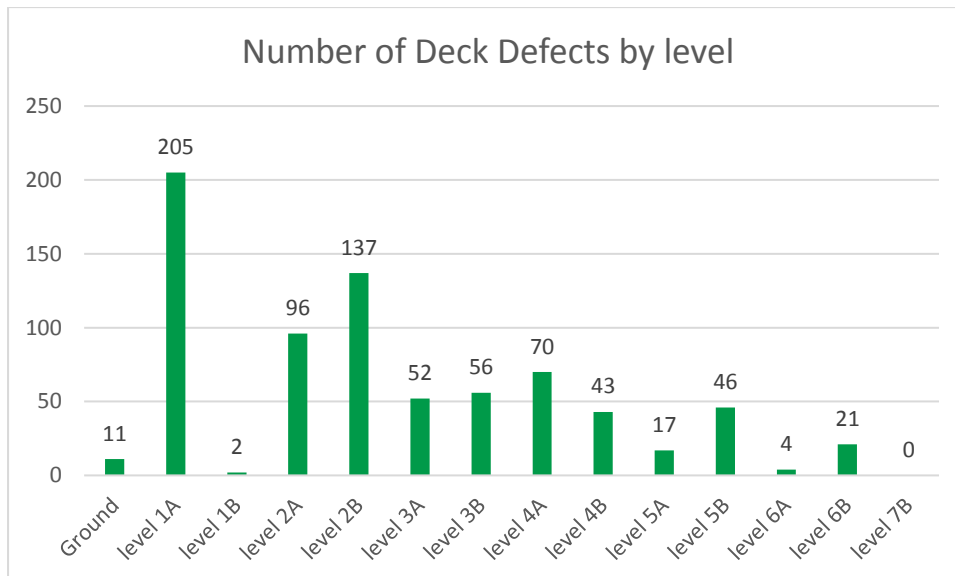
Chart 6-1 Number of defects on each deck

A summary of concrete defects identified is presented in the Charts 6-1 and 6-2. Of note is the general pattern of reduction of the number of deck defects with increasing level in the car park, the large number of defects at Levels 1A, 2A and 2B, and the absence of these defects at Level 1B (coated with mastic asphalt).
