Appendix A

Harbour & River Avon asset condition surveys – high priority conclusions & recommendations

Executive Summary

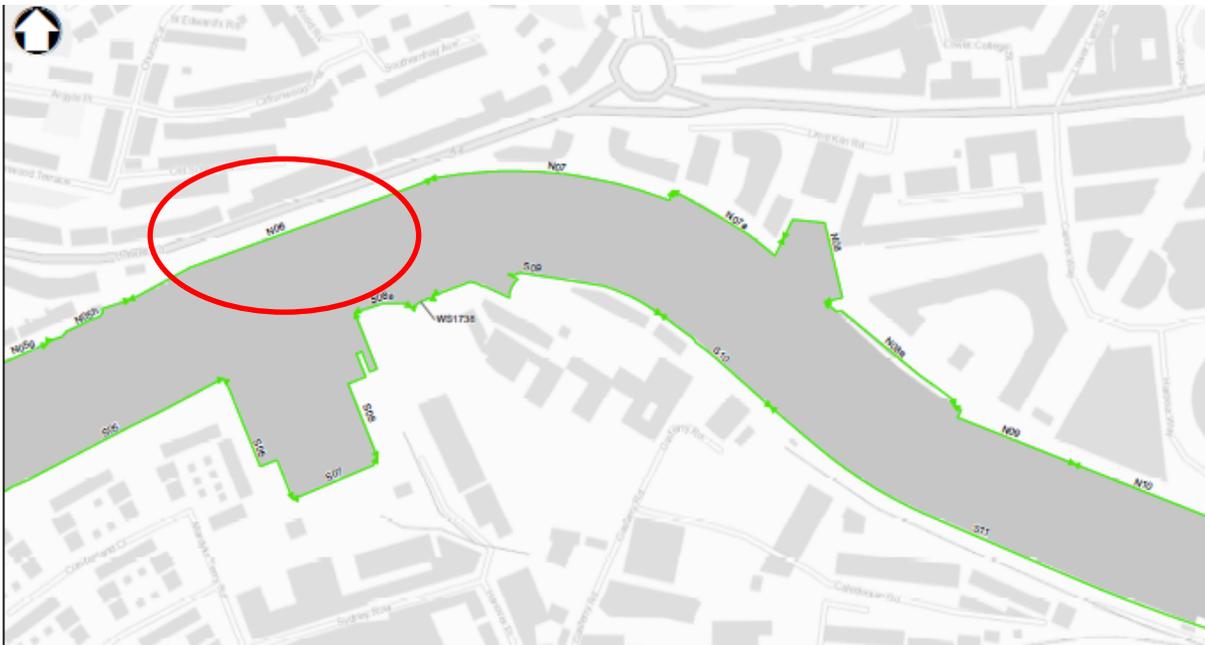
N06

North side of the harbour, adjacent to Hotwells Rd, where the Grain Barge is moored

Deformation of underwater arches and areas of lost masonry, see image below showing deformation of arches.

If the wall were to collapse, there is a risk that Hotwell Road will also be affected by a loss of support and lane closures would be necessary. There are boats moored along the asset in the vicinity of the critical defects and there is the potential for them to be damaged by falling masonry

- Install and monitor survey points
- Dive inspection of affected arches

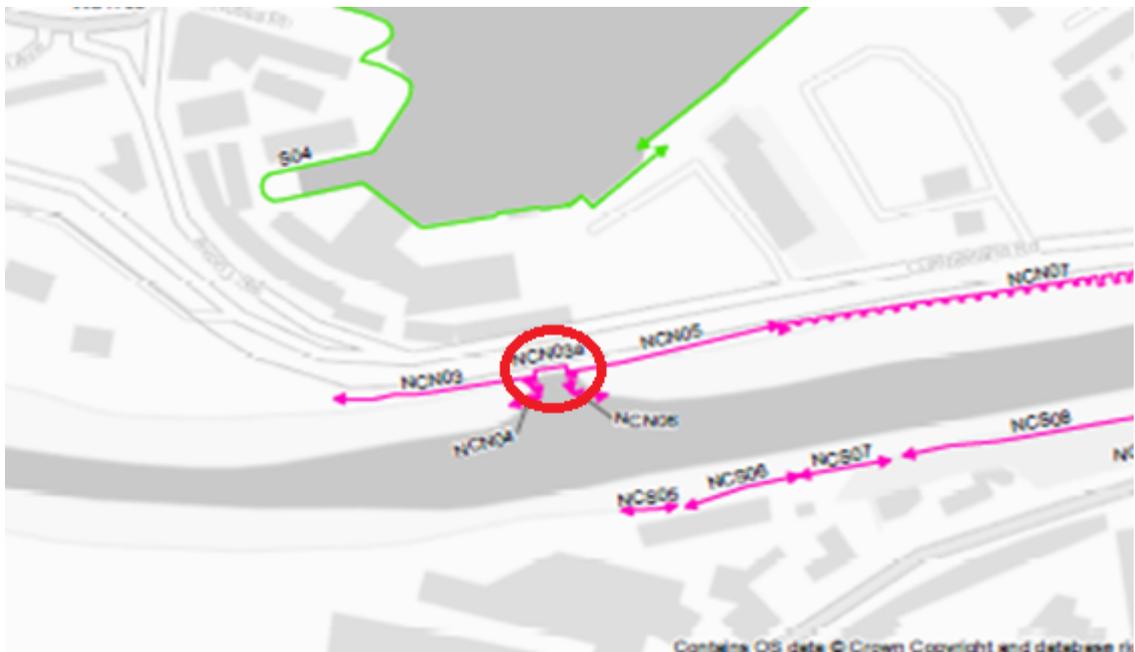
NCN03a

Steel beam supporting chocolate path where it bridges the Underfall sluices

Severe corrosion of steel beam as shown in image below

Collapse of the structure poses risk to life, reputational risk, financial risk and loss of function of Underfall sluice gates. Loss of the sluice gates would result in a loss of the ability to control the water level in the harbour with far reaching consequences.

- Cordon off bridge to prevent pedestrian access (actioned)
- *Motts recommendation*: Investigation to determine the capacity of the girder and place load restrictions on the bridge. Action subsequent recommendations accordingly
- BCC structures recommendation: no further investigation required. Replace girder

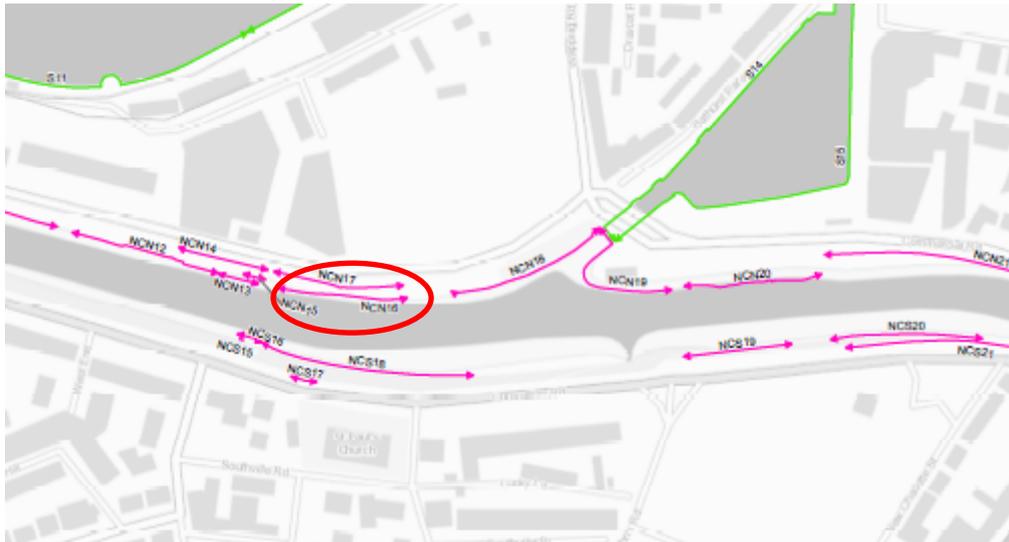
The critical section of the asset is an area of lost masonry measuring 6m x 4.5m

The failure of NCN16 could cause a failure in NCN17 resulting in a collapse of the footpath and partial collapse of Cumberland Road. There is a risk of major travel disruption.

- Install and monitor survey points
- Undertake repairs of the critical section

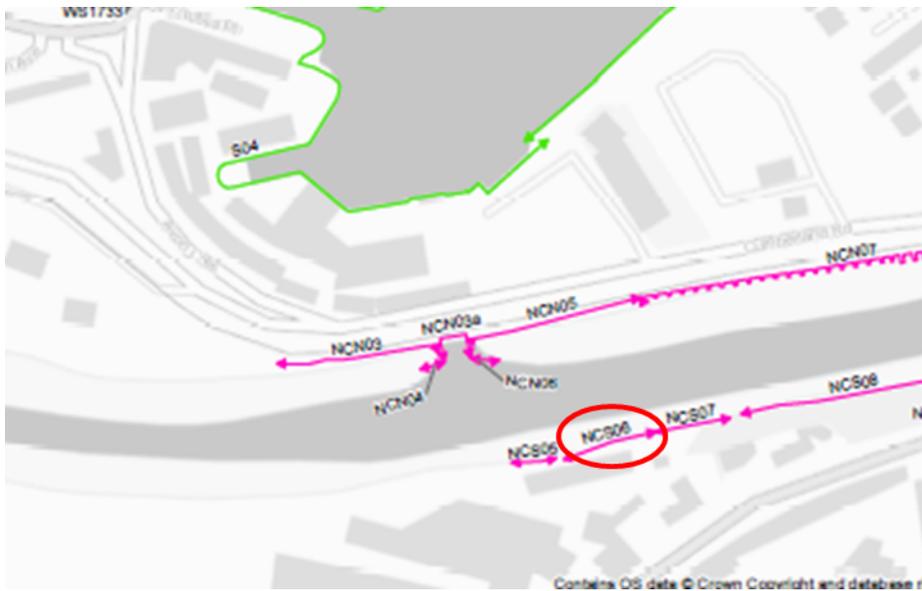
NCS06

Riverside wall set back from Coronation road, adjacent to industrial / warehouse building

Several areas of collapsed wall along the length of the asset and the remaining masonry is generally in a poor condition as shown the image below.

Potential for a loss of support to building foundations and the building could collapse, presenting risk to life.

- Conduct investigation to gauge whether the asset is providing direct support to the building at the western end and to confirm the depth of foundations of the building behind

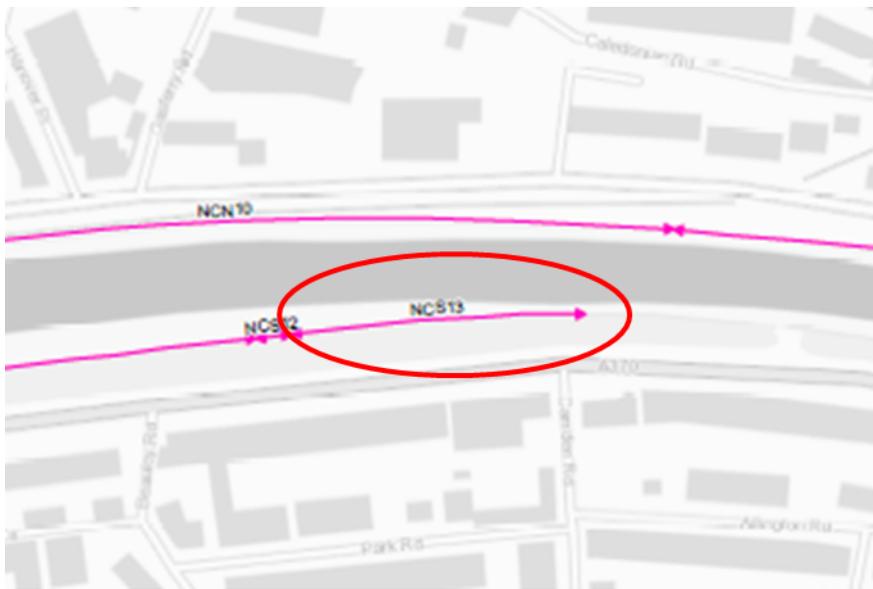
NCS13

Riverside wall adjacent to Coronation Road in vicinity of Camden Road

Numerous collapsed sections along the full length of the asset and the masonry is in a poor condition with deformations noted. Scour is affecting the rock outcrops which the asset is constructed on.

If there was a loss of support to the embankment, Coronation Road may be affected. There is a risk of major disruption to travel.

- Install and monitor survey points
- Repairs to eastern section of the asset where the embankment is directly supported by the wall

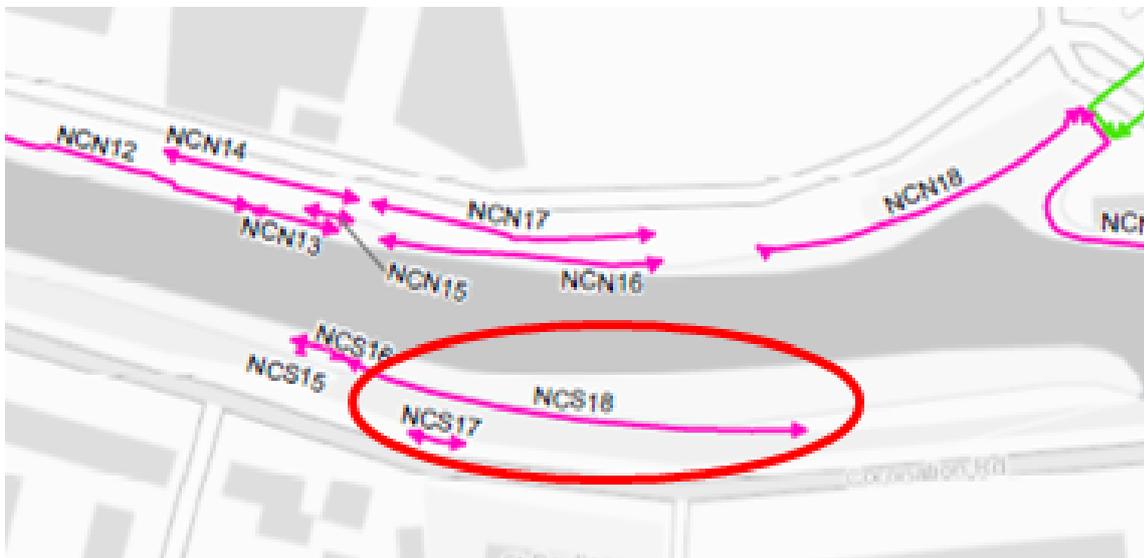
NCS18

Adjacent to Coronation Road near Gaol Ferry Bridge

Several collapsed sections and areas of deformation along the length of the asset including slipway

Coronation Road may be affected by a loss of support and failure. There is a risk of major travel disruption

- Install and monitor survey points
- Repairs to the areas of deformation and collapsed sections where the wall directly supports the embankment

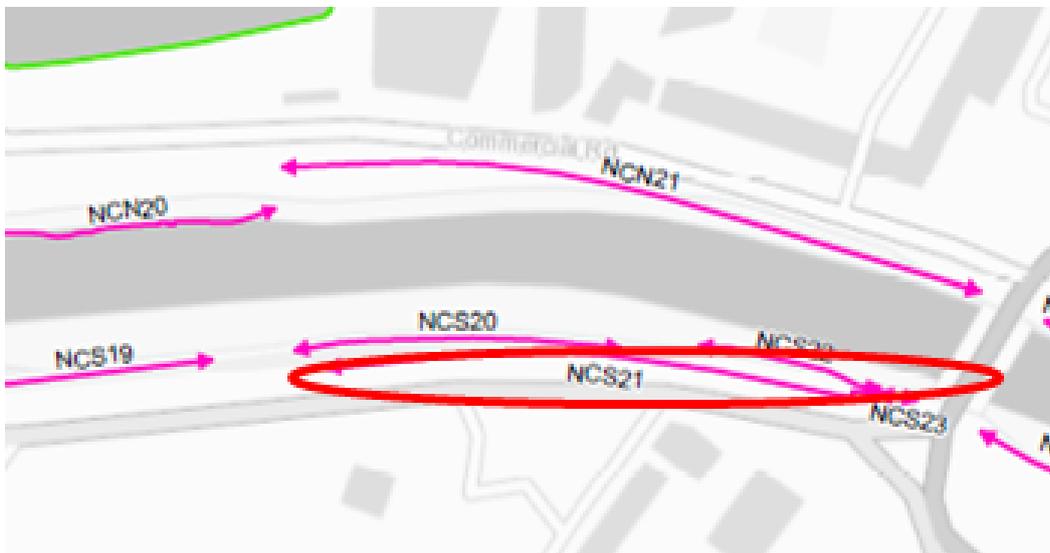
NCS21

Adjacent to Coronation Road east of Gaol Ferry Bridge

Significant deformed area situated at the eastern end of the asset

Loss of support/collapse of the footpath is likely in the event of a failure. Load restrictions and a partial closure would be necessary. There is a risk of major travel disruption.

- Protect rear of the footpath with barrier
- Undertake vegetation removal at critical location and repairs to the area of deformation

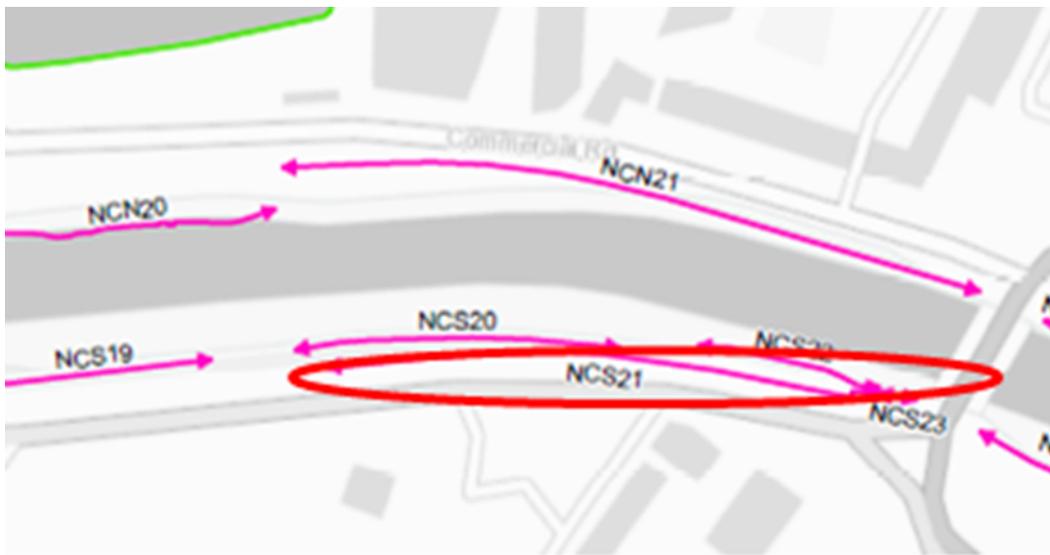
Coronation Road adjacent to Bedminster Bridge Roundabout

Area of deformation at the crest of the wall adjacent to Bedminster Bridge roundabout

Loss of support to footpath and a collapse is likely in the event of a failure. Load restrictions or a partial closure may be necessary. There is a risk of major travel disruption.

- Protect rear of the footpath with barrier
- Vegetation removal at critical location
- Repairs to the area of deformation

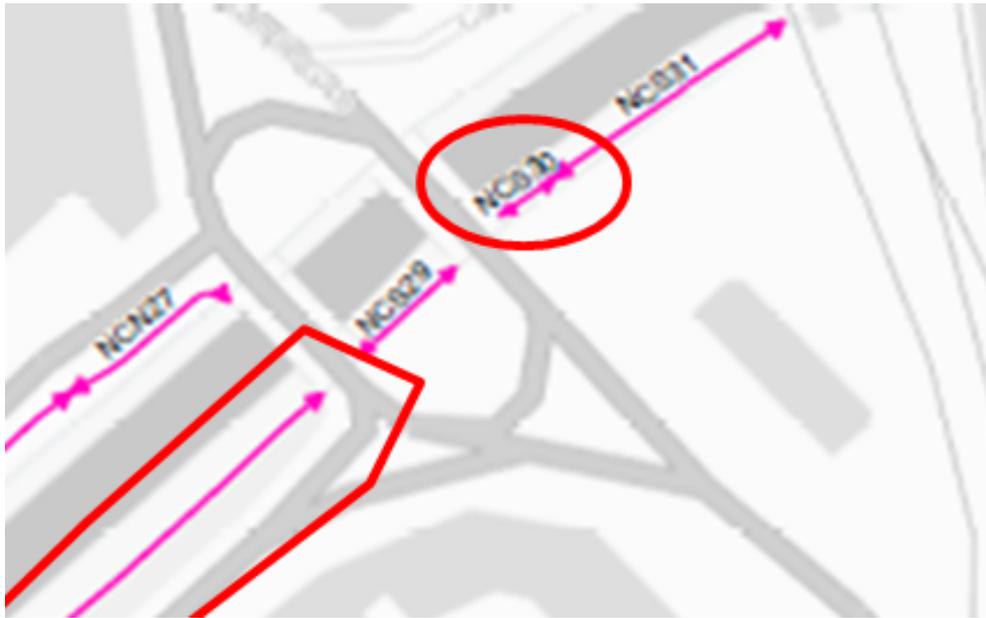
Immediately to the east of Bath Bridge Roundabout on south side of river

The arch adjacent to Bath Bridge Roundabout has failed from its springing point and the masonry is bulging significantly. There are also areas of collapsed masonry above this arch

Collapse of the arch will cause a loss of support to the retained material leading to a collapse of Network Rail land. It would also expose the edge of the bridge abutment and is likely to affect the stability of the road approaching the bridge. Bath Bridge Roundabout is not expected to be damaged as a result of a failure, there is potential for the road approaching the bridge to require a partial closure. The NR access road is likely to be affected, risk to life if people are on the land close to the river used for car parking.

- Install barrier to prevent pedestrian access
- Installation of props or ties to restrain the bulging area and carry out repairs / reconstruction

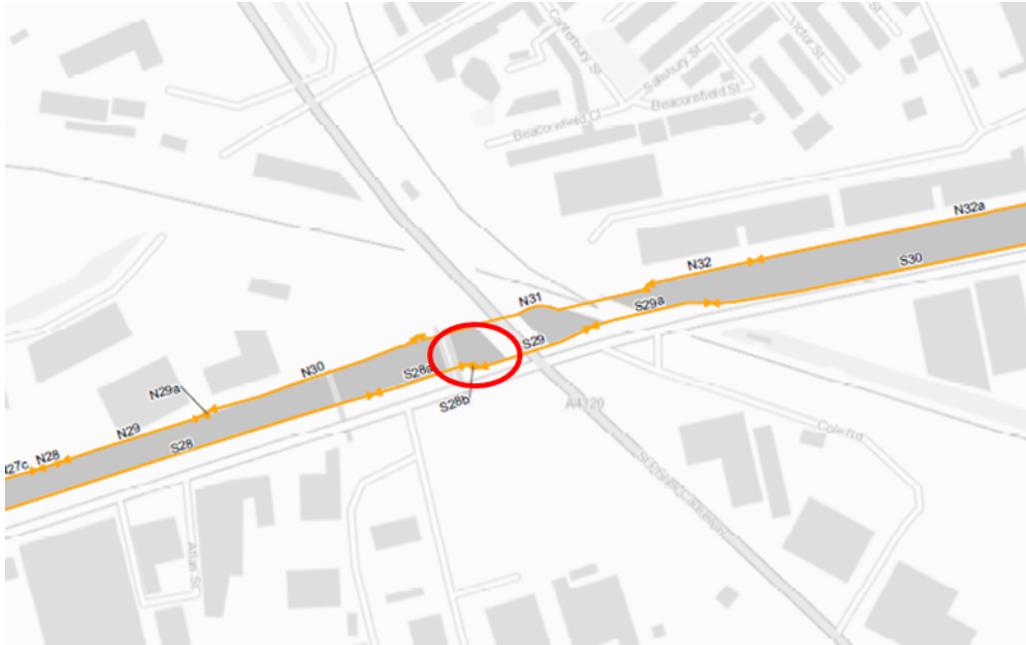
North side of Feeder road (canal south bank), in vicinity of St Phillips Causeway flyover

There are large areas of lost masonry underwater at the western end and numerous capping beam failures along the length. There is an extensive amount of vegetation growth from gaps between the concrete planks. There are several large areas of deformation visible on the capping beam
