## Harbour Condition Survey - Appendix B - Structural Recommendations

**Figure 1. Location of all identified 11 highest priority assets (Refer to following Asset information)**

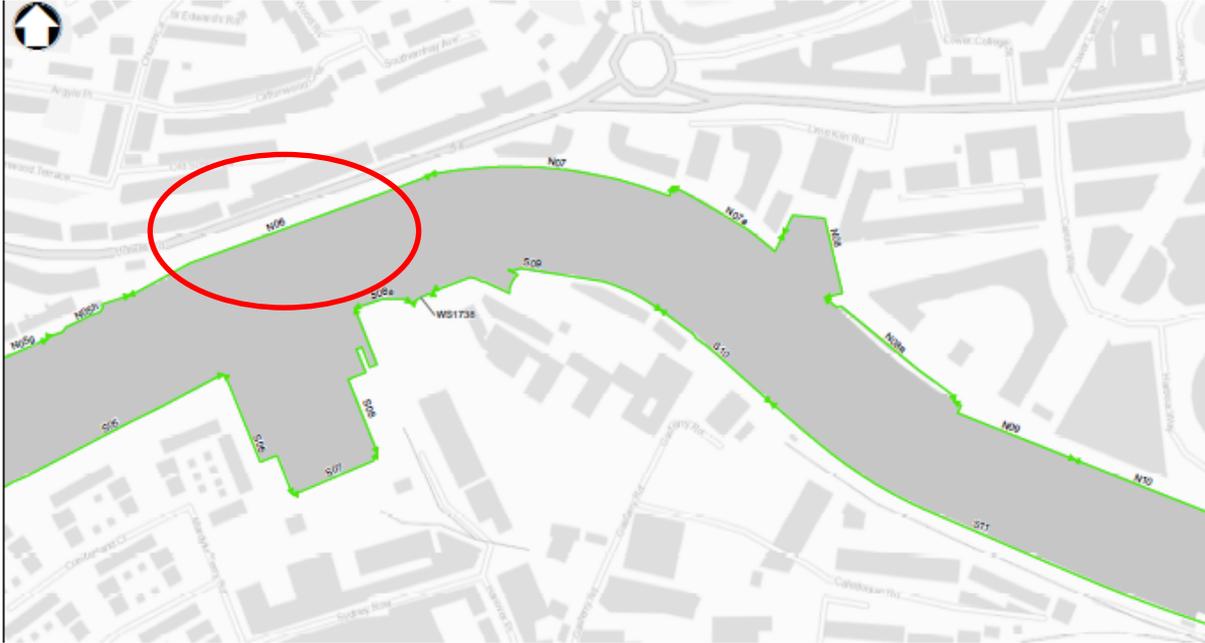
North side of the harbour, adjacent to Hotwells Rd, where the Grain Barge is moored

Deformation of underwater arches and areas of lost masonry, see image below showing deformation of arches.

If the wall were to collapse, there is a risk that Hotwell Road will also be affected by a loss of support and lane closures would be necessary. There are boats moored along the asset in the vicinity of the critical defects and there is the potential for them to be damaged by falling masonry

- Install and monitor survey points
- Dive inspection of affected arches

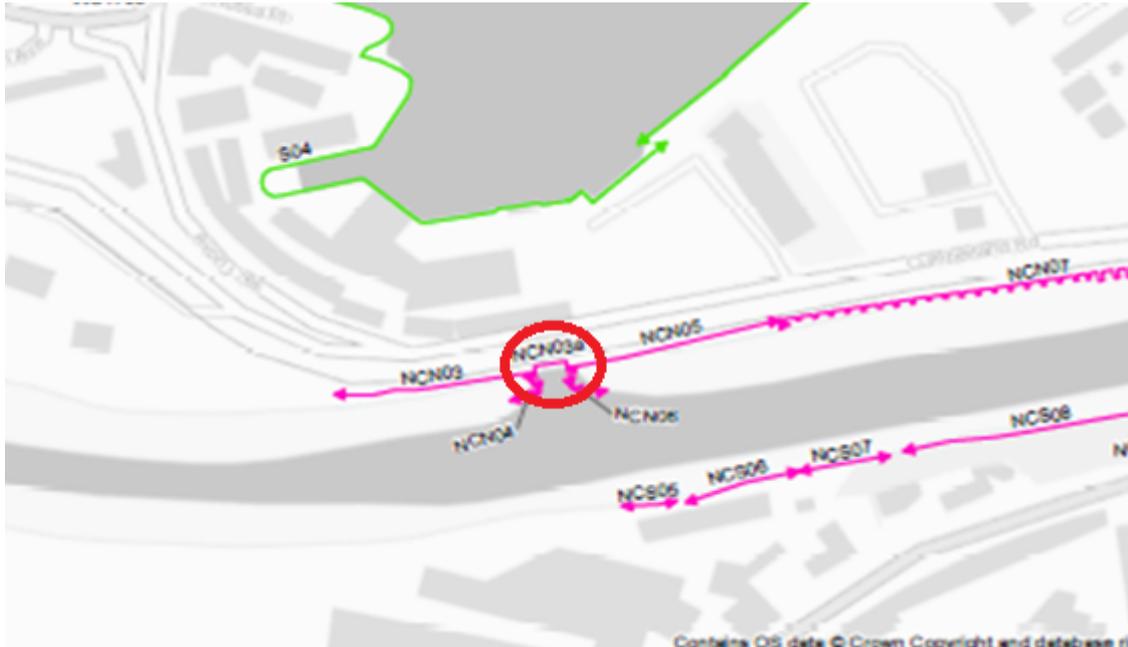
Steel beam supporting chocolate path footbridge where it bridges the Underfall sluices

Severe corrosion of steel beam footbridge as shown in image below

Collapse of the structure poses serious risk to life, reputational risk, financial risk and loss of function of Underfall sluice gates. Loss of the sluice gates would result in a loss of the ability to control the water level in the harbour with far reaching consequences. Flooding and damage to property.

- Cordon off bridge to prevent pedestrian access (actioned)
- Investigation to determine the capacity of the girder and place load restrictions on the bridge. Action subsequent recommendations accordingly

- Replace whole Structure. Estimated Cost = **£1,000,000.00**

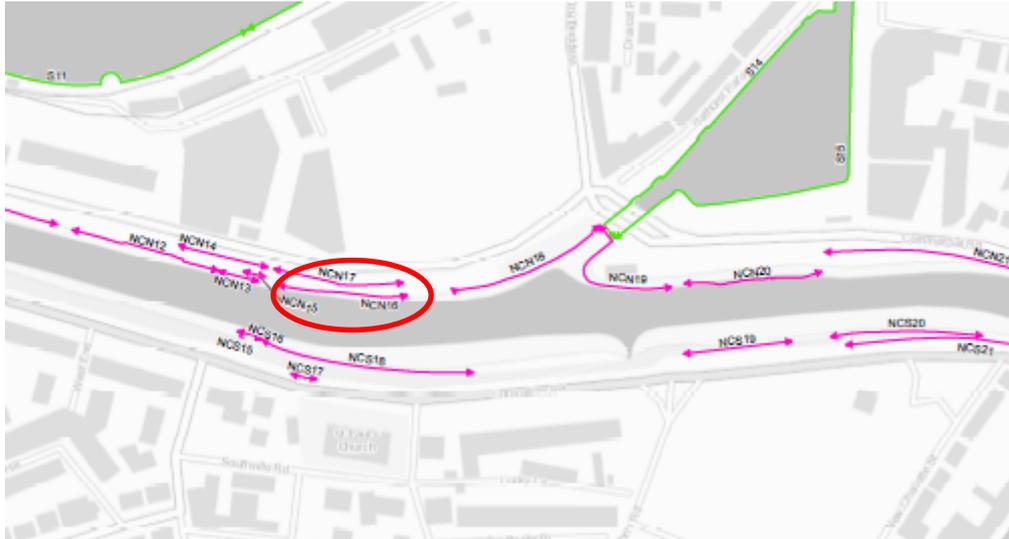
## Asset No. 3 - NCN16 – Lower Level Masonry Retaining Wall on Cumberland Road

The critical section of the asset is an area of lost masonry measuring 6m x 4.5m

The failure of NCN16 could cause a failure in NCN17 resulting in a collapse of the footpath and partial collapse of Cumberland Road. There is a risk of major travel disruption.

- Install and monitor survey points
- Undertake repairs of the critical section

- Undertake full masonry reconstruction/masonry Repairs and underpinning at base  
Estimate = **£1.550,000.00**

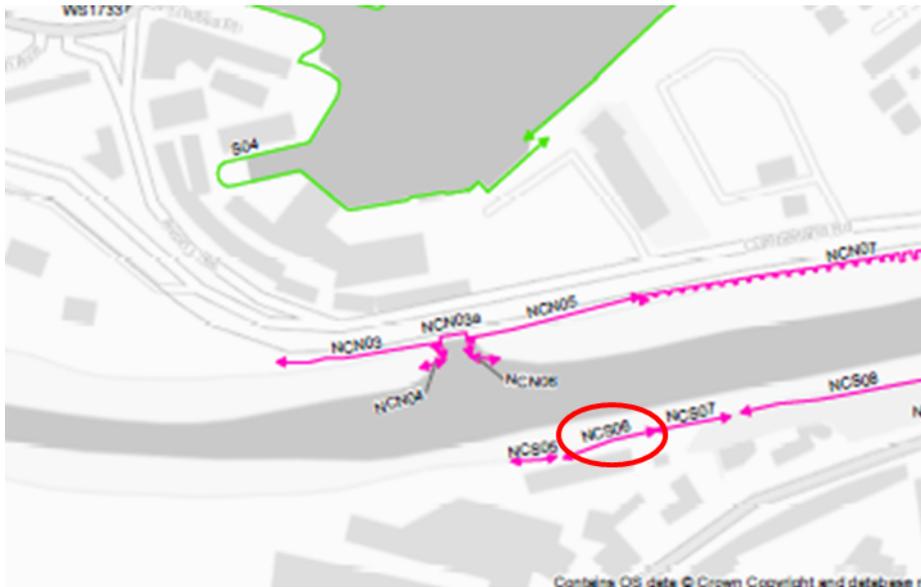
Riverside wall set back from Coronation road, adjacent to industrial / warehouse building

Several areas of collapsed wall along the length of the asset and the remaining masonry is generally in a poor condition as shown the image below.

Potential for a loss of support to building foundations and the building could collapse, presenting risk to life.

- Conduct investigation to gauge whether the asset is providing direct support to the building at the western end and to confirm the depth of foundations of the building behind.

- Masonry Repair and rebuild along with some foundation underpinning  
Estimated Cost = **£550,000.00**

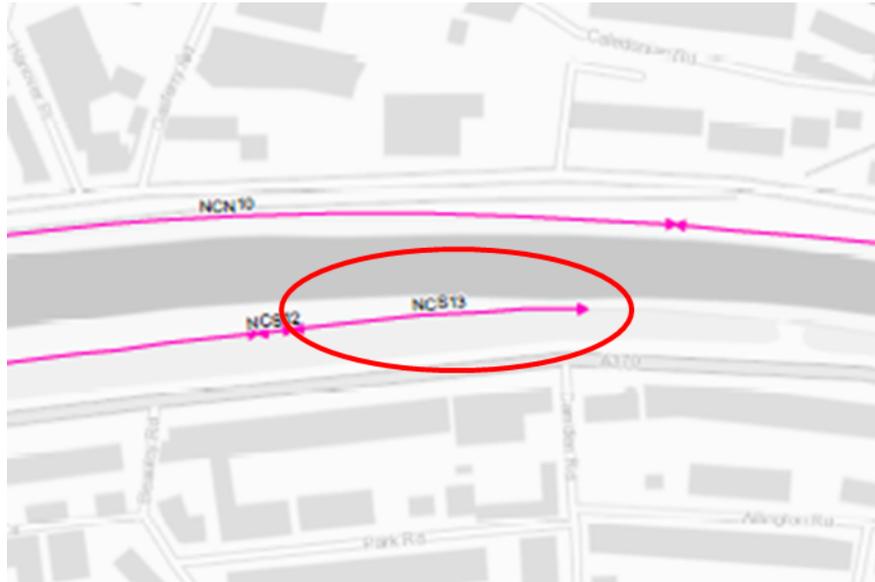
Riverside wall adjacent to Coronation Road in vicinity of Camden Road

Numerous collapsed sections along the full length of the asset and the masonry is in a poor condition with deformations noted. Scour is affecting the rock outcrops which the asset is constructed on.

- Install and monitor survey points
- Repairs to eastern section of the asset where the embankment is directly supported by the wall.

- Masonry Rebuilds and repair along with some underpinning and rock anchoring at base.  
Structural Estimate = **£850,000.00**

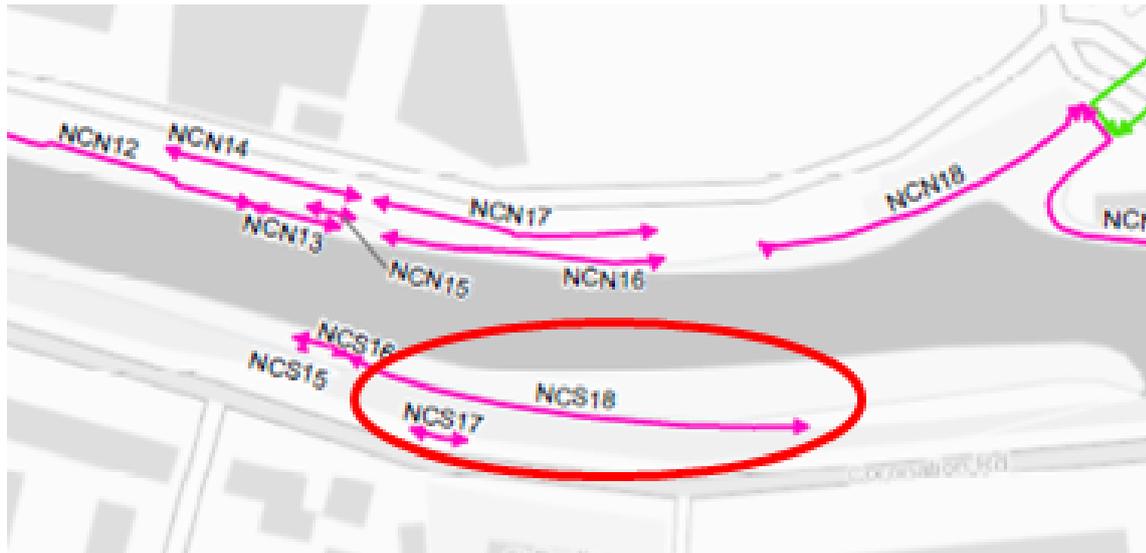
Adjacent to Coronation Road near Gaol Ferry Bridge

Several collapsed sections and areas of deformation along the length of the asset including slipway

Coronation Road may be affected by a loss of support and failure. There is a risk of major travel disruption.

- Install and monitor survey points
- Repairs to the areas of deformation and collapsed sections where the wall directly supports the embankment.

- Masonry Rebuilds and repair along with some underpinning and rock anchoring at base.  
Structural Estimate = **£1,600,000.00**

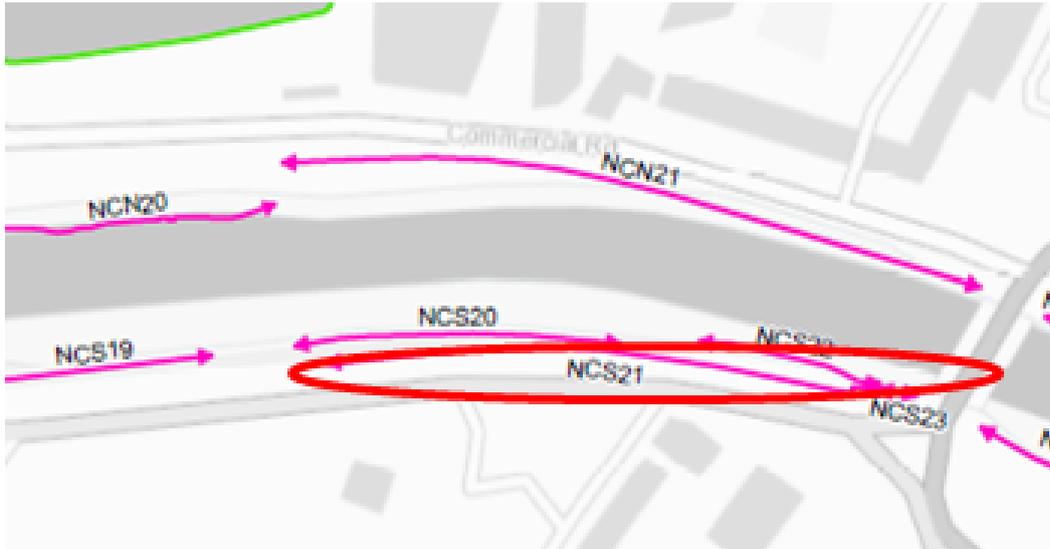
Adjacent to Coronation Road east of Gaol Ferry Bridge

Significant deformed area situated at the eastern end of the asset

Loss of support/collapse of the footpath is likely in the event of a failure. Load restrictions and a partial closure would be necessary. There is a risk of major travel disruption.

- Protect rear of the footpath with barrier
- Undertake vegetation removal at critical location and repairs to the area of deformation.

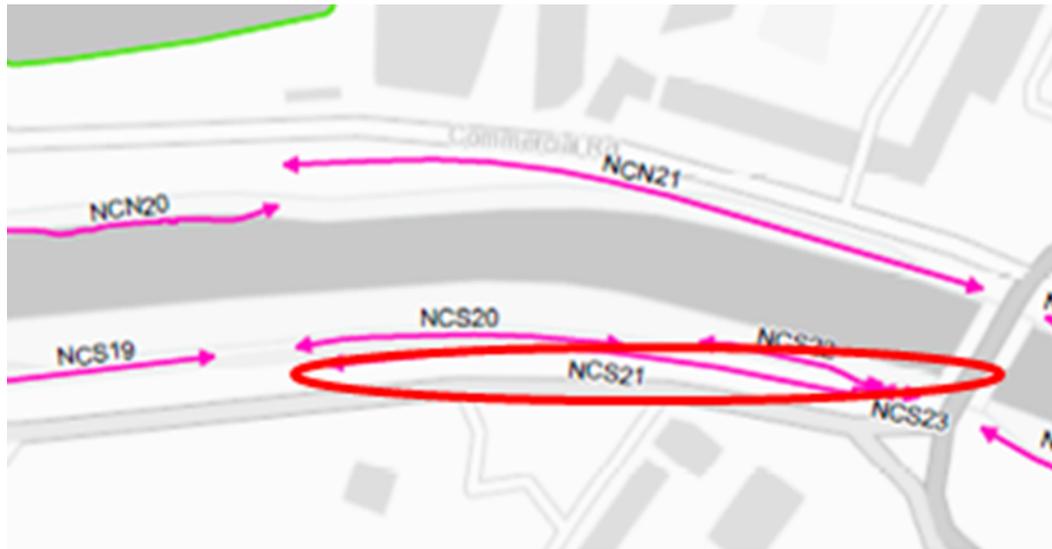
Coronation Road adjacent to Bedminster Bridge Roundabout

Area of deformation at the crest of the wall adjacent to Bedminster Bridge roundabout

Loss of support/collapse of the footpath is likely in the event of a failure. Load restrictions and a partial closure would be necessary. There is a risk of major travel disruption.

- Protect rear of the footpath with barrier
- Vegetation removal at critical location
- Repairs to the area of deformation

Stabilise lower level wall with rock anchors and repair masonry facing. Structural Estimate = **£400,000.00**

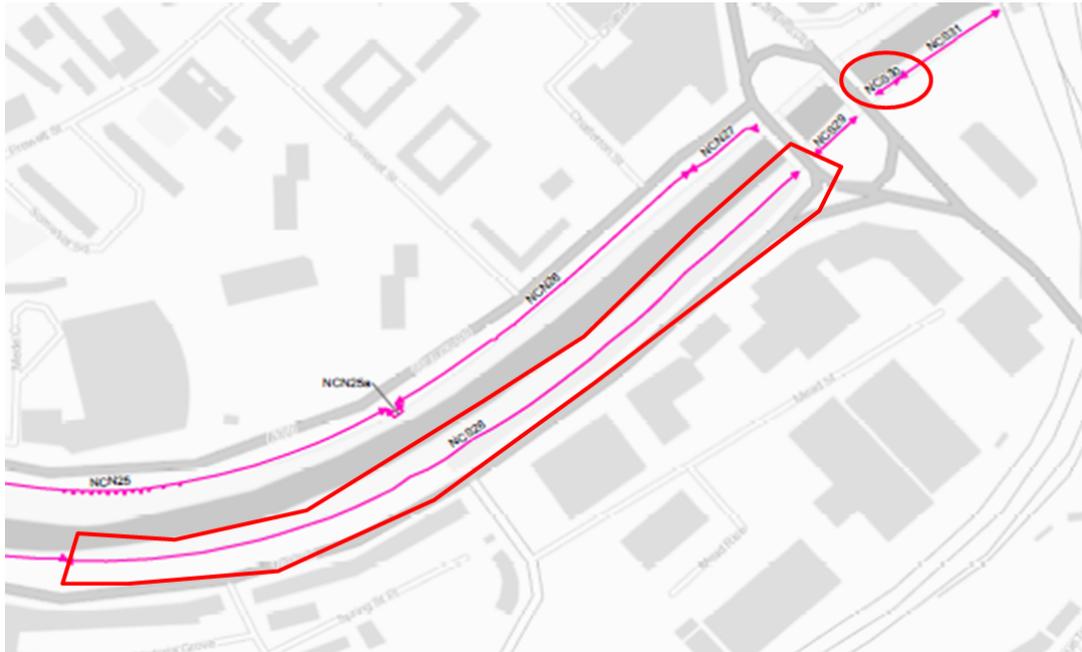
York Road, critical location in vicinity of Langton Street footbridge

There are several areas of significant masonry loss and extensive deformed sections, particularly in the vicinity of Langton Street footbridge. The asset is generally in a poor condition along the entire length

- Confirm the depth of foundations for Langton Street footbridge
- Installation of survey points on the asset and bridge
- Installation of survey pegs on the fill behind the asset

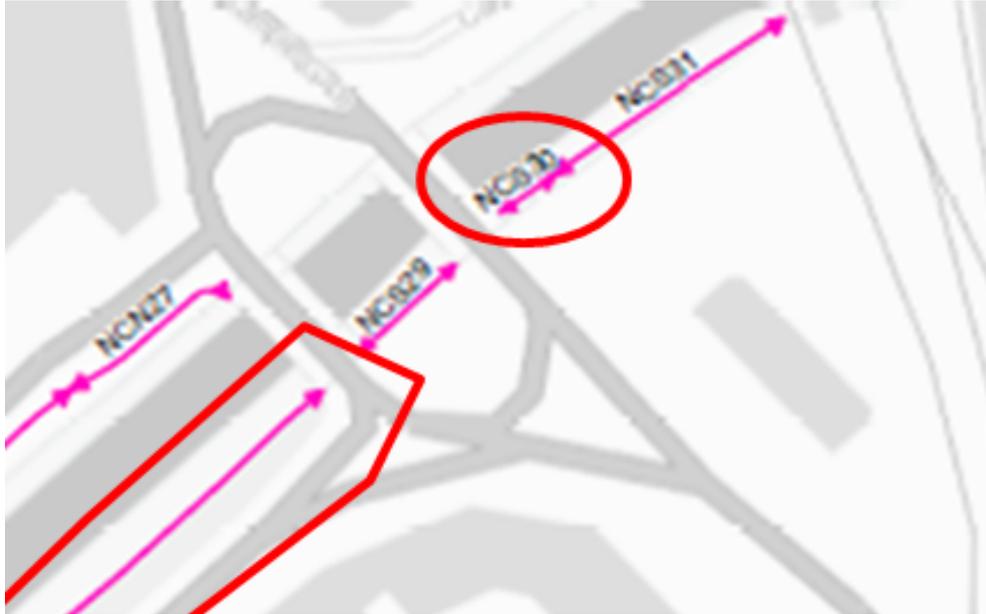
Immediately to the east of Bath Bridge Roundabout on south side of river

The arch adjacent to Bath Bridge Roundabout has failed from its springing point and the masonry is bulging significantly. There are also areas of collapsed masonry above this arch

Collapse of the arch will cause a loss of support to the retained material leading to a collapse of Network Rail land, exposing the edge of the bridge abutment and is likely to affect the stability of Bath Road

- Install barrier to prevent pedestrian access
- Installation of props or ties to restrain the bulging area and carry out repairs / reconstruction

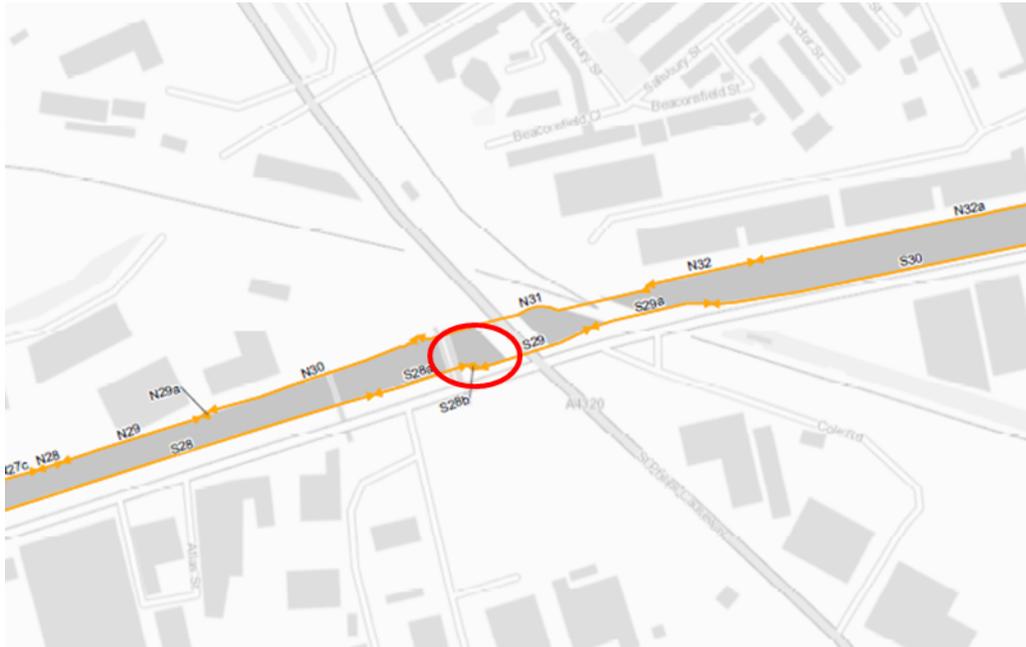
North side of Feeder road (canal south bank), in vicinity of St Phillips Causeway flyover

There are large areas of lost masonry underwater at the western end and numerous capping beam failures along the length. There is an extensive amount of vegetation growth from gaps between the concrete planks. There are several large areas of deformation visible on the capping beam
