Underfall Yard MEICA Inspection Report

24 May 2019

Bristol City Council

Document reference: WS1718-MEICA-INSP-B01

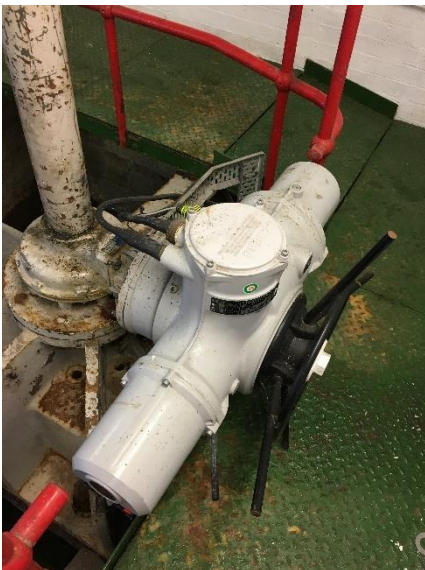
Figure 18: Actuator one – main sluice gate one

The main sluice gate Rotork actuators appeared to be in good condition, no defects were found apart from the bending of the rising stem of main sluice gate 2, which was mentioned in section 3.1. Actuator 4 also appeared to have seen little use in some time. It is worth noting that limited support and spares are available from the manufacturer for the “A-series” actuators (3 and 4) due to their age and obsolescence.

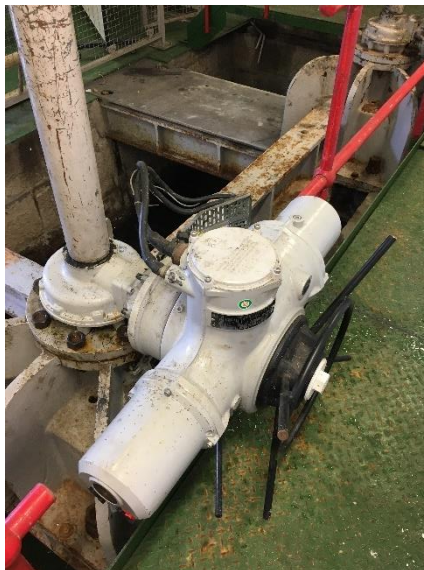
Figure 19: Actuator two – main sluice gate two

The actuator rising stem for the main sluice no.2 appears to be deflected. The operators informed the surveyors that the gate is over-driven in its closed position, which has resulted in the deflection of the stem. Some corrosion was also found on the actuator rising stem of sluice gate no.2. (Figure 11).

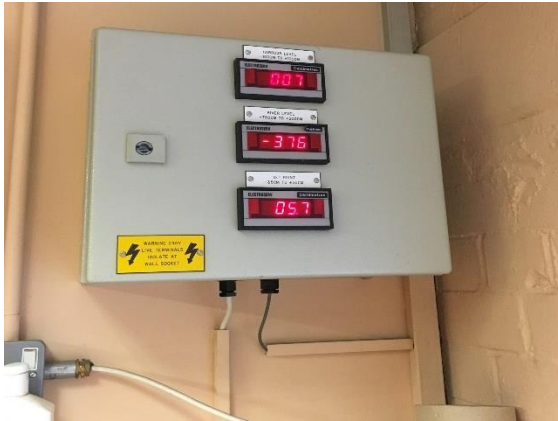
Figure 24: Levels display panel

The Harbour Master office has a panel with the level displays for the harbour float level and the River Avon level as shown in Figure 24. Following conversations with the operators on site it is understood that the harbour level displayed is measured in *cm* above ordnance datum (\pm cm AOD) and the river level is also measured in *cm* above ordnance datum (\pm cm AOD). The third level display indicates the level set point that sets the harbour's level in *cm* above or below the river's level according to the principles of harbour level control operation.

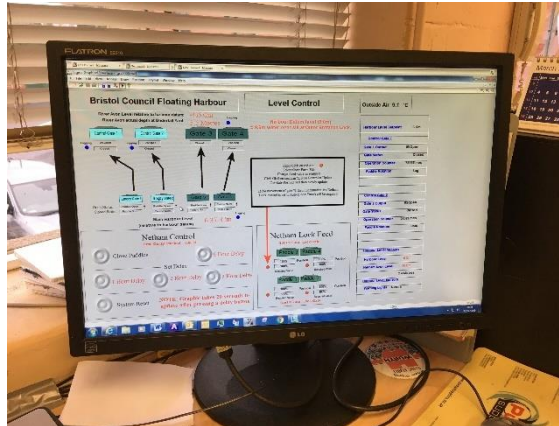
Figure 25: Harbour Master office SCADA station

It was also understood that the operator has the facility to select the harbour level set point from the computer based SCADA station in the office as shown in Figure 25 above. Note that the exact principle of harbour level control is not fully understandable due to the limitations of the readily available review material.

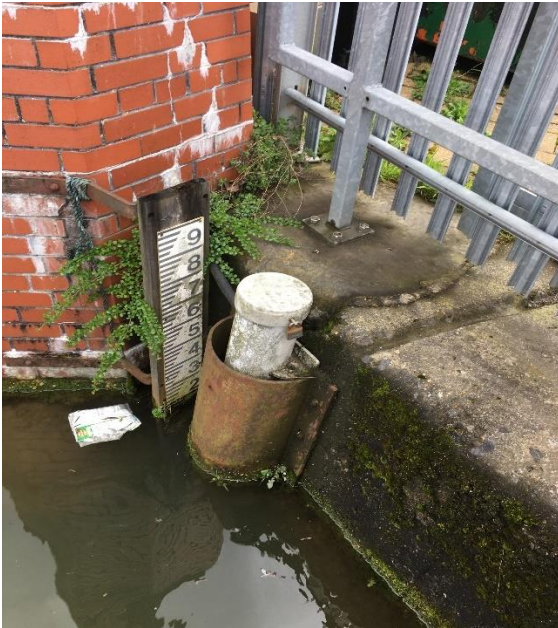
Figure 26: Harbour's level measuring instrument

Figure 26 below shows the harbour's level measuring instrument which is a pressure transducer guided through a PVC tube and located in the harbour master's yard next to the parking area. Figure 27 shows a panel where the instrument cable is wired to. It is believed to house the instrument controller. Access to the panel could not be obtained at the time of visit.

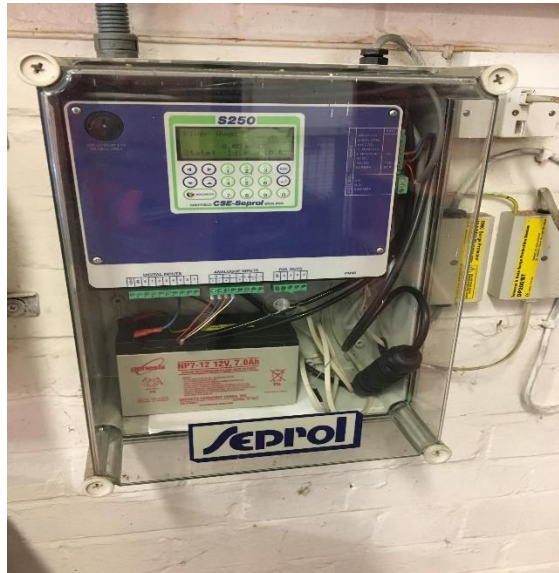
Figure 29: Telemetry outstation

As part of the Telemetry and communications scheme there is a Seprol S250 Telemetry outstation unit and a radio communications station as shown in Figure 29 and Figure 30 respectively. It is noted that the details regarding the Telemetry system and communications network could not be obtained due to limitations of readily available material on site.

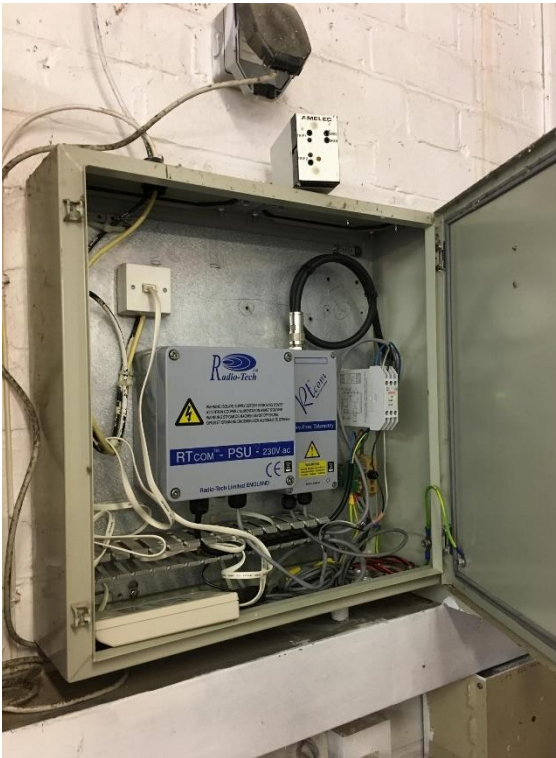
Figure 30: Radio communications station

In various locations there are cable installations within the electrical and instrumentation cubicles that was not done in a neat manner, following good installation practice. Lengths of cable were left untidy and not securely fixed. Examples can be seen in Figure 30, Figure 31, and Figure 34. This increases the possibility of the cables being damaged during any intrusive work therefore the installation should be revisited and rectified.

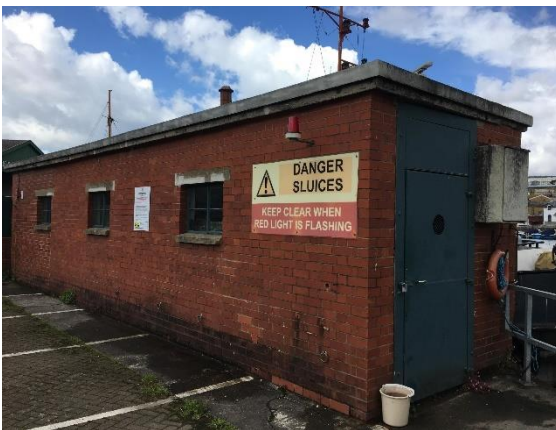
Figure 39: Emergency sluices building

The building housing the emergency sluices in Figure 39 is in Underfall Yard adjacent to the parking area. This building houses the control panel for the operation of the HPU and the sluices, the HPU and electrical distribution panels.

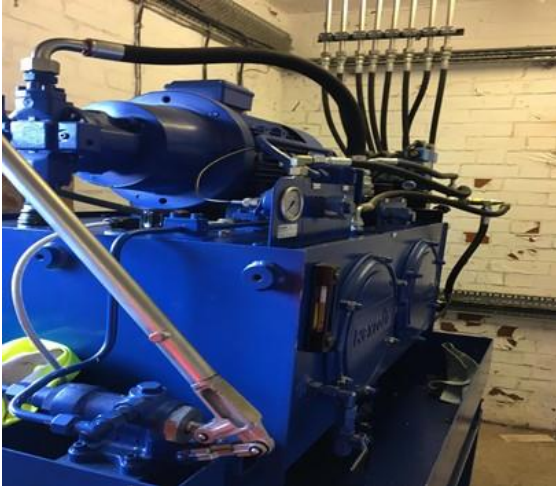
Figure 41: Emergency sluices HPU

The HPU for the emergency sluices appeared to be in good condition. No functional defects were found although it was not connected to sluice gate 4 which was mentioned earlier. Various items were found around the area which should be cleared. Some debris was also found in the bund of the HPU which should be cleaned.

The HPU unit and the motor shown in Figure 41 and Figure 42 are in good condition and the associated cables appear in good condition with regards to the cable terminations and insulation.

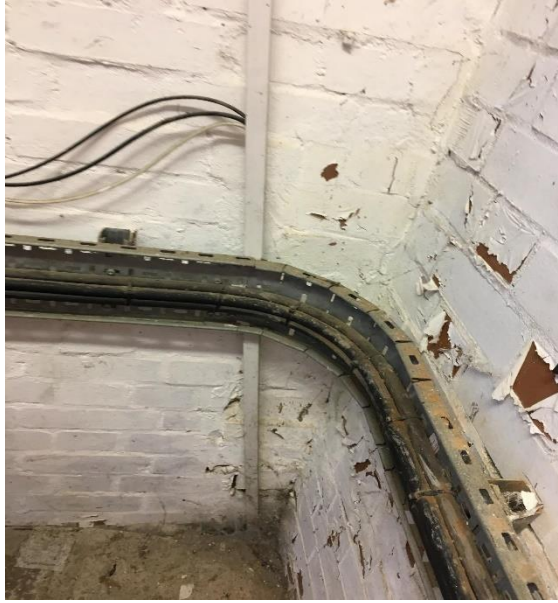
Figure 48: Unsupported cable trunking

Figure 48 shows a cable trunking which is not supported and securely fixed on the wallside with cables hanging and exposed. Dirt covering the opening for the cable through the floor at the cable trunking was obstructing to observe whether the opening has been sealed with the appropriate foam sealant to prevent vermin intrusion. However it appears that the sealant was not applied. This shall be further investigated and sealant to be applied in case it was not done previously.
