# **SPI - Asset Investigations and Repairs Project ID 052**

Critical Asset Overview Report

June 2023

**Document reference:** | 100105143-MMD-00-XX-RP-CV-003 | A01 |

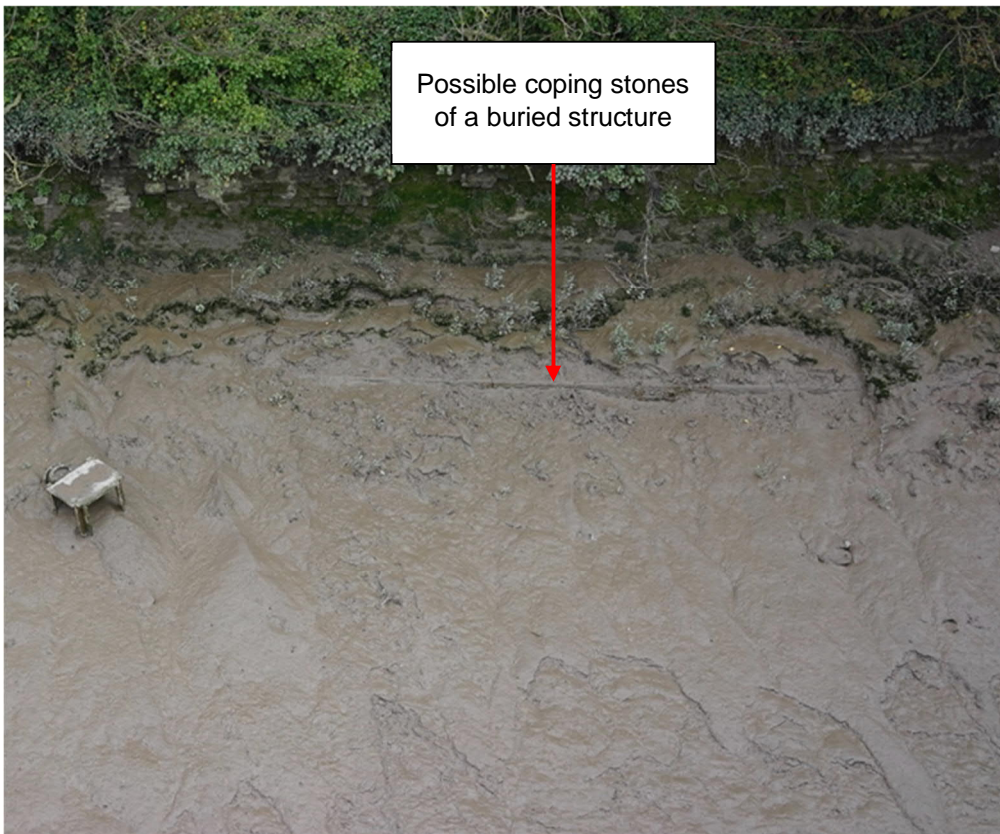
**Figure 6.2: NCS06 Buried structure**

There is potential evidence of a structure buried in sediment in front of NCS06 and a review of historical mapping indicates that there was previously a ferry crossing in this approximate location. It may also be a potential continuation of an apparent slipway located approximately 13m upstream. The feature is shown in Figure 6.2.

The drone survey has revealed further evidence that there is a buried structure as highlighted in Figure 6.2. This is shown in Figure 6.10, where it appears that there may potentially be buried steps.

It is recommended that ground investigations and a slope stability analysis are undertaken to confirm ground properties, wall function, slope stability, and the presence of a buried structure in-front of the asset (Figure 6.2).

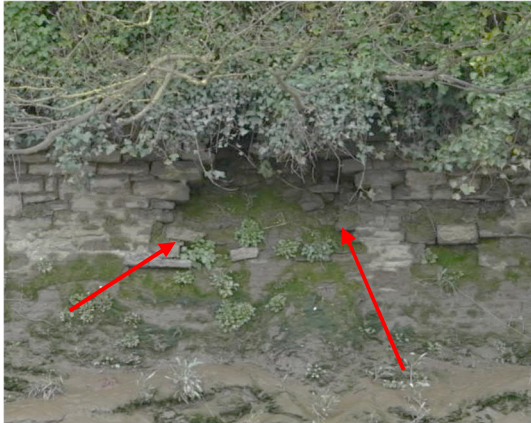
**Figure 6.6: Defect example 1 2019**

In October 2022, a drone survey was completed of the asset. The collapsed sections are all similar in appearance with no discernible changes to the masonry. There has potentially been some washout of fill, however, it is unknown whether this is retained or deposited material. Examples are shown in Figure 6.6, Figure 6.7, Figure 6.8 and Figure 6.9 below. The area of wall deformation is also similar in appearance and does not appear to have changed discernibly.

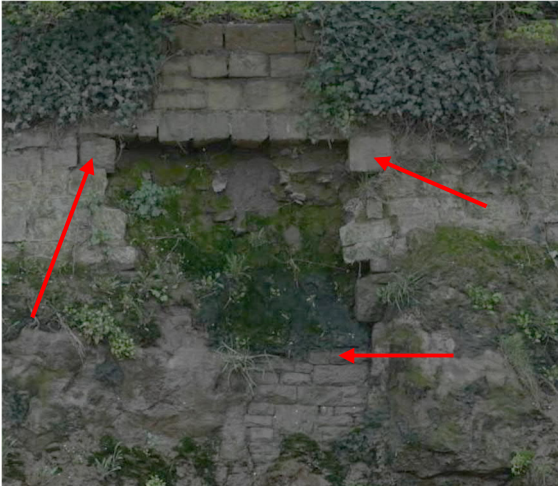
**Figure 7.7: NCS13 Collapsed section 2019**

In October 2022, a drone survey was completed of the asset. As shown in Figure 7.7 and Figure 7.8, the collapsed section is similar in appearance with no discernible changes to the masonry. The minor wall deformation shown in Figure 7.9 and Figure 7.10, is also similar in appearance, however, due to the vegetation removal, the size of the defect area is more apparent.

The 2019 drone data was compared to the 2022 drone data and the critical defect (Figure 7.3, Figure 7.7) does not appear to have changed significantly. The areas of minor wall deformation are more apparent, due to vegetation clearance, but they are not considered critical in nature.

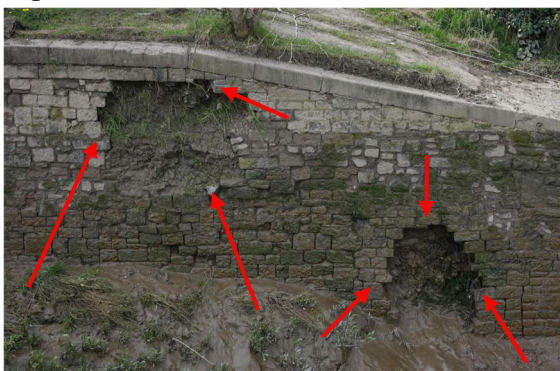
**Figure 8.8: NCS18 Defect A and B 2019**

In October 2022, a drone survey was completed of the asset. As shown in Figure 8.8, Figure 8.9, Figure 8.10 and Figure 8.11 the defects are similar in appearance with no discernible changes to the masonry. The other defects highlighted previous for NCS18 have not been shown as their 2022 appearance is similar to 2019.

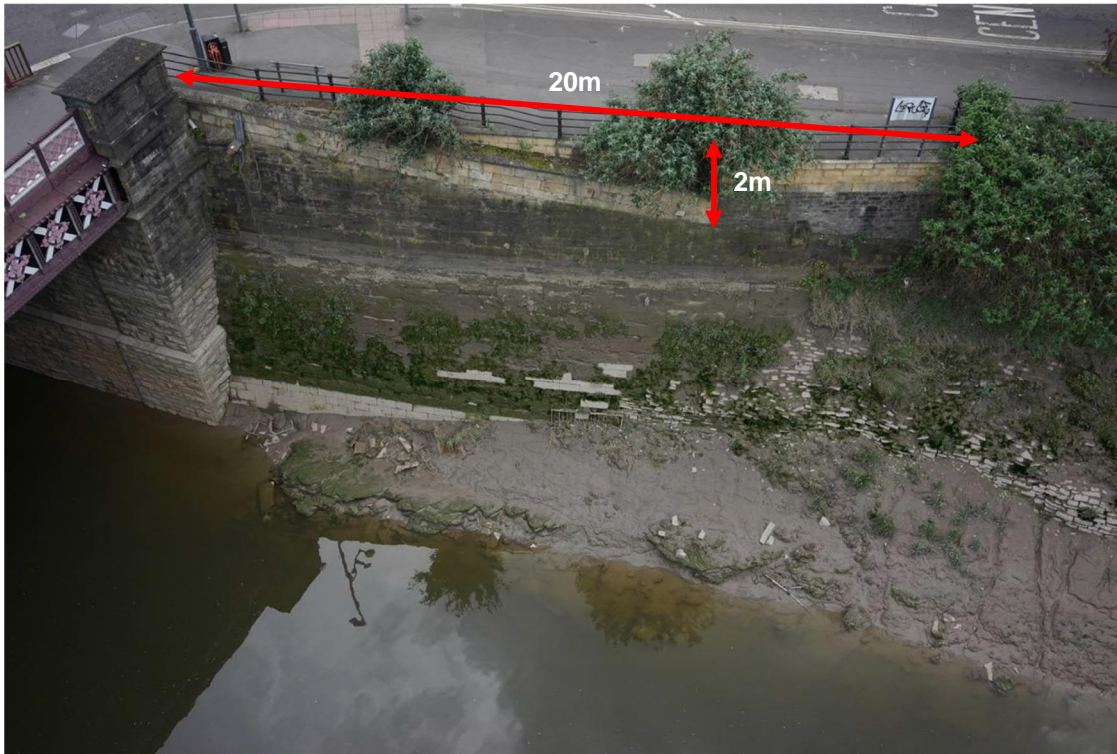
**Figure 9.3: NCS21 & NCS23 Dimensions**

The critical sections are the deformed areas over a 20m length, situated along the top of the wall, shown in Figure 9.3. There is evidence of significant buddleia growth potentially causing the damage. These sections would be unlikely to resist a vehicle or concentrated pedestrian loading and sections of the wall are unstable. The defects can be seen in Figure 9.4, Figure 9.5 and Figure 9.6. Cracks are visible in the blockwork where the wall is leaning.

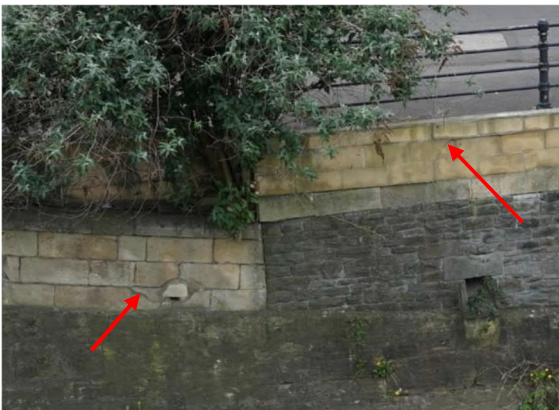
**Figure 9.7: NCS21 & NCS23 Wall deformation 2019**

In October 2022, a drone survey was completed of the asset. As shown in Figure 9.7, Figure 9.8, Figure 9.9 and Figure 9.10 the asset appears to be in a similar condition with no discernible changes to the face of the wall. There has been a loss of the copings shown in Figure 9.11 which occurred between the site walkover in January 2022 and the drone survey. The cause of this is unknown but given the condition appears similar across the remaining wall it is likely to have been as a result of vandalism.

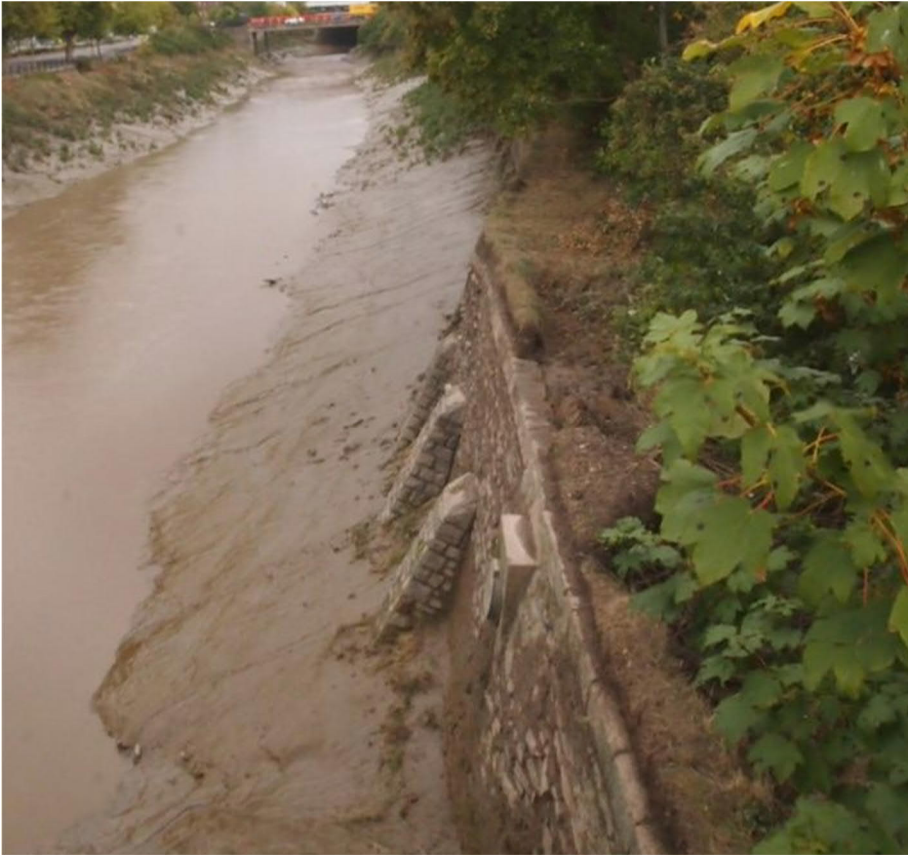
**Figure 10.5: NCS28 Upstream area of deformation view from bridge**

The critical area of the asset is an approximate 100m section centred at the Langton Street Bridge, see Figure 10.3. There are numerous areas of deformation, with open joints and pointing loss. These areas can be seen in Figure 10.4 and Figure 10.9.

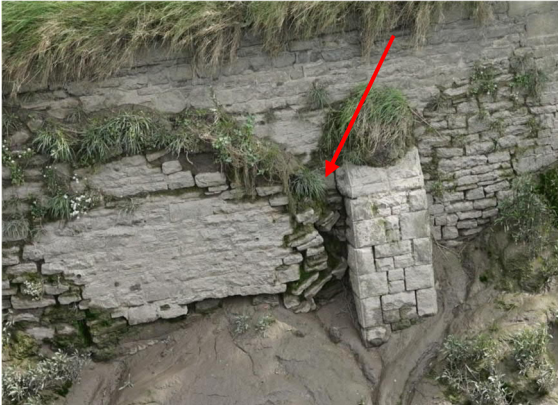
**Figure 10.15: NCS28 Wall deformation 2019**

In October 2022, a drone survey was completed of the asset. Changes between Figure 10.15 and Figure 10.16 show a small amount of masonry loss adjacent to a buttress. There are minor changes between Figure 10.21 and Figure 10.22, the joint between blocks on one buttress appears to have widened and there is a new crack through a block on another buttress. The remaining length of wall within the critical area appears to be in a similar condition to how it was in 2019. There does not appear to have been any further loss of masonry, opening of joints, and the deformed sections appear in similar positions. However, it is difficult to determine changes as there was extensive vegetation growth covering sections of masonry during the 2019 survey as shown in the images. Deterioration appears to be ongoing but at a slow rate between 2019 and 2022.

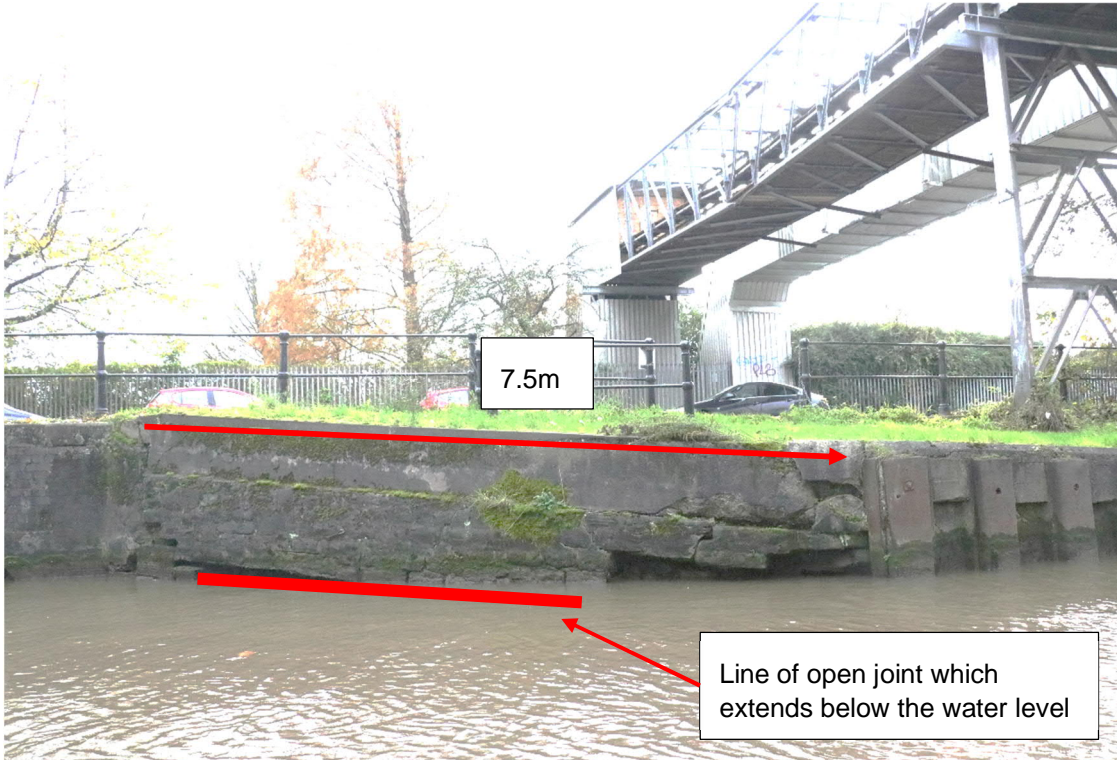
**Figure 11.2: Asset S28b**

There is an open joint across the whole asset length, approximately 7.5m, due to the separation between the upper and lower sections. An image of the asset is shown in Figure 11.2 below. There is also an area of potential washout at the base of the wall where it abuts the adjacent sheet piles, see Figure 11.3.

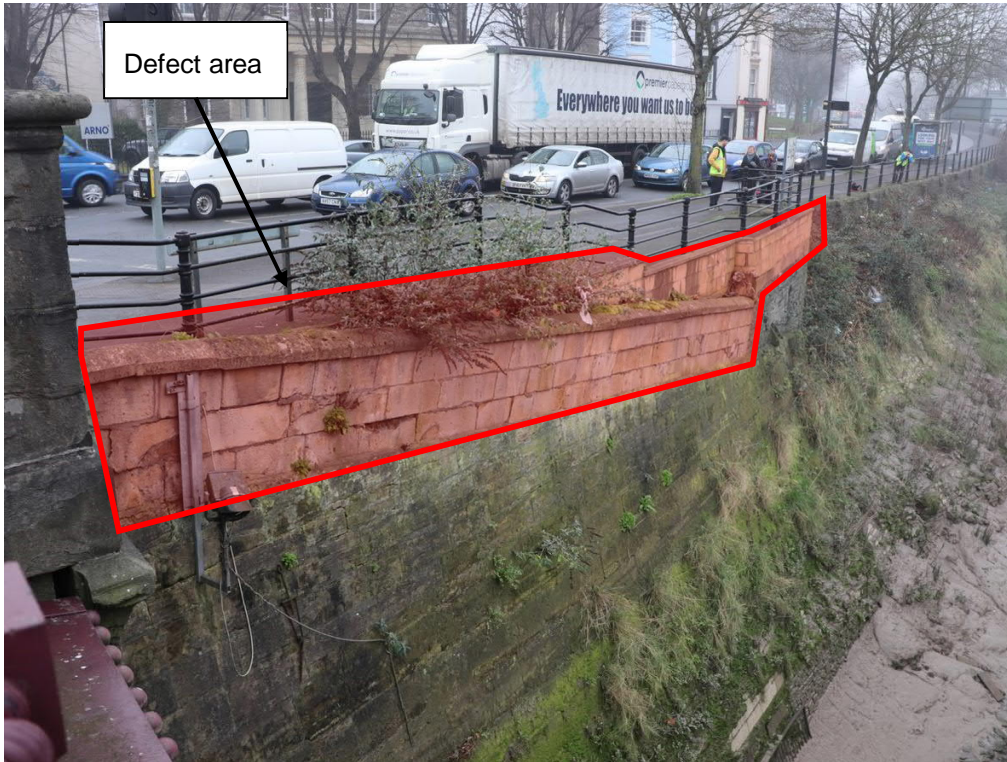
**Figure 12.1: NCS21 & NCS23 Defect area**

There are significant concerns over the stability of the wall where it is supporting the adjacent footway (as highlighted in Figure 12.1). There is a clear risk that the wall is unlikely to resist vehicle loading, concentrated pedestrian loading, or a significant saturation event (e.g., burst water main). These modes of failure cannot be predicted and would come about as a sudden event with no prior indication of happening. Given the asset's well trafficked location (and therefore inherent risk to members of the public), it is considered as being in the highest priority group for repair.

A failure of the asset would also require the closure of the footway (and potentially York Road) while the extent of damage was being assessed, with potential long-term closures to follow affecting the wider road network whilst repair activities are undertaken. Failure could also result in potential loss of life or serious injury and have financial, environmental and reputational damage to BCC and the local economy and South-West Region.

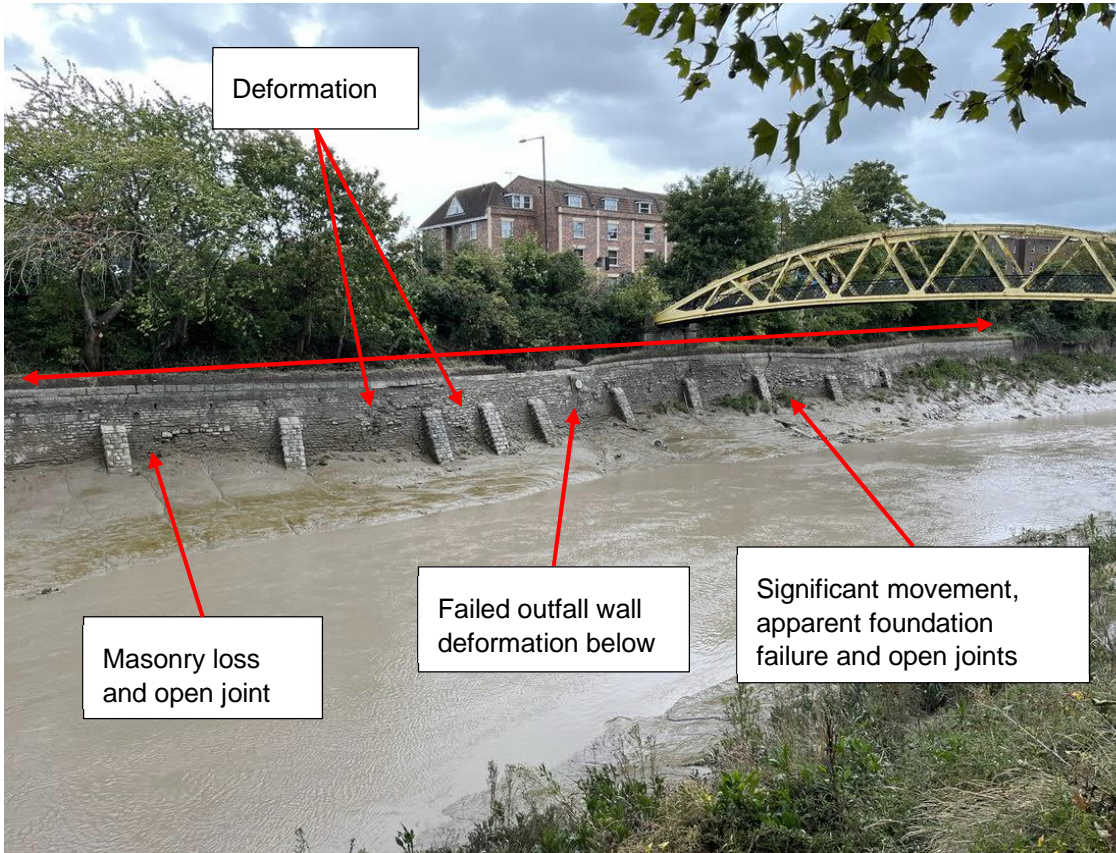
**Figure 12.2: NCS28 Area of concern**

The asset likely functions as a retaining wall for the area of fill and slope behind. There are areas of significant global and local deformation across the area shown in Figure 12.2. Any further such deformation could result in a loss of support to the fill behind the asset. There is the potential for a sudden collapse of the asset, causing a loss of support to the slope, the footway and potentially the bridge. This may lead to potential long-term road closures affecting the wider road network whilst repair activities are undertaken. Failure could also result in potential loss of life or serious injury and have significant financial, environmental and reputational damage to BCC and the full local economy and South-West Region.

Due to the extent of movement which has already taken place, the apparent deterioration over the last 10-15 years (Section 10.1.3) and the risk of damage to the surrounding infrastructure, the asset is rated in the highest priority group to repair.

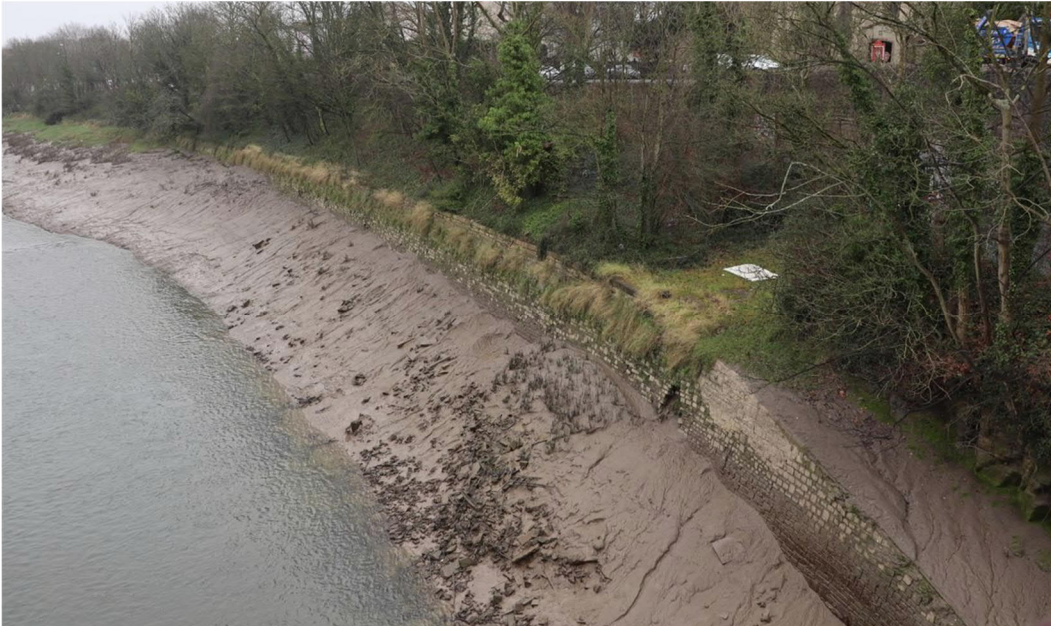
**Figure 12.3: NCS18 View from Gaol Ferry Bridge looking upstream**

There are several areas of lost masonry and deformation where the wall appears to retain the bank behind. These defects are considered to be a lower priority than slipway defects as it is thought that a slope failure, resulting in a loss of support to Coronation Road is unlikely in the short-term. However, if these wall failures are allowed to deteriorate, the washout of the slope will increase the long-term risk of a slope failure affecting the road network and potentially causing injury or death to the public. The overall risk of this occurring is lower as there should be signs of failure over a longer period of time that allows timely repairs.

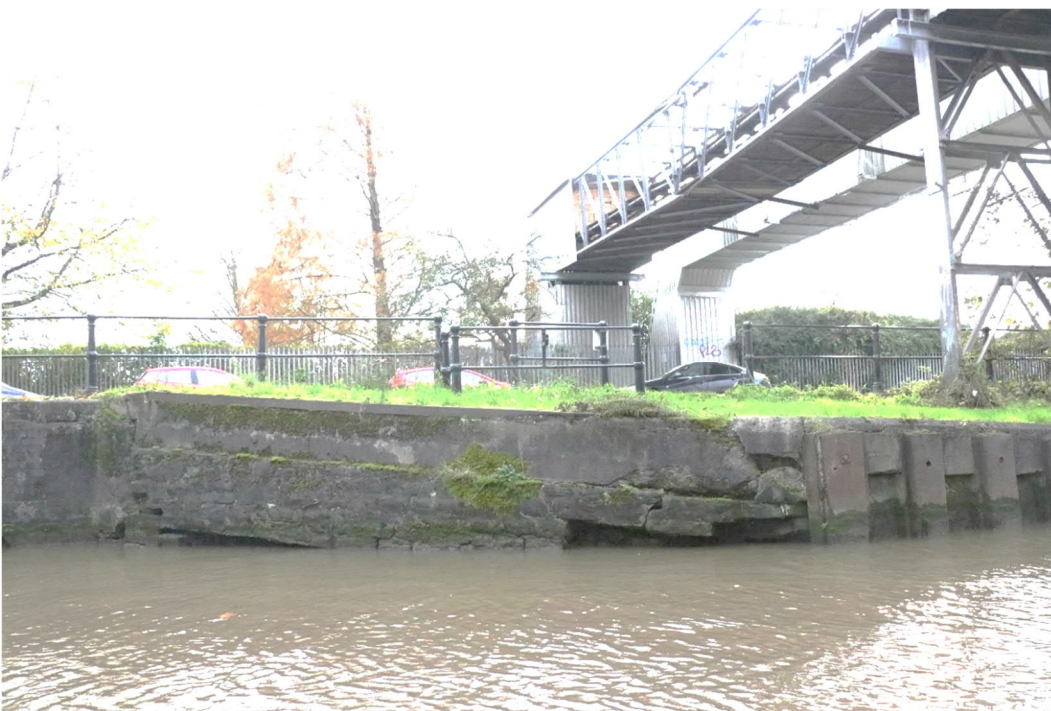
**Figure 12.4: Asset S28b**

The asset is likely retaining the footway and potentially the carriageway. If allowed to deteriorate further, there is a risk of the footway collapsing and a road closure affecting the road network in that area. Injury to the public may also potentially occur. There is a horizontal open joint across the face of the asset and a recess at the toe of the wall.

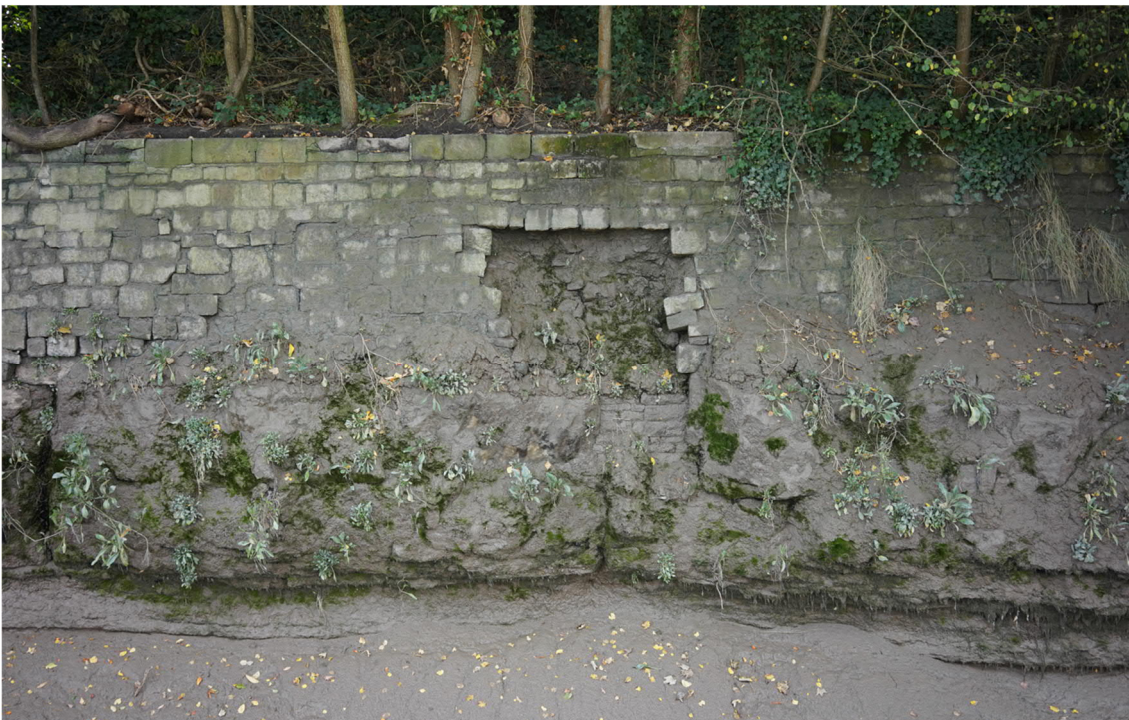
**Figure 12.5: NCS13 Collapsed section**

The asset likely functions at least partially as a retaining wall, providing support to the slope behind. The single collapsed section and areas of minor deformation in the region where the slope is directly supported by the wall do not appear to have deteriorated between 2019 and 2022. The slope also appears to have remained stable in the vicinity of these defects.
