## Appendix Aii – Original BCC Structural Recommendations

**Asset No. 1 - N06 – Harbour Wall, Masonry Arches deformed below waterline**

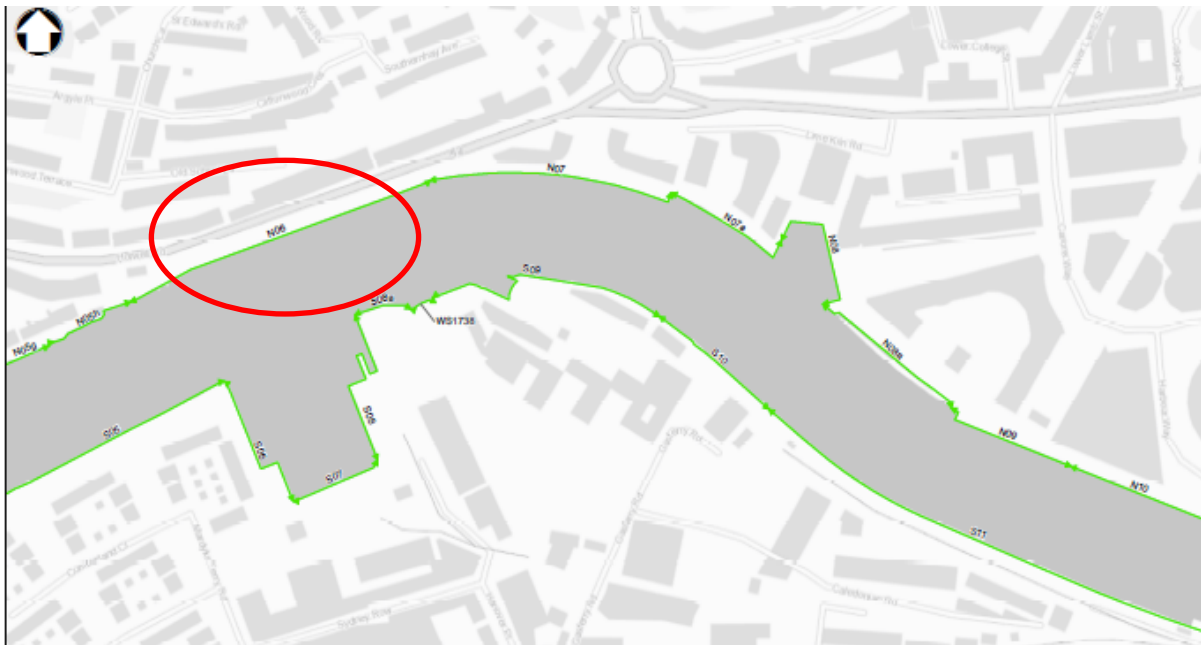
North side of the harbour, adjacent to Hotwells Rd, where the Grain Barge is moored

Deformation of underwater arches and areas of lost masonry, see image below showing deformation of arches.

If the wall were to collapse, there is a risk that Hotwell Road will also be affected by a loss of support and lane closures would be necessary. There are boats moored along the asset in the vicinity of the critical defects and there is the potential for them to be damaged by falling masonry

- Install and monitor survey points
- Dive inspection of affected arches

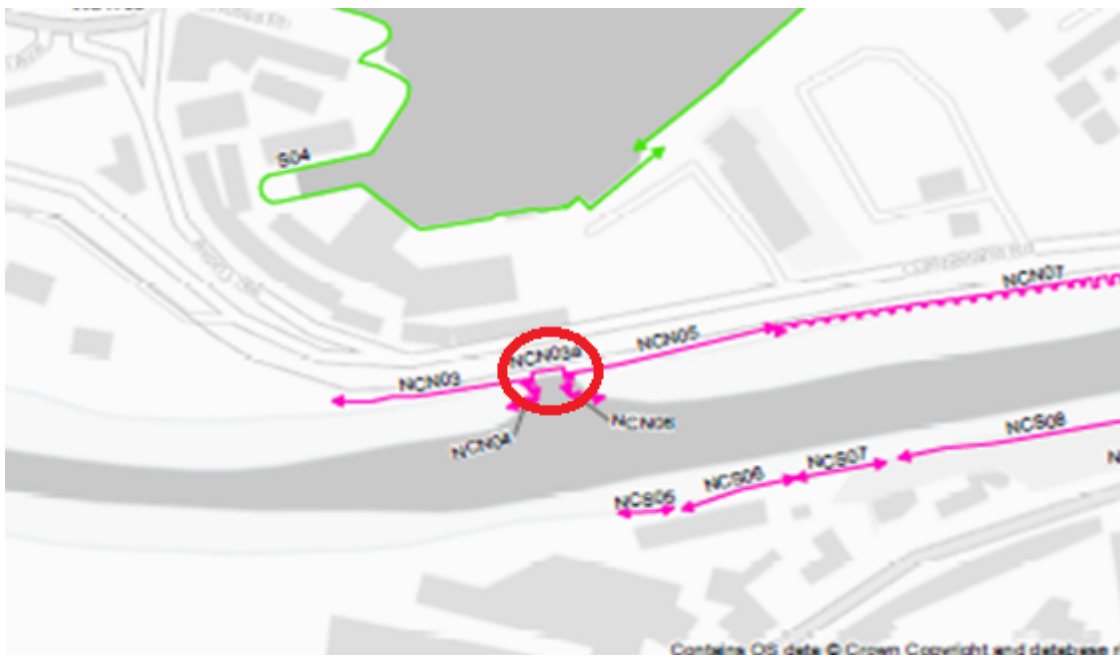
Steel beam supporting chocolate path footbridge where it bridges the Underfall sluices

Severe corrosion of steel beam footbridge as shown in image below

Collapse of the structure poses serious risk to life, reputational risk, financial risk and loss of function of Underfall sluice gates. Loss of the sluice gates would result in a loss of the ability to control the water level in the harbour with far reaching consequences. Flooding and damage to property.

- Cordon off bridge to prevent pedestrian access (actioned)
- Investigation to determine the capacity of the girder and place load restrictions on the bridge. Action subsequent recommendations accordingly

- Replace whole Structure. Estimated Cost = **£1,000,000.00**

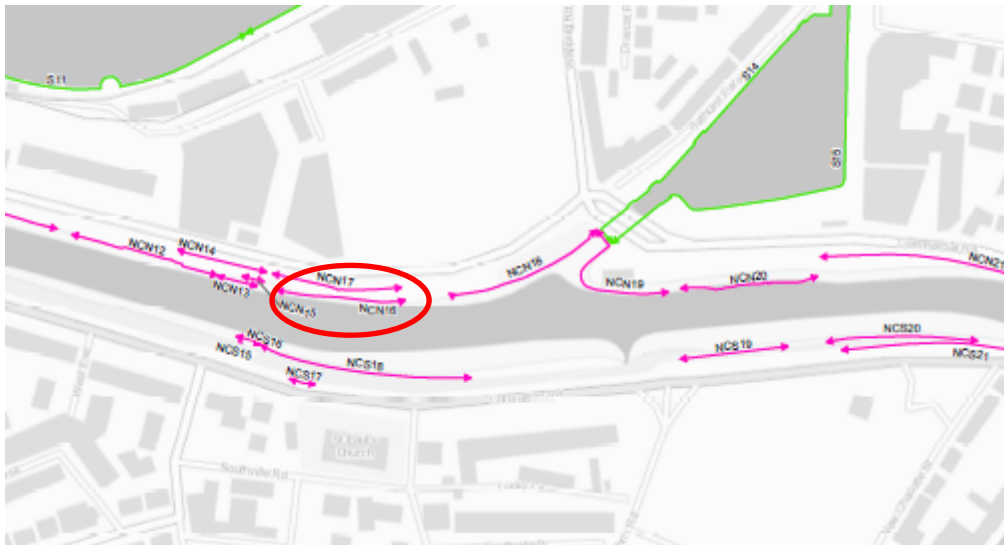
**Location:** Cumberland Road Adjacent to Bathurst Lock (now filled in)

The critical section of the asset is an area of lost masonry measuring 6m x 4.5m

The failure of NCN16 could cause a failure in NCN17 resulting in a collapse of the footpath and partial collapse of Cumberland Road. There is a risk of major travel disruption.

- Install and monitor survey points
- Undertake repairs of the critical section

- Undertake full masonry reconstruction/masonry Repairs and underpinning at base  
Estimate = **£1.550,000.00**

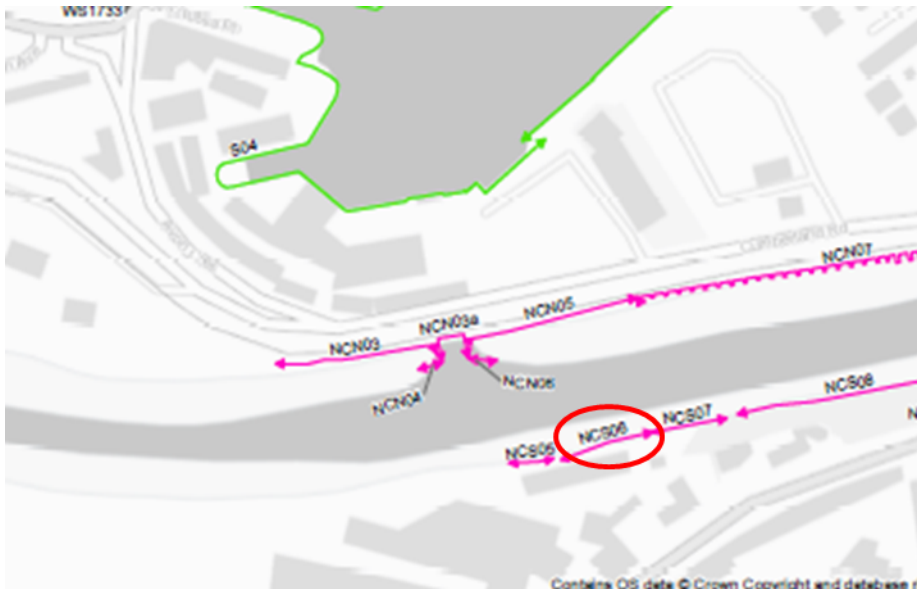
Riverside wall set back from Coronation road, adjacent to industrial / warehouse building

Several areas of collapsed wall along the length of the asset and the remaining masonry is generally in a poor condition as shown the image below.

Potential for a loss of support to building foundations and the building could collapse, presenting risk to life.

- Conduct investigation to gauge whether the asset is providing direct support to the building at the western end and to confirm the depth of foundations of the building behind.

- Masonry Repair and rebuild along with some foundation underpinning  
Estimated Cost = **£550,000.00**

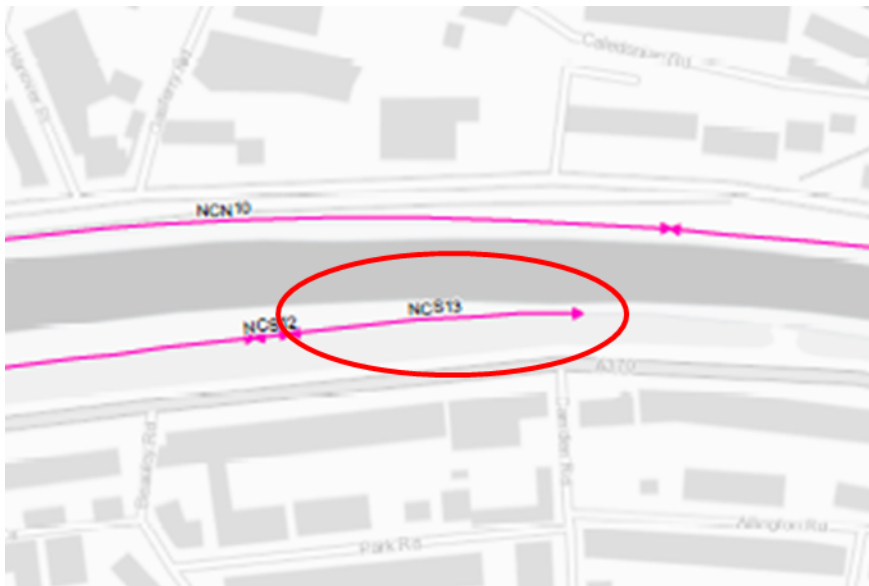
Riverside wall adjacent to Coronation Road in vicinity of Camden Road

Numerous collapsed sections along the full length of the asset and the masonry is in a poor condition with deformations noted. Scour is affecting the rock outcrops which the asset is constructed on.

- Install and monitor survey points
- Repairs to eastern section of the asset where the embankment is directly supported by the wall.

- Masonry Rebuilds and repair along with some underpinning and rock anchoring at base.  
Structural Estimate = **£850,000.00**

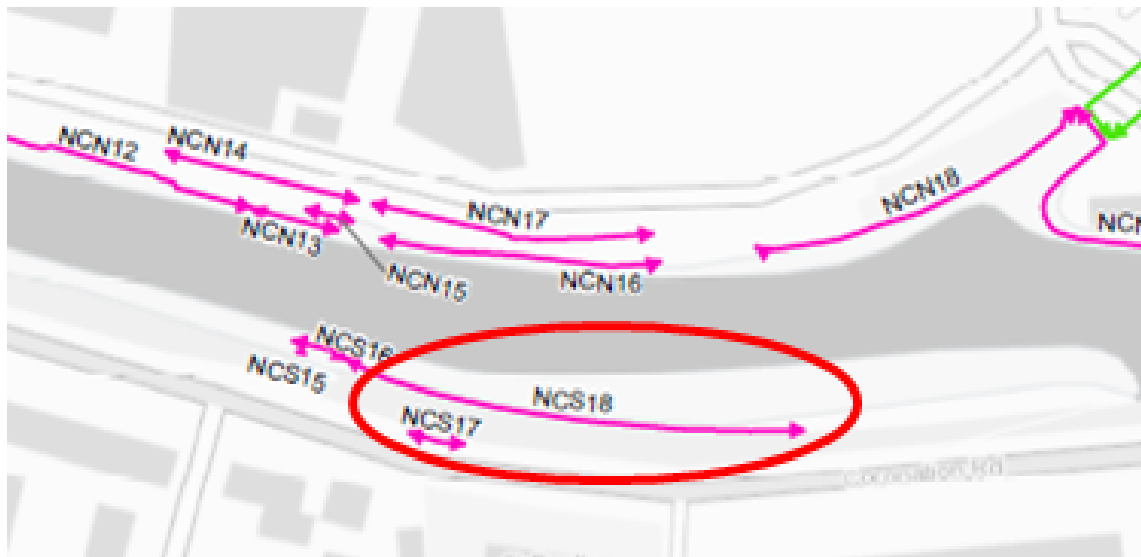
Adjacent to Coronation Road near Gaol Ferry Bridge

Several collapsed sections and areas of deformation along the length of the asset including slipway

Coronation Road may be affected by a loss of support and failure. There is a risk of major travel disruption.

- Install and monitor survey points
- Repairs to the areas of deformation and collapsed sections where the wall directly supports the embankment.

- Masonry Rebuilds and repair along with some underpinning and rock anchoring at base.  
Structural Estimate = **£1,600,000.00**

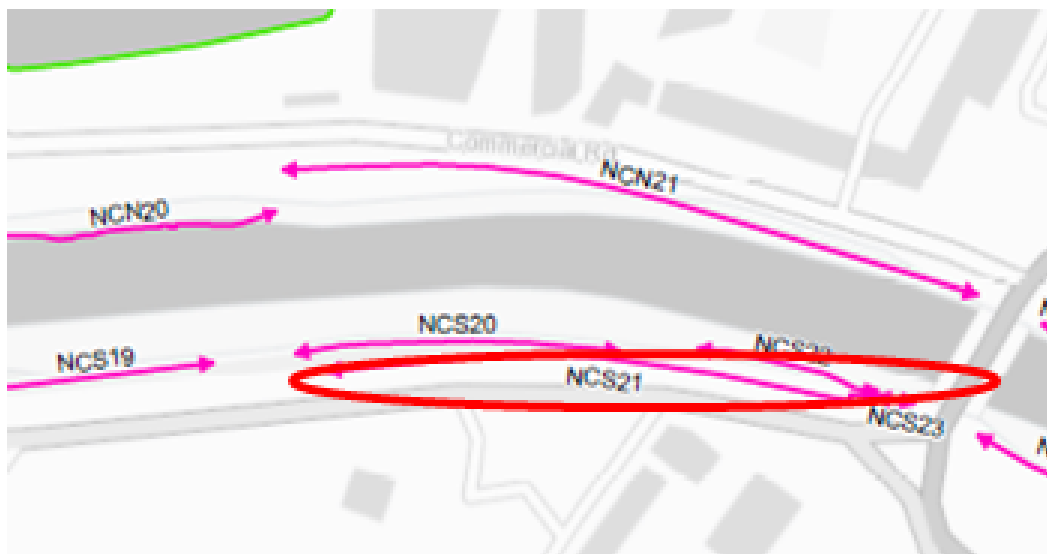
Adjacent to Coronation Road east of Gaol Ferry Bridge

Significant deformed area situated at the eastern end of the asset

Loss of support/collapse of the footpath is likely in the event of a failure. Load restrictions and a partial closure would be necessary. There is a risk of major travel disruption.

- Protect rear of the footpath with barrier
- Undertake vegetation removal at critical location and repairs to the area of deformation.

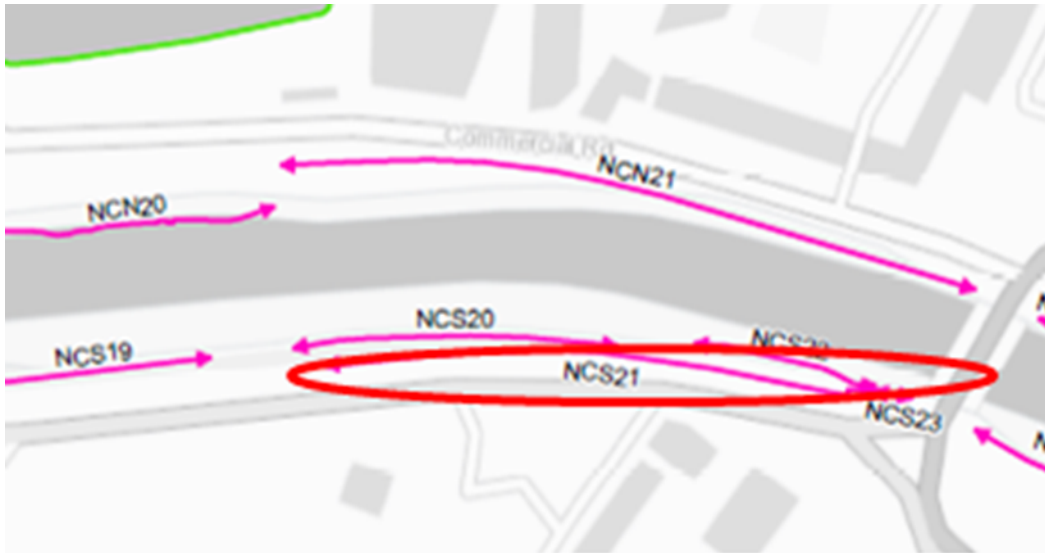
Coronation Road adjacent to Bedminster Bridge Roundabout

Area of deformation at the crest of the wall adjacent to Bedminster Bridge roundabout

Loss of support/collapse of the footpath is likely in the event of a failure. Load restrictions and a partial closure would be necessary. There is a risk of major travel disruption.

- Protect rear of the footpath with barrier
- Vegetation removal at critical location
- Repairs to the area of deformation

Stabilise lower level wall with rock anchors and repair masonry facing. Structural Estimate = **£400,000.00**

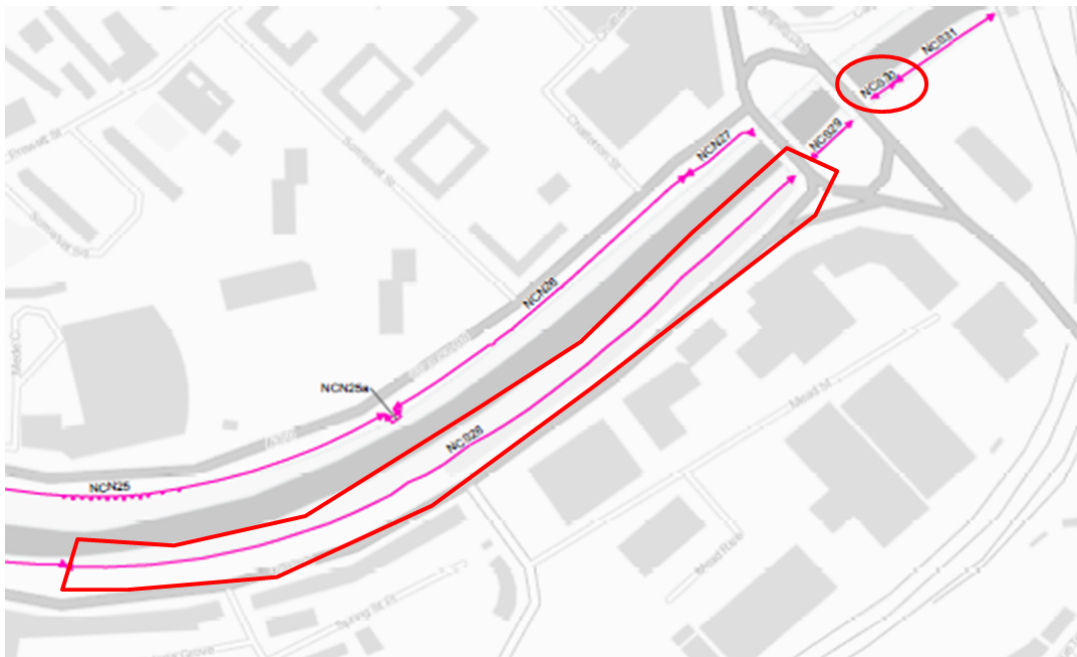
York Road, critical location in vicinity of Langton Street footbridge

There are several areas of significant masonry loss and extensive deformed sections, particularly in the vicinity of Langton Street footbridge. The asset is generally in a poor condition along the entire length

- Confirm the depth of foundations for Langton Street footbridge
- Installation of survey points on the asset and bridge

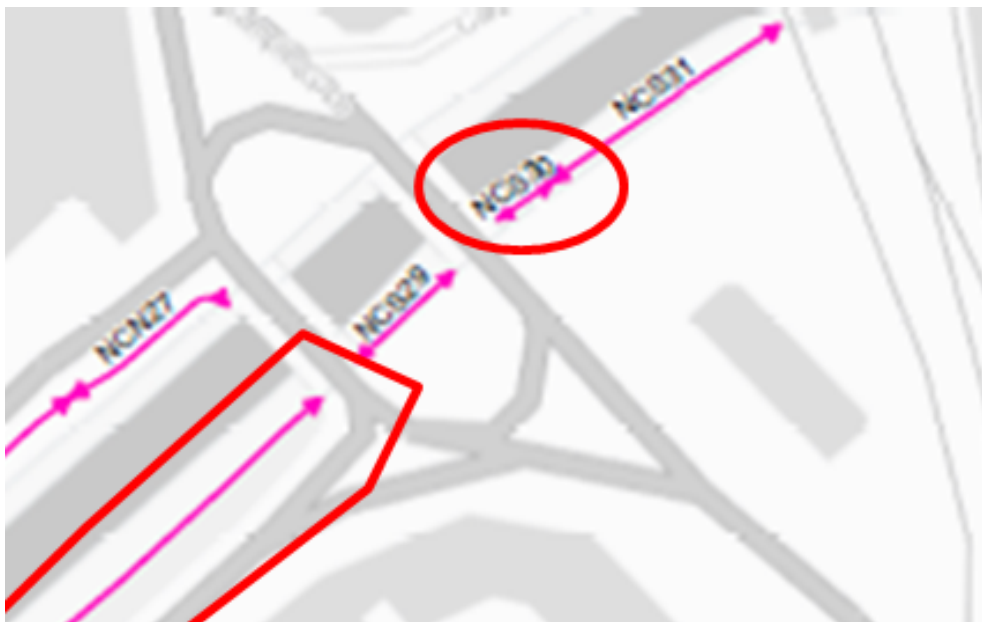
Immediately to the east of Bath Bridge Roundabout on south side of river

The arch adjacent to Bath Bridge Roundabout has failed from its springing point and the masonry is bulging significantly. There are also areas of collapsed masonry above this arch

Collapse of the arch will cause a loss of support to the retained material leading to a collapse of Network Rail land, exposing the edge of the bridge abutment and is likely to affect the stability of Bath Road

- Install barrier to prevent pedestrian access
- Installation of props or ties to restrain the bulging area and carry out repairs / reconstruction

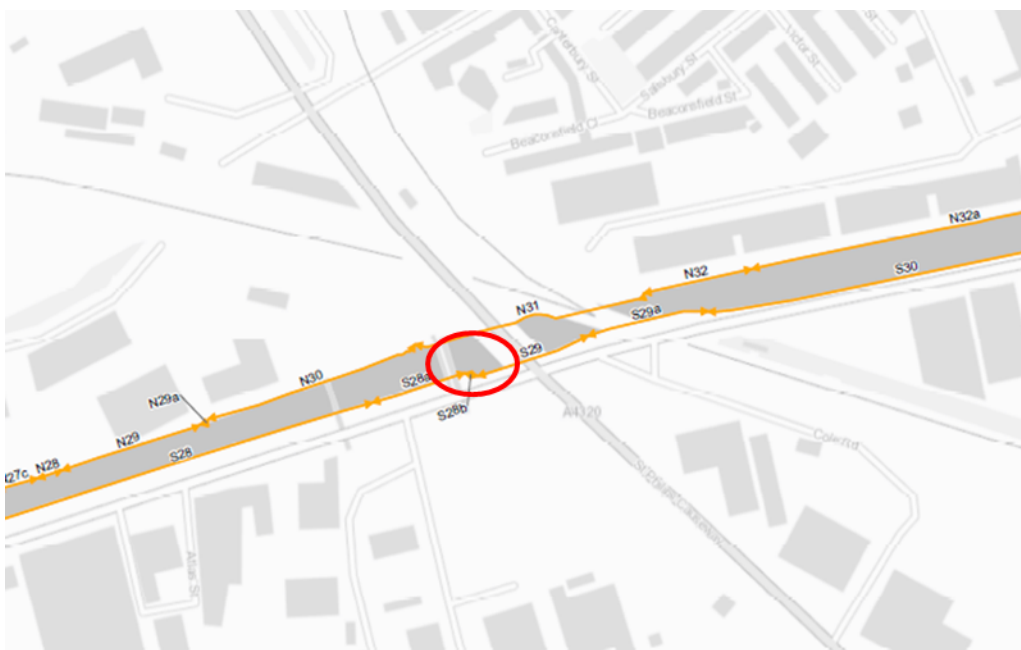
North side of Feeder road (canal south bank), in vicinity of St Phillips Causeway flyover

There are large areas of lost masonry underwater at the western end and numerous capping beam failures along the length. There is an extensive amount of vegetation growth from gaps between the concrete planks. There are several large areas of deformation visible on the capping beam
