# Bristol City Council

## Planned Preventative Maintenance Report

ELMFIELD SCHOOL, GREYSTOKE AVENUE,  
BRISTOL, BS10 6AY

**Prepared by:** Ben Hick (BSc (Hons))  
**Checked by:** Richard Turton BSc (Hons) MRICS  
**Date:** 30th April 2019  
**Our reference:** 3051556/BJH  
**Revision:**

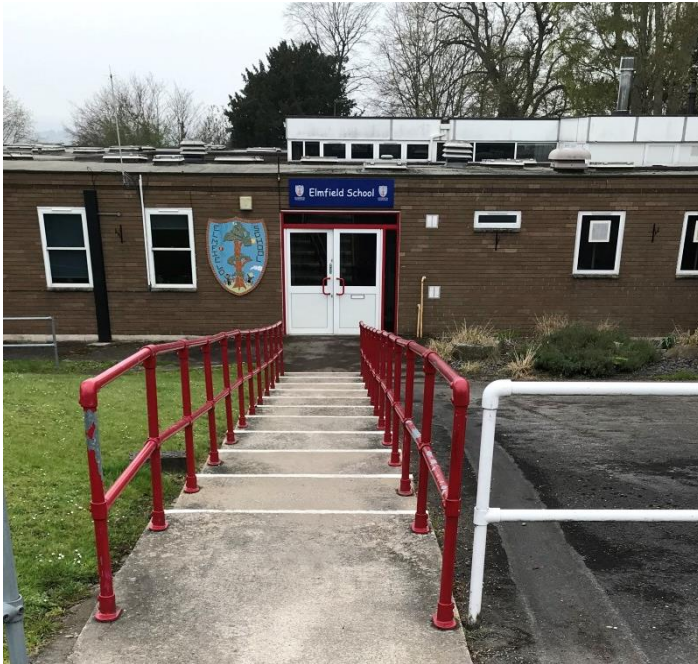
Summary: Elmfield School, Greystoke Avenue, Bristol, BS10 6AY

Property is a single storey structure with mineral felt flat roof and numerous Georgian wire roof lights. External walls are fair faced brickwork and powder coated aluminium double-glazed sash windows. Internal finishes to the majority comprise of a combination of vinyl and carpet floor coverings decorative finishes to walls and suspended ceilings.

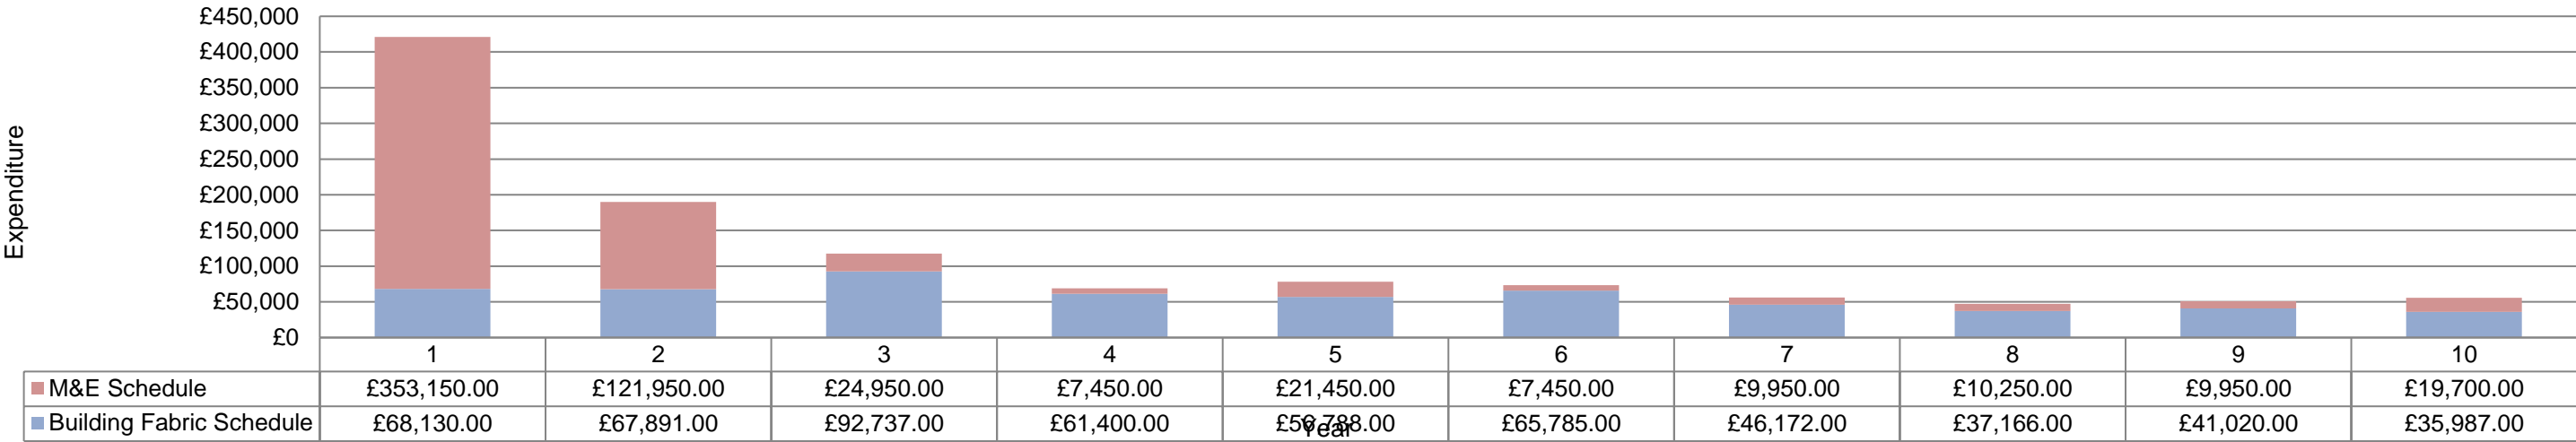
Annual Expenditure Summary: Graph

Year										
Ref.	Location	1	2	3	4	5	6	7	8	9	10	TOTAL
1	Building Fabric Schedule	£ 68,130.00	£ 67,891.00	£ 92,737.00	£ 61,400.00	£ 56,788.00	£ 65,785.00	£ 46,172.00	£ 37,166.00	£ 41,020.00	£ 35,987.00	£ 573,076.00
2	M&E Schedule	£ 353,150.00	£ 121,950.00	£ 24,950.00	£ 7,450.00	£ 21,450.00	£ 7,450.00	£ 9,950.00	£ 10,250.00	£ 9,950.00	£ 19,700.00	£ 586,250.00
	Totals

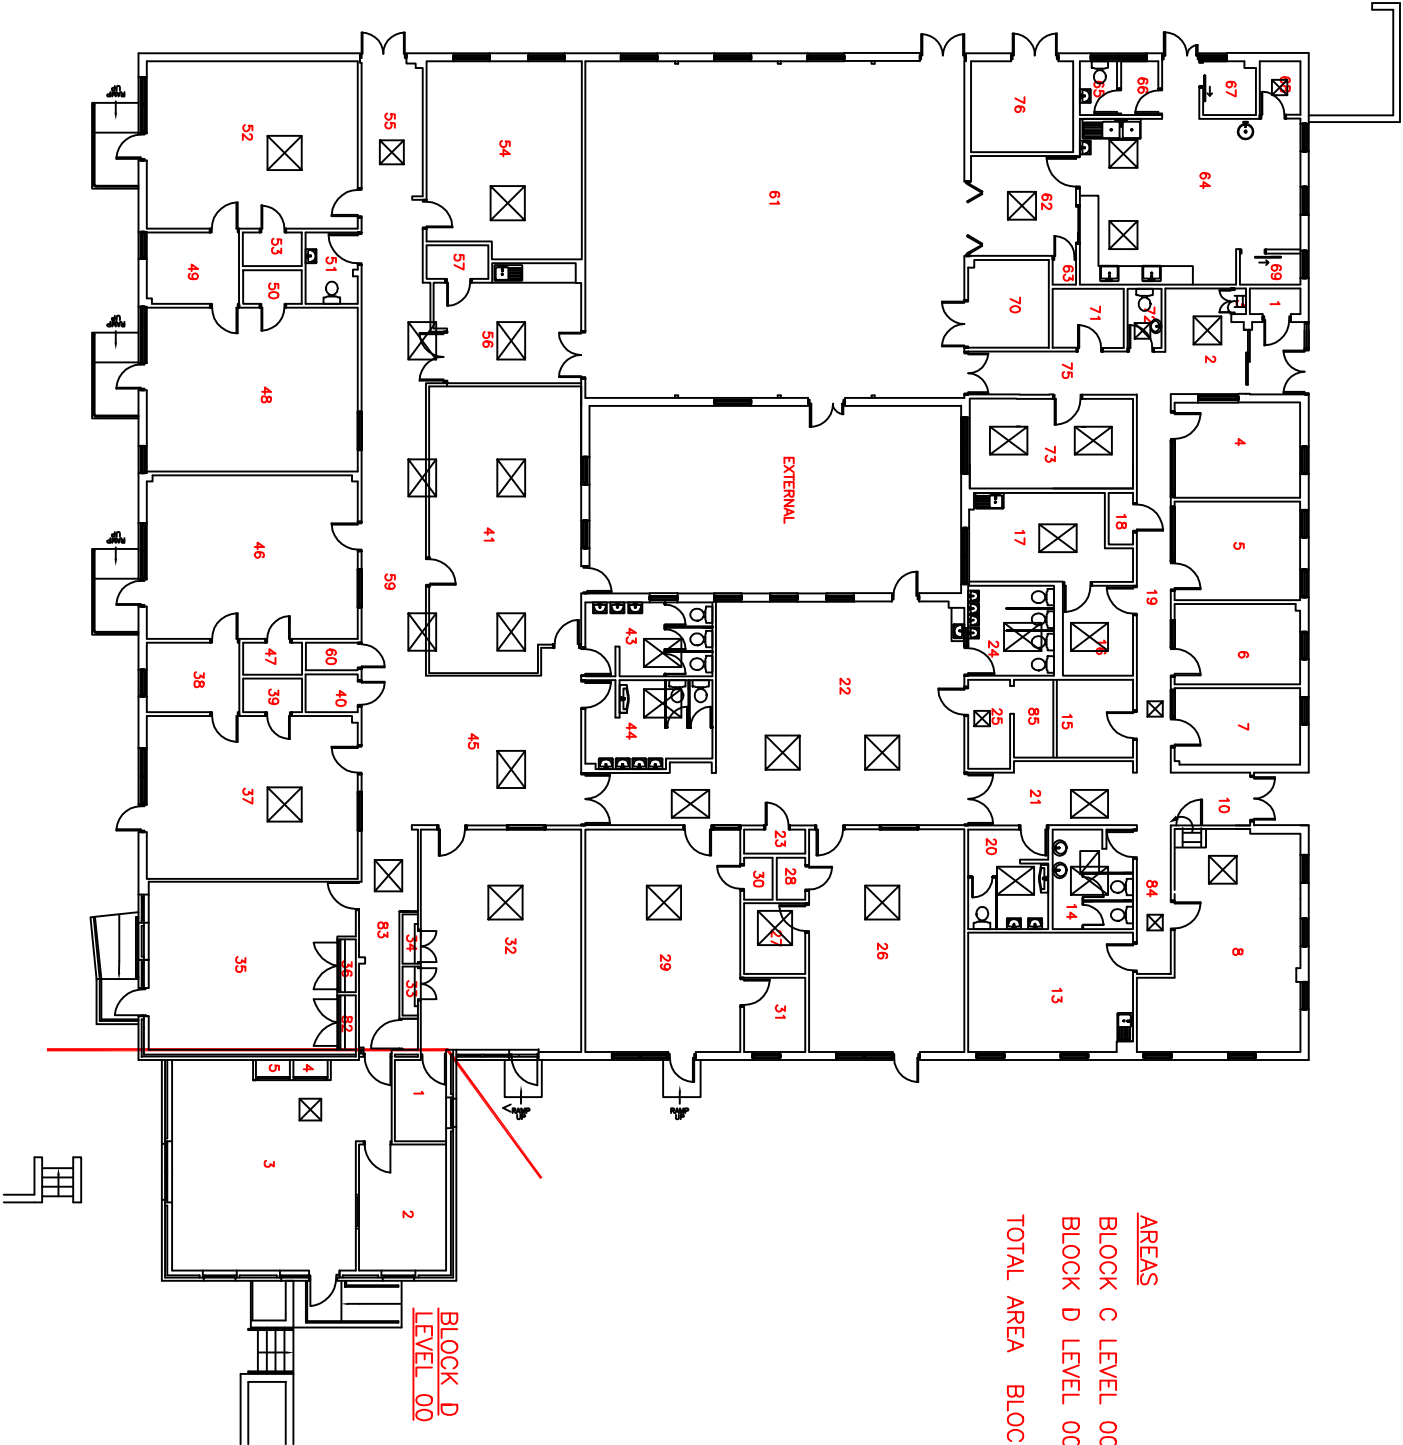
BLOCK C LEVEL 00 = 1102.7
